A techno-economic balance for zonal

The selection of refractory lining design and installation of targeted high-wear areas of torpedo ladle lining using innovative techniques have doubled the life of torpedo ladles to 2,500 cycles equating to the transport of 775kt hot metal per ladle before relining. This is the first step in the direction of endless lining in torpedo ladles, argues **RB Gupta***

lining of Torpedo ladles at Rourkela

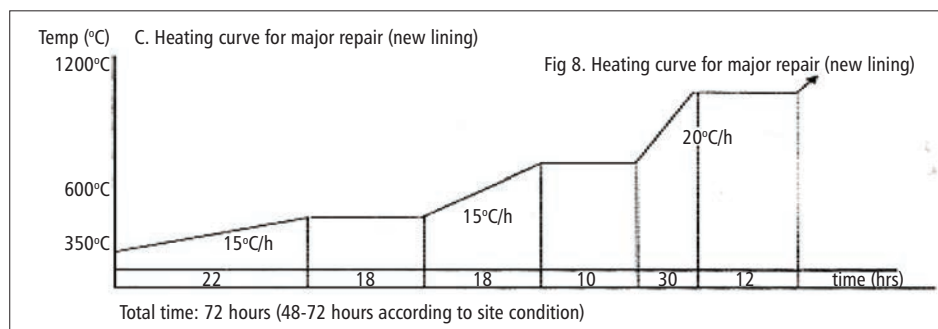
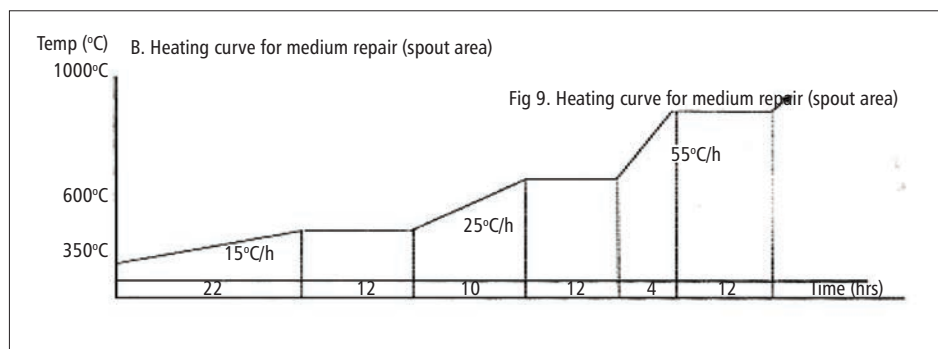
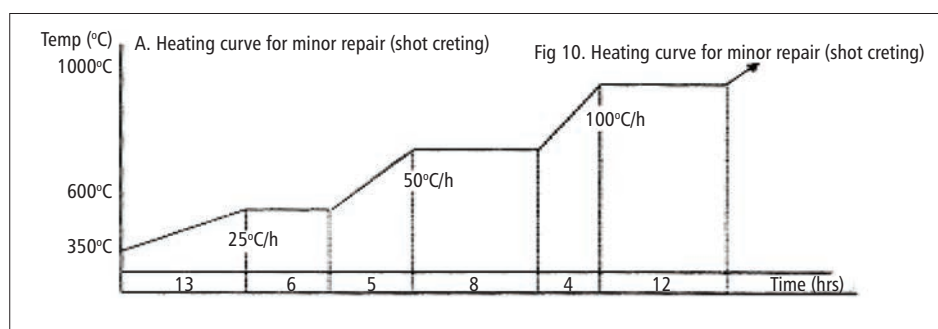
mitigating the number of cracks. Also, uniform heat penetration fosters more favourable conditions for chemical reactions in the lining. This strengthens material properties while reducing thermal shock when hot metal is freshly poured into the repaired torpedo ladle. The modified heating cycles have been shown in **Figs 3-5**.

Modification in heating cycle following repair / new lining: This was carried out with the aim of homogeneity in the heat-up of replaced refractory to achieve a constant and uniform removal of water (free and combined) and binding compounds. Uniform temperature distribution with a regular heating rate lessens thermal stresses upon the refractory lining thereby
