**Top Glove , Top Quality , Top Efficient ,  
Good Health , Safety First & Be Honest  
Production Department (F10)**

**THIN AREA – ROOT CAUSE  
&  
CORRECTIVE/PREVENTIVE ACTIONS.  
(NATURAL RUBBER PRODUCT )**

**Present By :  
MR. NYANASEKARAM  
ASSISTANT MANUFACTURING MANAGER (F10)**

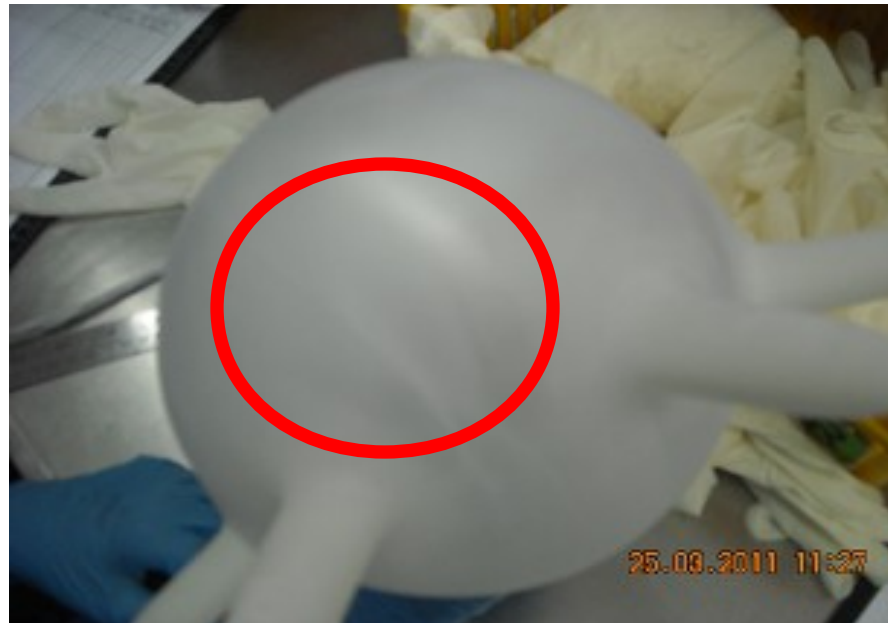
- Thin Area Gloves (TA)

It can be defined as severe thin area which can be easily torn . \_

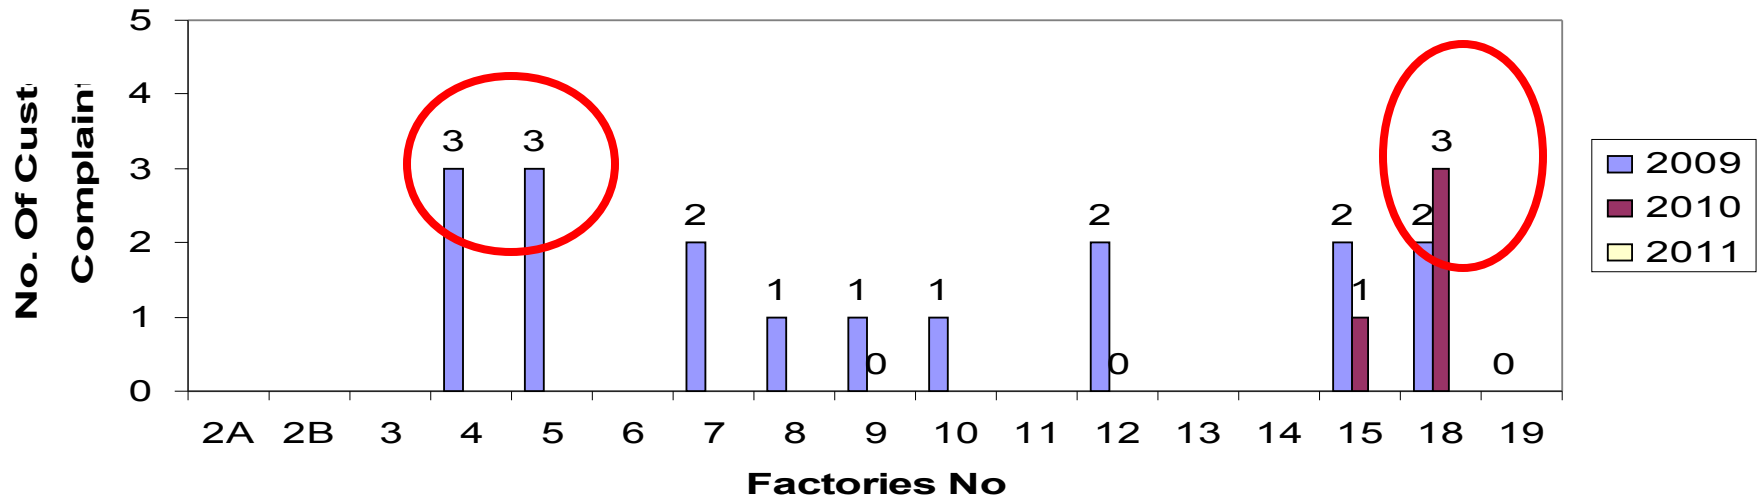
Comparison Based On Thin Area Gloves For All TG Factories For Year 2009/2010/2011

- The highest complaint for 2009 are from **F4 and F5 with 3 complaints.**
- For 2010, **significance improvement** has been shown from all factories **excepted F15 and F18** with 1 and 3 complaints respectively.
- For 2011, until current date, no TA complaint has been forwarded by our customer.

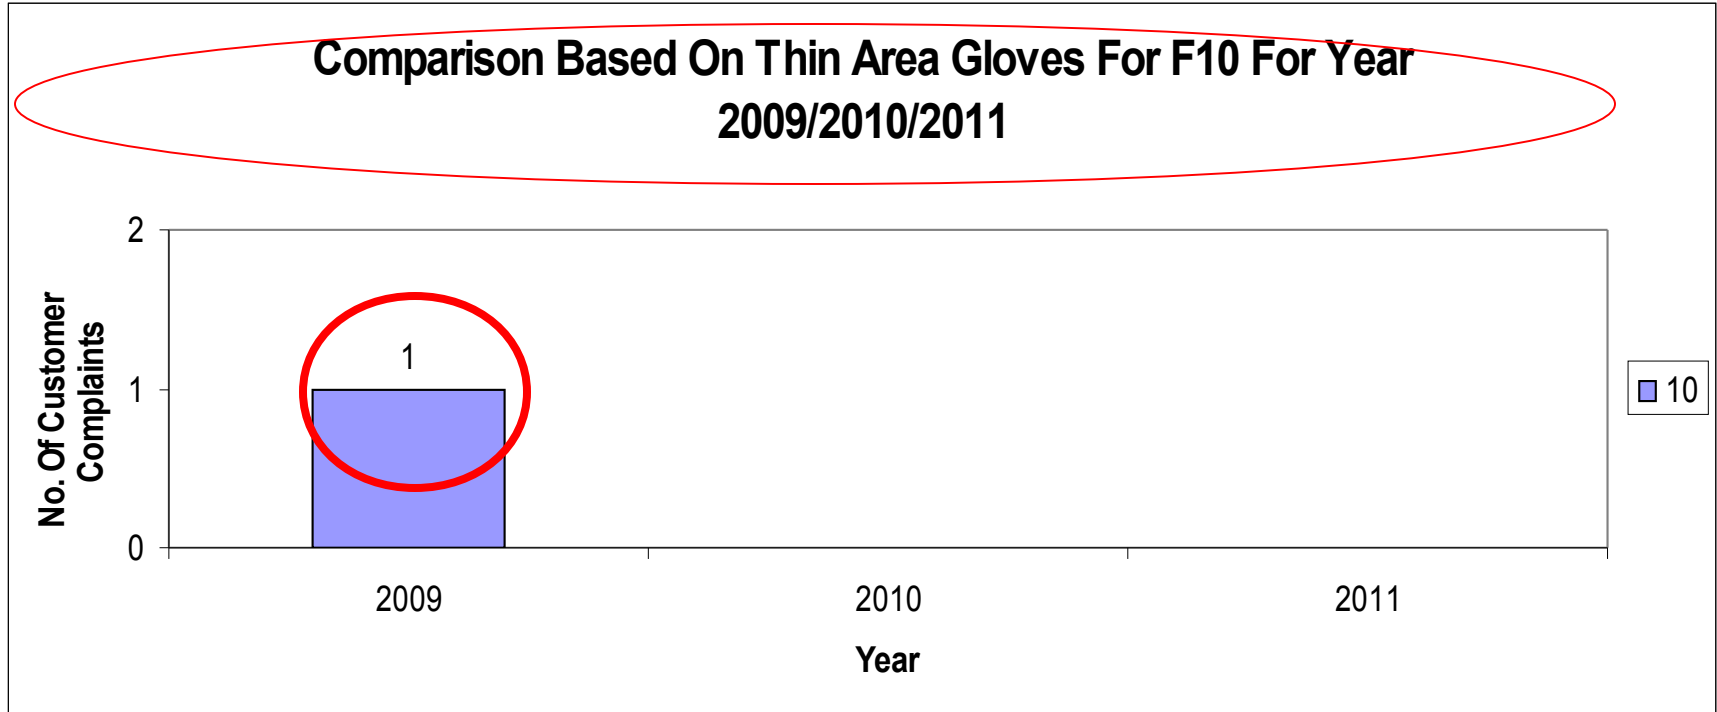
- F10 has only received one complaint for this defect which is in year 2009.

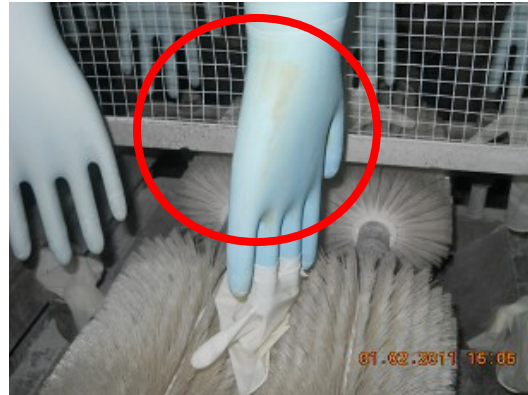
➡ Operators did not **clean the formers properly.**

1. Each line **need to screen former by daily basis**. The defective formers such as crack former, former with pimples , worn out former need to be replaced.

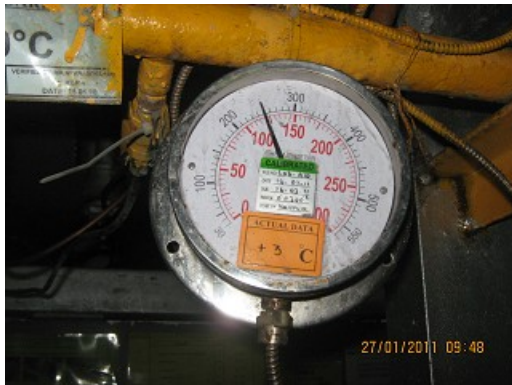
**Wrong setting ( below std. ) of latex oven temperature and wrong position of burners arrangement .**

1. To ensure the **correct setting of burners position**. This is able to ensure sufficient **gelling of latex to prevent “wash off”** .
2. **The latex TSC and SI need to be controlled well** based on type of glove weight .
3. **The latex tank temperature cannot be too low** must be within standard .

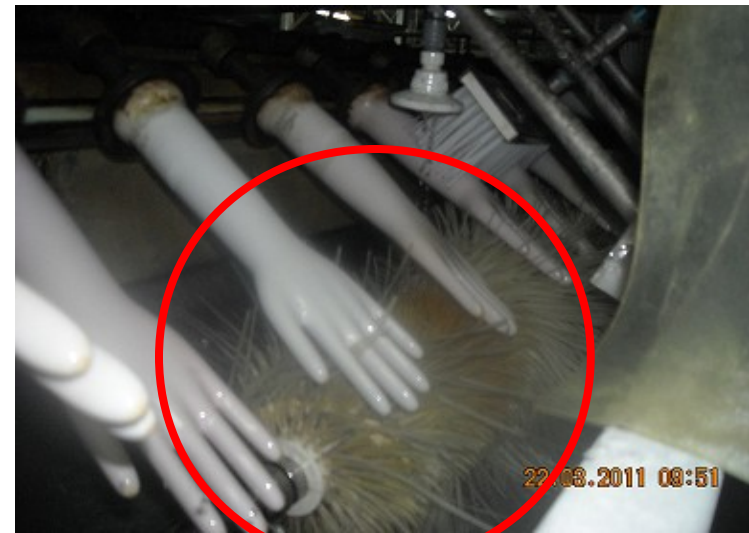
➡ **Using worn out brushes .**

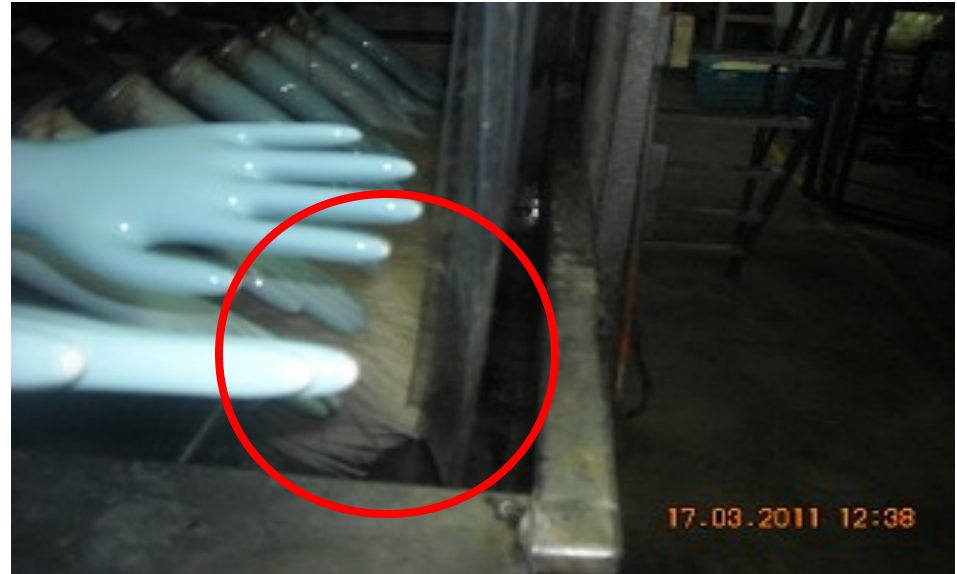
➡ **Poor setting** of white brush at **SWB** tank.

➡ Ineffective **SWB** .

1. **Modified the small washing brush** by lifted up the brushes until it is able to wash the between fingers area effectively.
2. **Installed a “bumper” on former track in SWB so that the former can be cleaned effectively at both side .**
