Problem 2: Aluminum ceiling corrosion

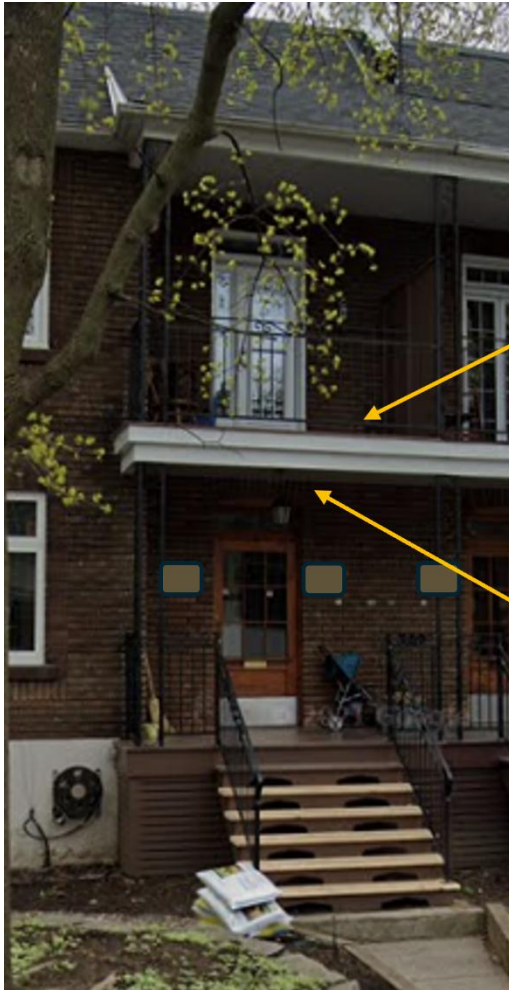
The floor of the 1st floor balcony is made with treated pine wood

The ceiling of the ground floor balcony is made with a painted aluminum panel
