RCA

IH 10

- Houston District
- IH 10
- 1995 to 1998
- 11"

Background

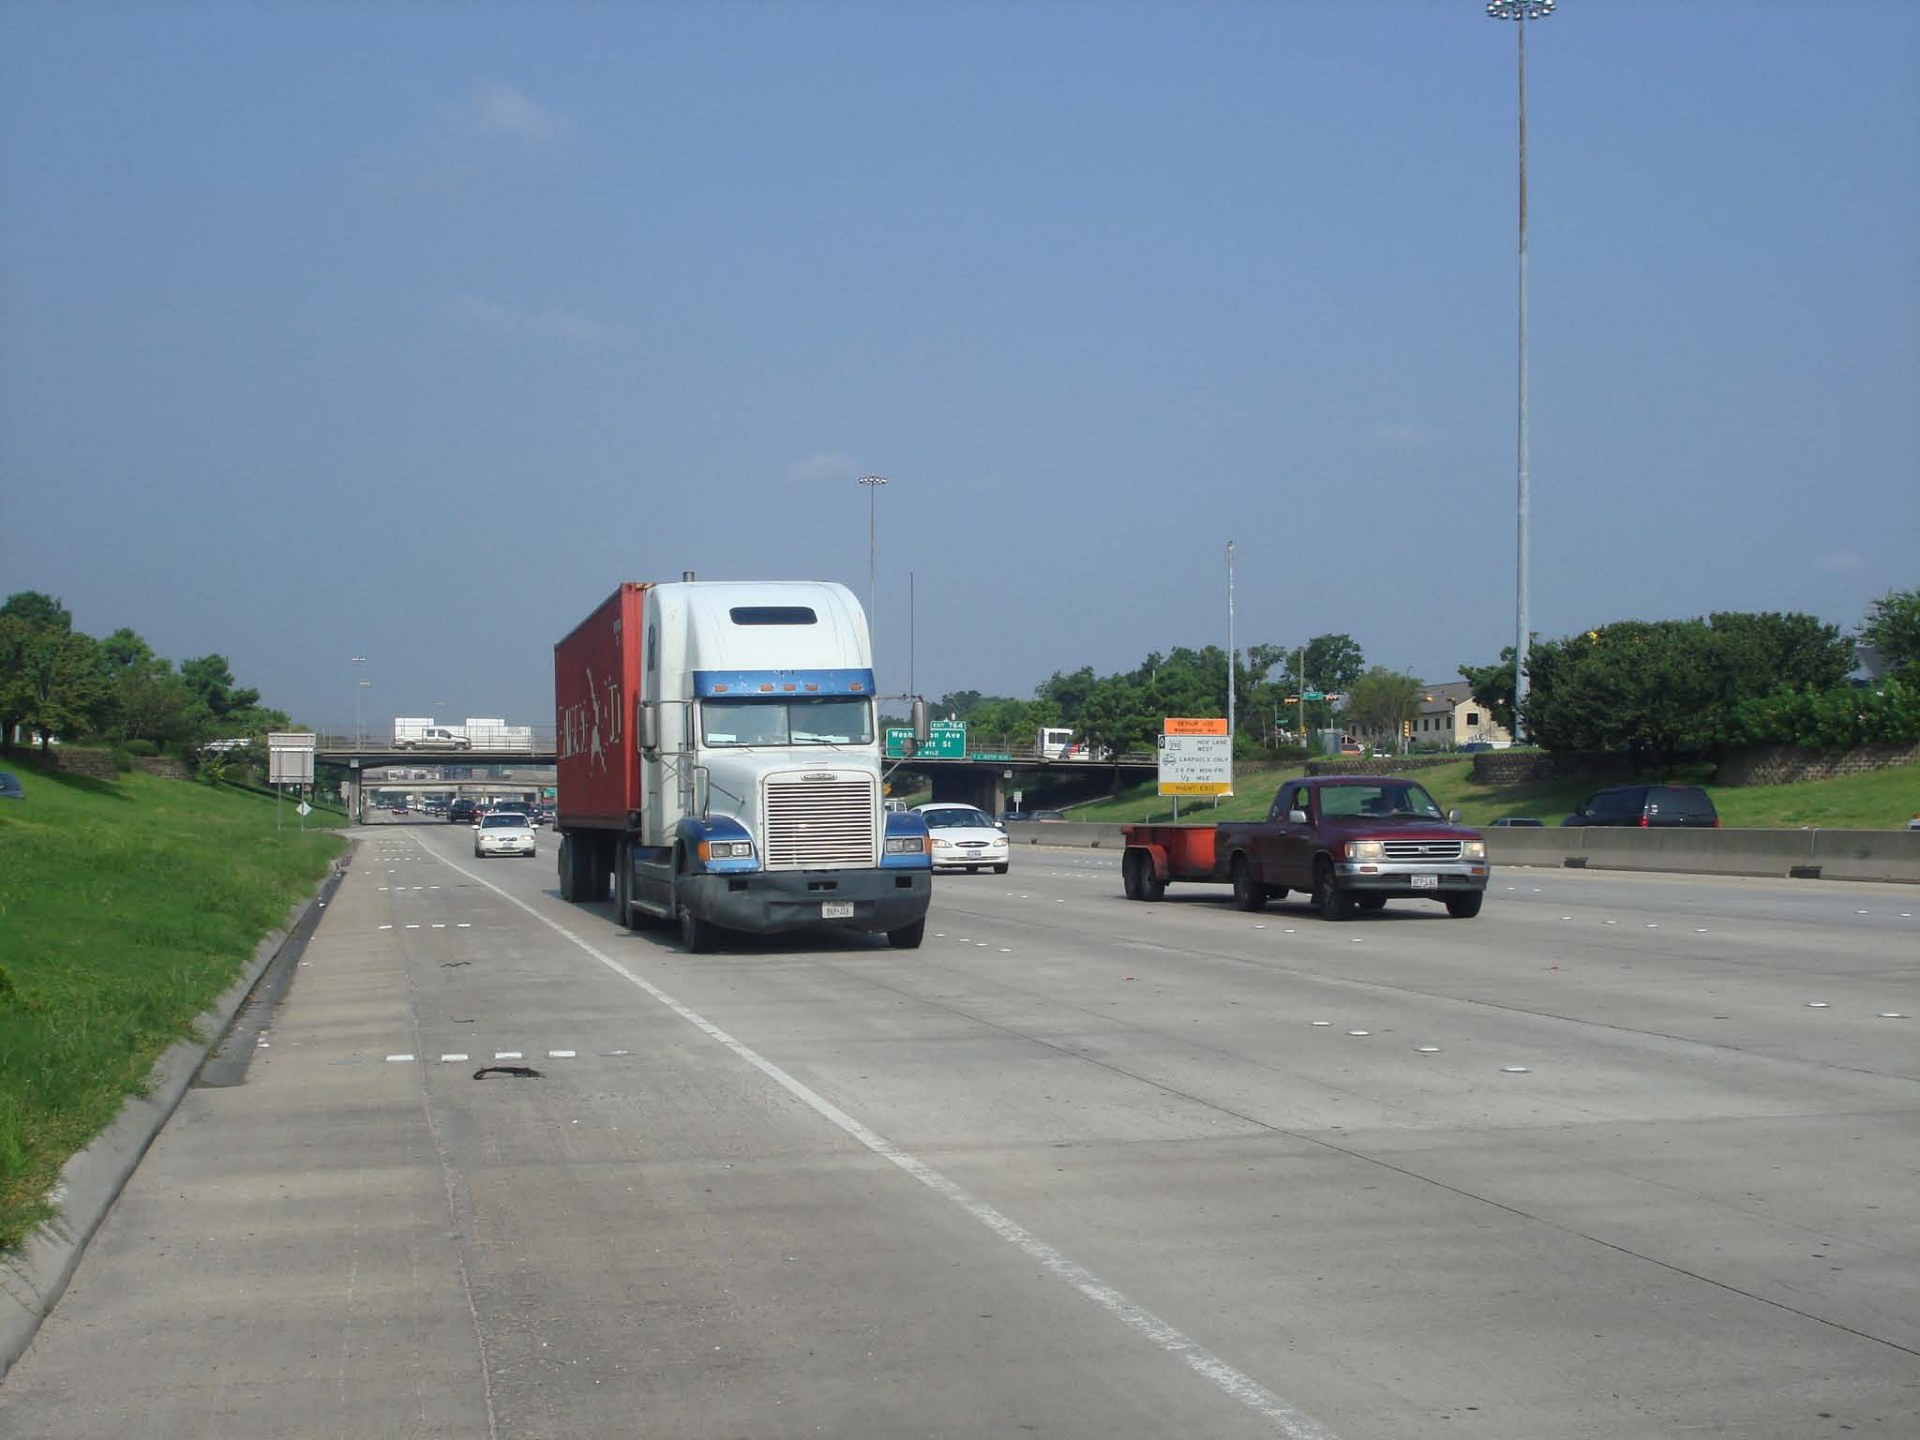
- **Rehab Project in Houston, Texas**
- **I-10 between I-45 & Loop 610 West**
- **Project Length: 5.8 Miles**
- **Existing CRCP: Constructed in 1968**
- **Rehab Project: 1995-1998**
- **10 Lanes + HOV**
- **No Virgin Aggregates Used for Concrete- All RCA
(Both Coarse & Fine)**

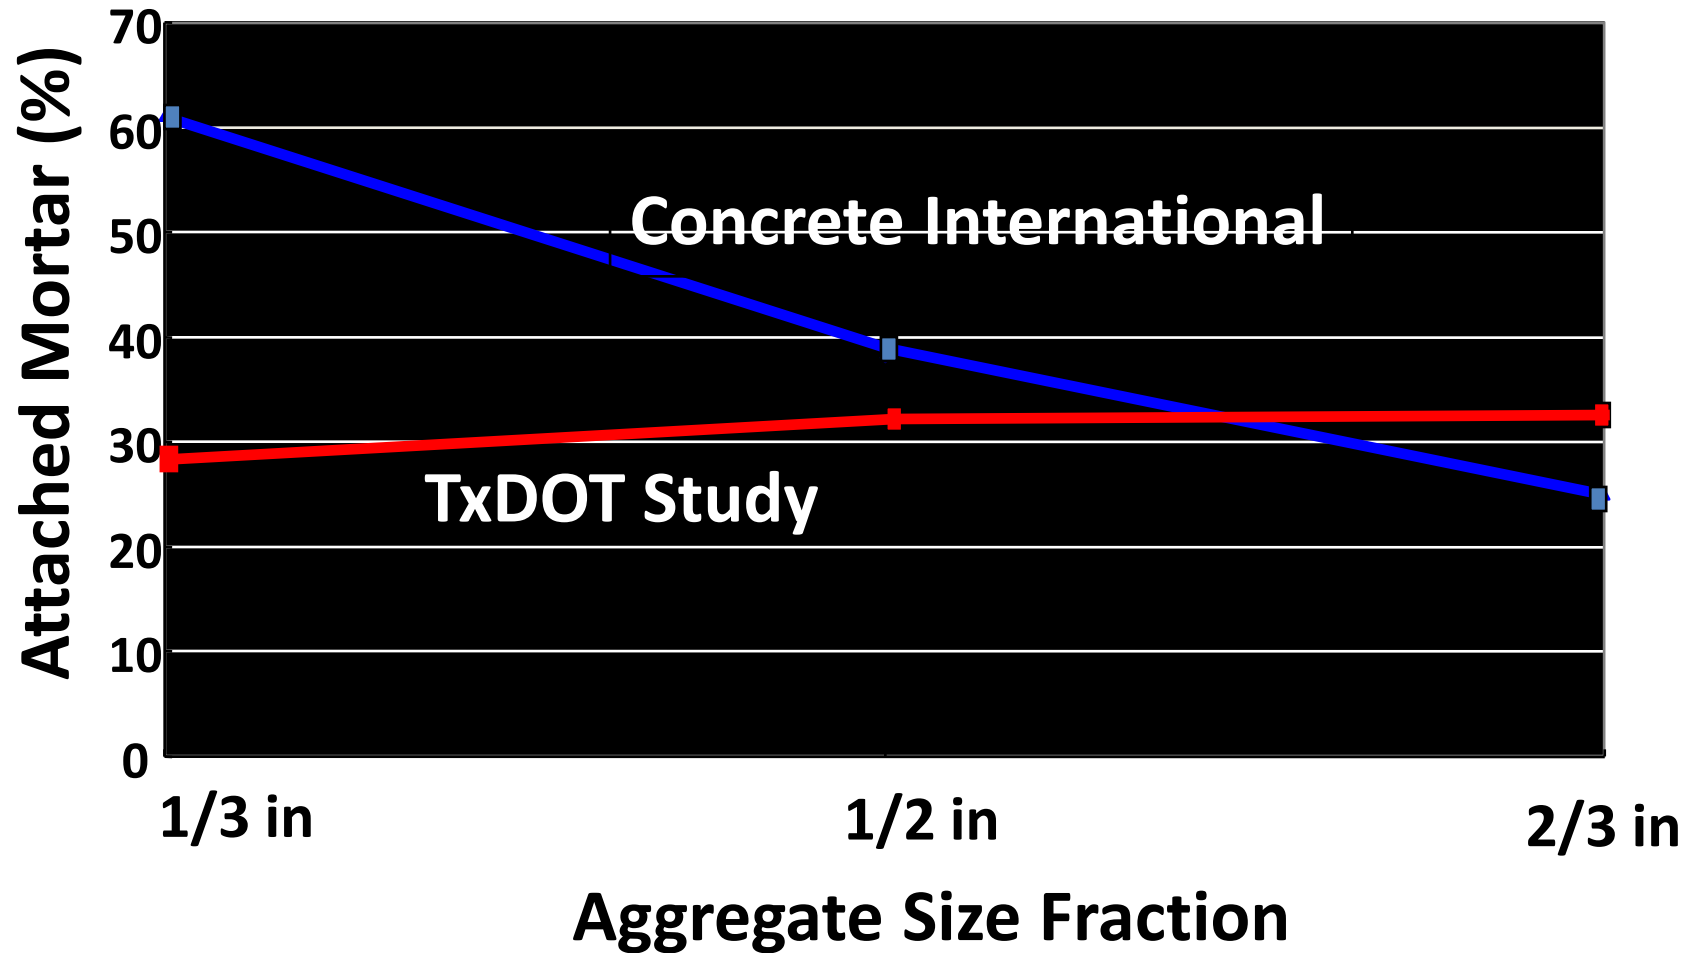
Mortar Volume Attached to Gravel

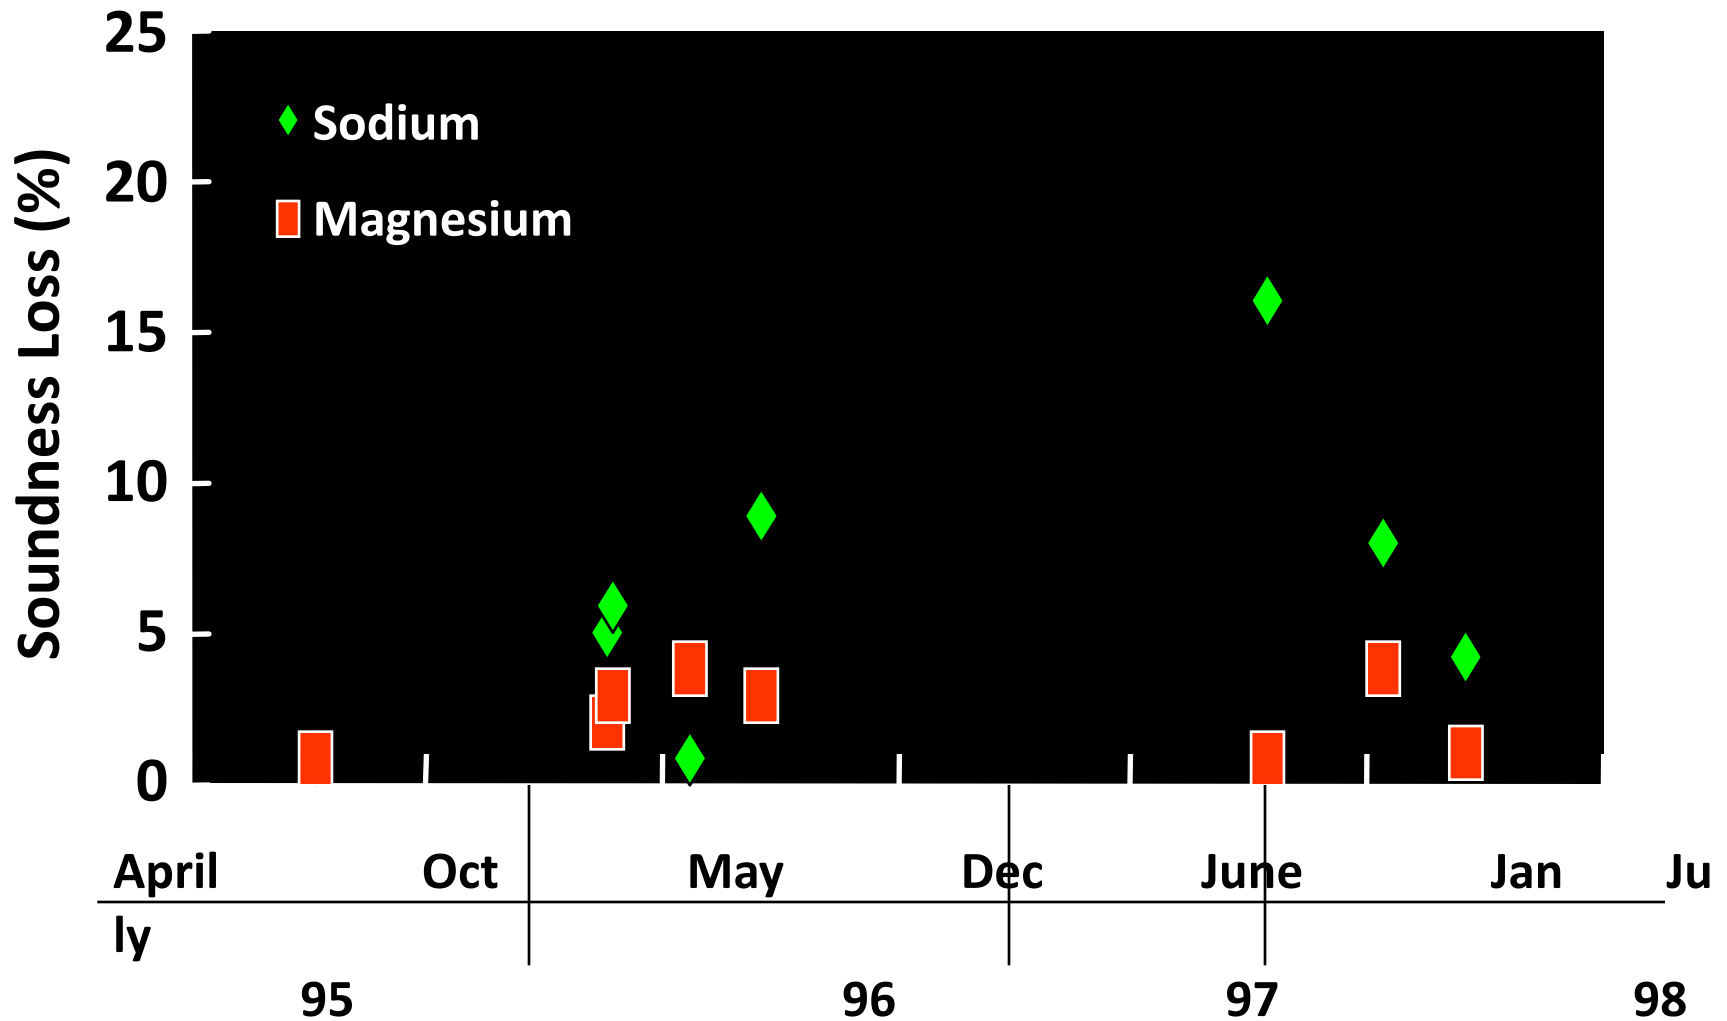
Soundness Loss of RCA

- The properties of RCA measured in this study are consistent with those reported elsewhere.
 1. Gs
 2. Water Absorption
 3. Sulfate Soundness Loss
 4. LA Abrasion Loss
 5. Angularity
- Sodium sulfate causes more damage to recycled aggregates than magnesium sulfate does.

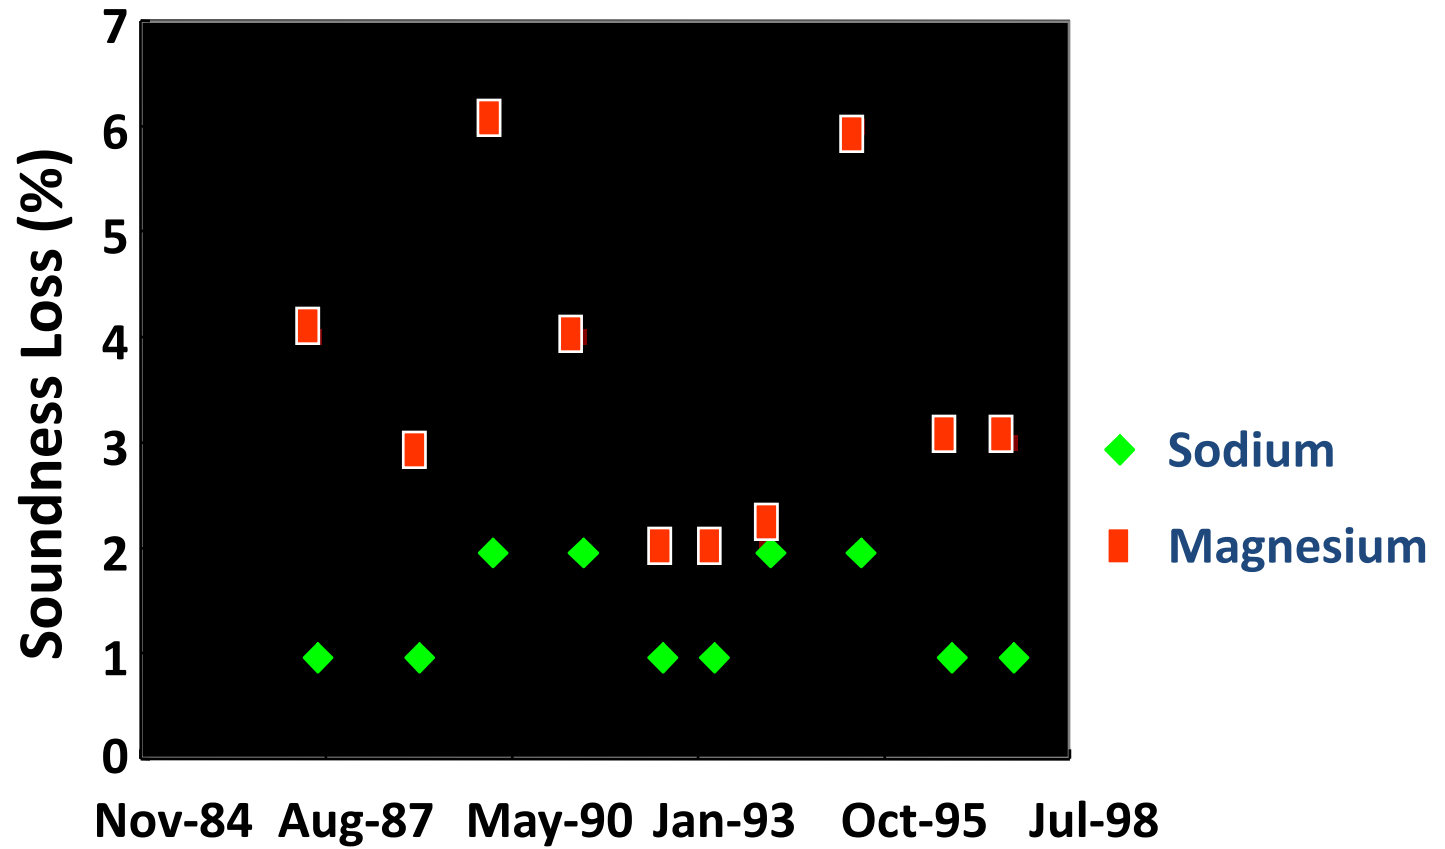
Soundness Loss of Gravel

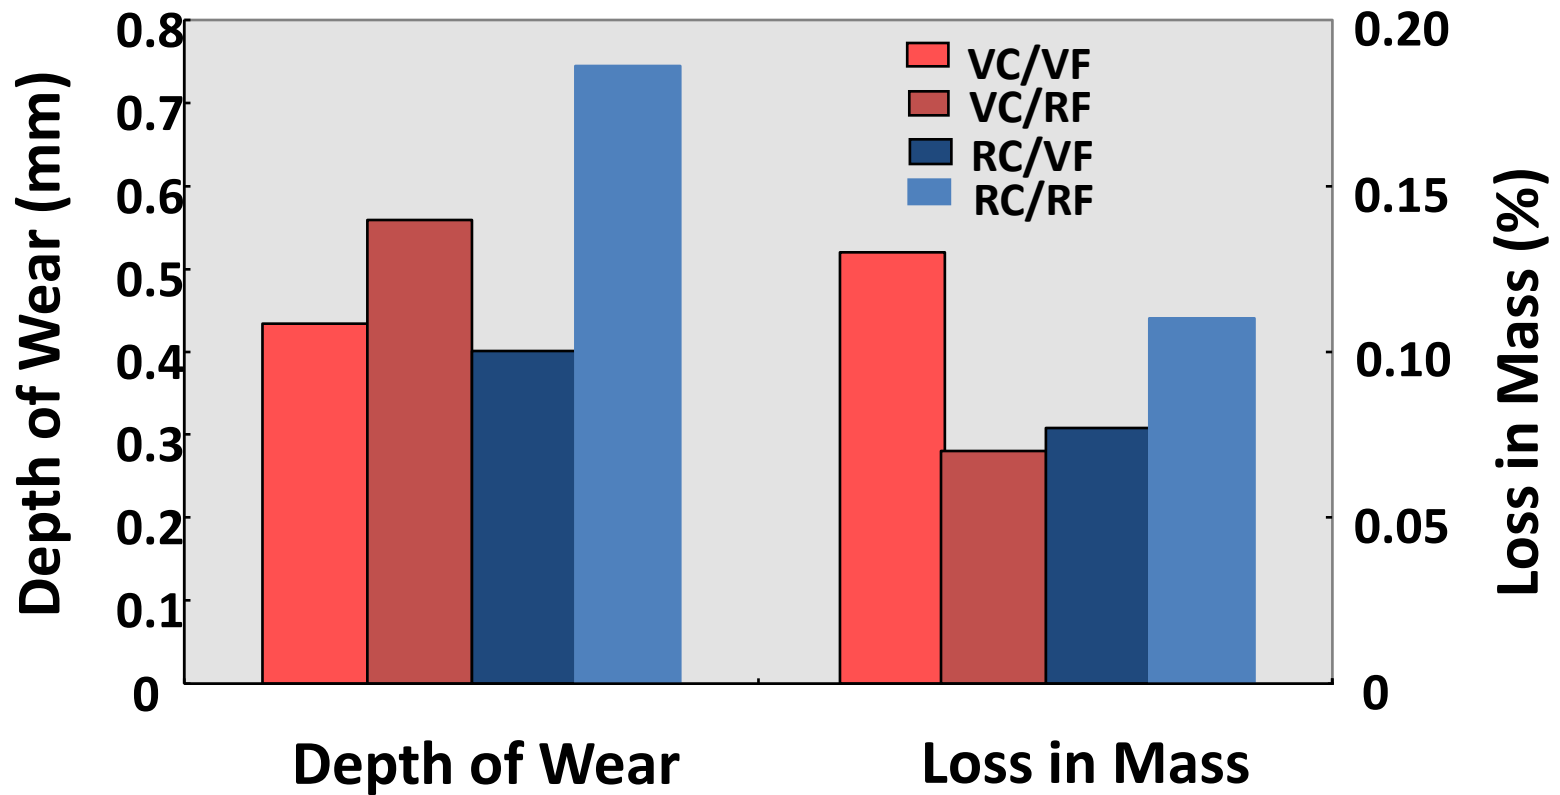
Abrasion resistance of various aggregate mixes

- Recycled fine aggregate has an adverse effect on strength.
- The use of both recycled coarse and fine aggregates reduces modulus of elasticity of concrete substantially.
- Thermal coefficient of concrete with 100% RCA is higher than that of virgin aggregate concrete.
- The effect of recycled aggregate on the abrasion resistance of concrete is inconclusive.

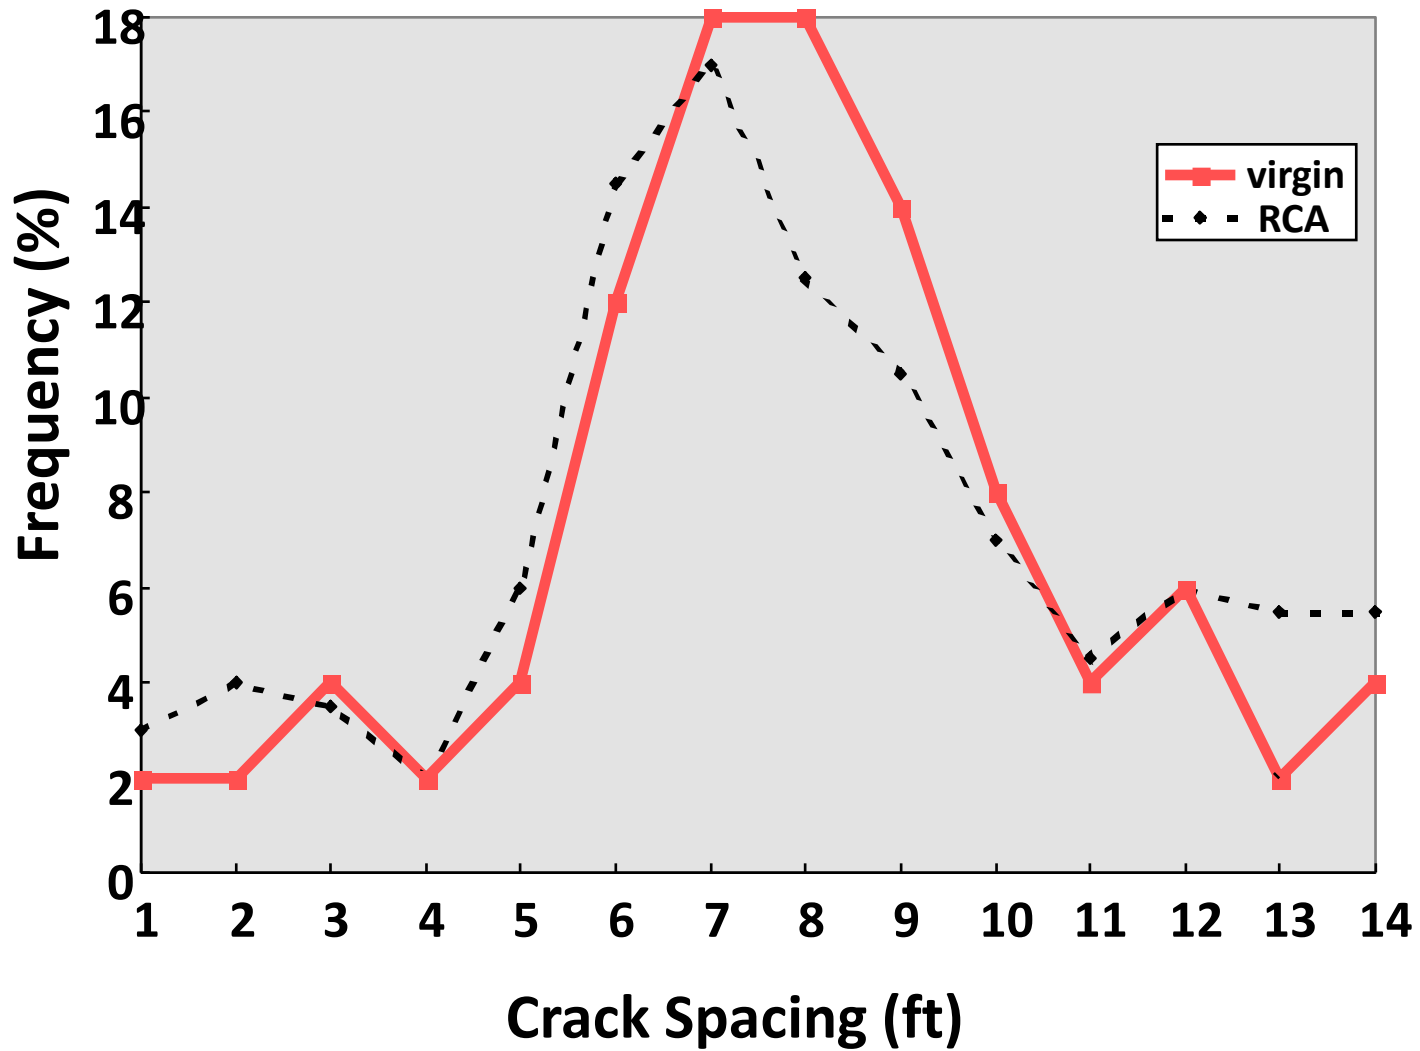
Crack Spacing Distribution of Virgin & Recycled Sections

- **CRCP utilizing 100% recycled coarse & fine aggregates has performed well.**
- **The large amount of old mortar in RCA does not appear to have adverse effect on CRCP performance.**
- **Moisture control of recycled aggregate is critical in producing consistent and workable concrete.**
- **No significant adjustment is necessary in paving operations due to the use of 100% RCA.**
