The development of a multi-spectral sensor and unmanned helicopter for the inspection of electrical power lines

Roel Stolper*, Peter Skinner*, Jaco Hart*, Thegaran Naidoo, Deon Joubert*
Nishal Mahotho**
Dean Grobbelaar***

*CSIR, Pretoria, South Africa
** Eskom Holding SA
*** Aerial Concepts SA

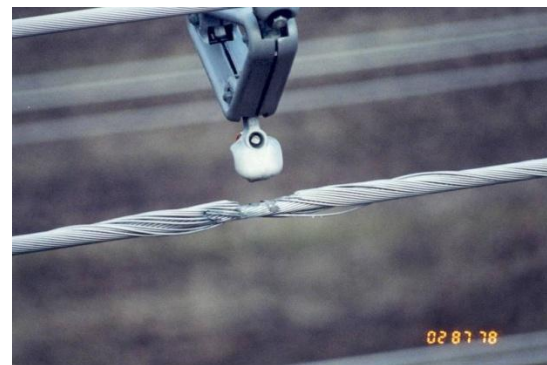
Figure 1. Transmission line defect – partially broken strands

Over time the insulators may crack or break due to wear or environmental conditions such as fungal growth on the insulators. Internal cracks in the insulators can be very difficult to detect. Another common problem is partially broken connections at various junction points. Such broken connections may not be easily detected through visual inspection alone since the transmission lines have multiple strands and some strands within the bundle may break making them difficult to detect.

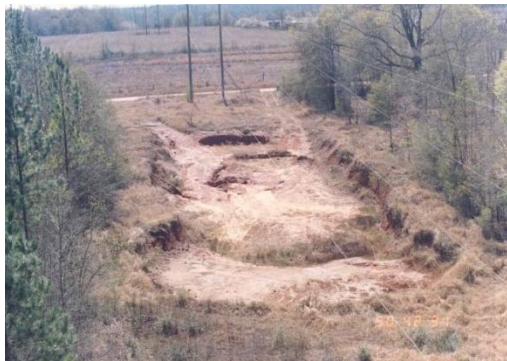
Figure 2. Inspections from the ground can be impeded by difficult terrain.

Currently, the inspection of the pylons and the servitude is performed in one of two ways. The first involves sending a two-man crew, equipped with a standard camera, to drive along the lines and perform the inspections from the ground. This limits the view of the insulators and sometimes the terrain can be difficult to cross. These foot patrols are carried out once per year.

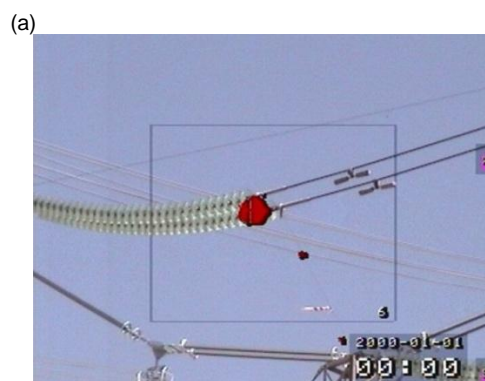
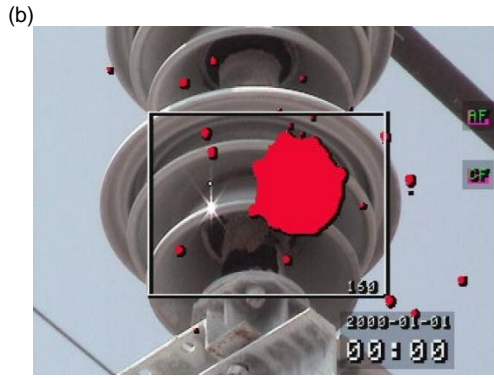
Figure 3(a) and (b). Corona which is invisible is detected on the insulators and highlighted as red blobs.

Corona discharges are typically associated with cracked or broken insulators, missing corona rings or broken ground plate connections. By analysing the amount and distribution of the corona effects one can detect these faults. As an example, figure 3(a) shows a ceramic insulator being inspected in the ultraviolet band using the multi-spectral camera. The red blob indicates that corona has been detected at the live end of the insulator and this degree of radiation typically indicates a missing corona ring. Figure 3(b) shows that significant corona radiation has been detected at earth level and this typically indicates either fungal growth or a cracked disc.

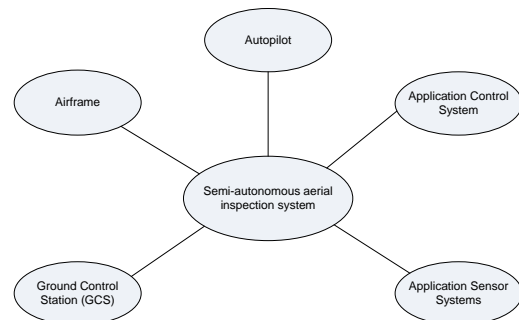
Figure 5. Technology building blocks for semi-autonomous aerial inspection system

Figure 5 shows the main technology building blocks of the aerial inspection system that was developed. The research focused on the development of the airframe, the application sensors and a safety system. This is described in section 4. The results achieved in these components are described in sections 4.3 and 5.

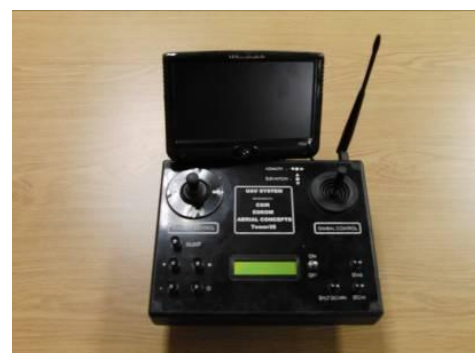
The gimbal transmits video telemetry and receives control commands from a ground control station which is shown in figure 7. The communications link operates at a 2.4GHz frequency.

Figure 7. Ground control station

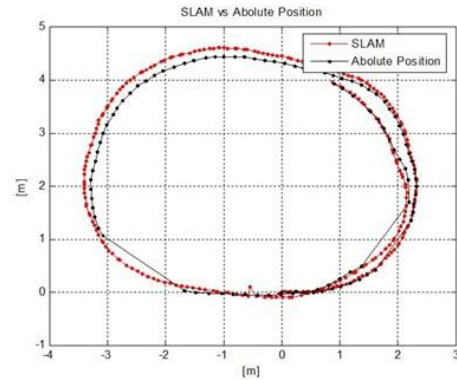
The system was implemented and evaluated and the results are summarized in the graphs in figure 8. The black graph shows the actual path (ground truth) traced out by the vehicle as measured by an external sensor. The red graph shows the path as determined by the EKF-SLAM algorithm. It was found that the areas of higher correlation corresponded to areas in the physical environment that contained more features to help the location. This result is expected with EKF-SLAM.

Figure 8. EKF-SLAM results.

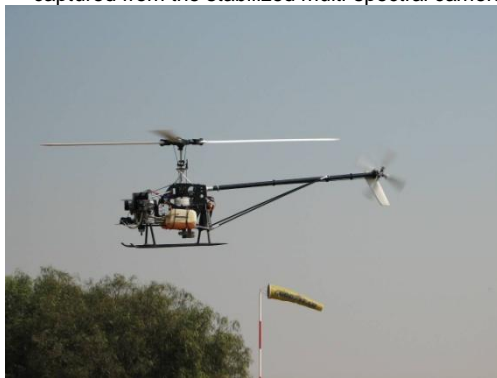
Figure 11. The RUAS flying 4 m above ground with a total lift weight 25kg

Currently the RUAS as shown in figure 11 is remotely piloted, with a total lift capacity of 25kg (airframe, fuel and payload) and it was able to fly for one hour on a single tank of fuel. The endurance test was carried out in intervals of ten minutes to allow the test pilot a break in between.
