IN THE HIGH COURT OF THE REPUBLIC OF SINGAPORE

[2017] SGHC 246

JUDGMENT

**Smile Inc Dental Surgeons Pte Ltd
v
OP3 International Pte Ltd**

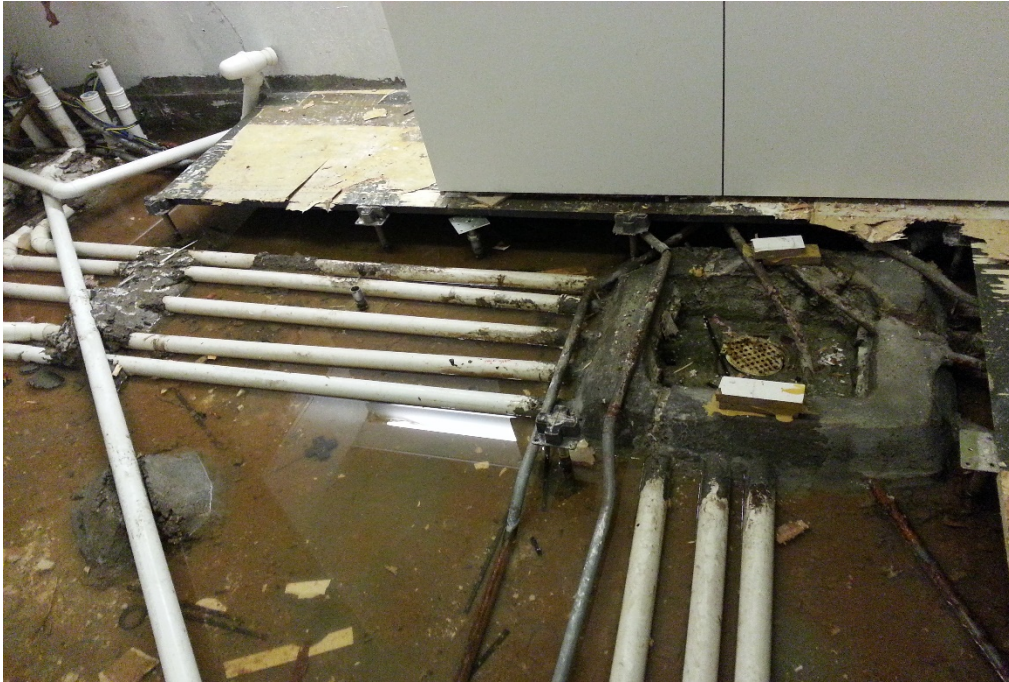
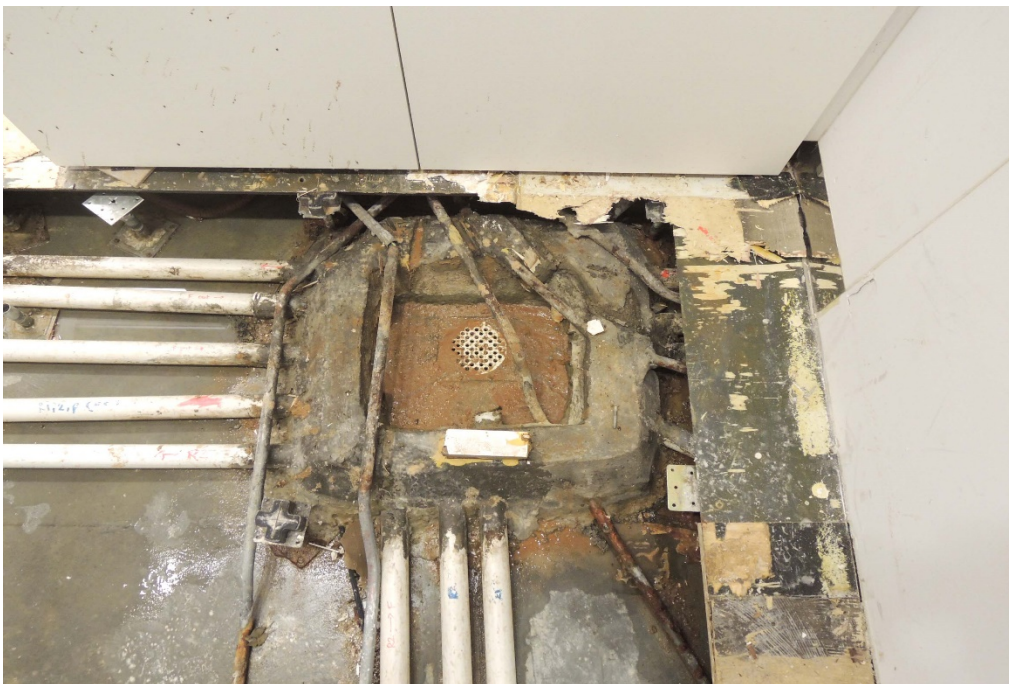
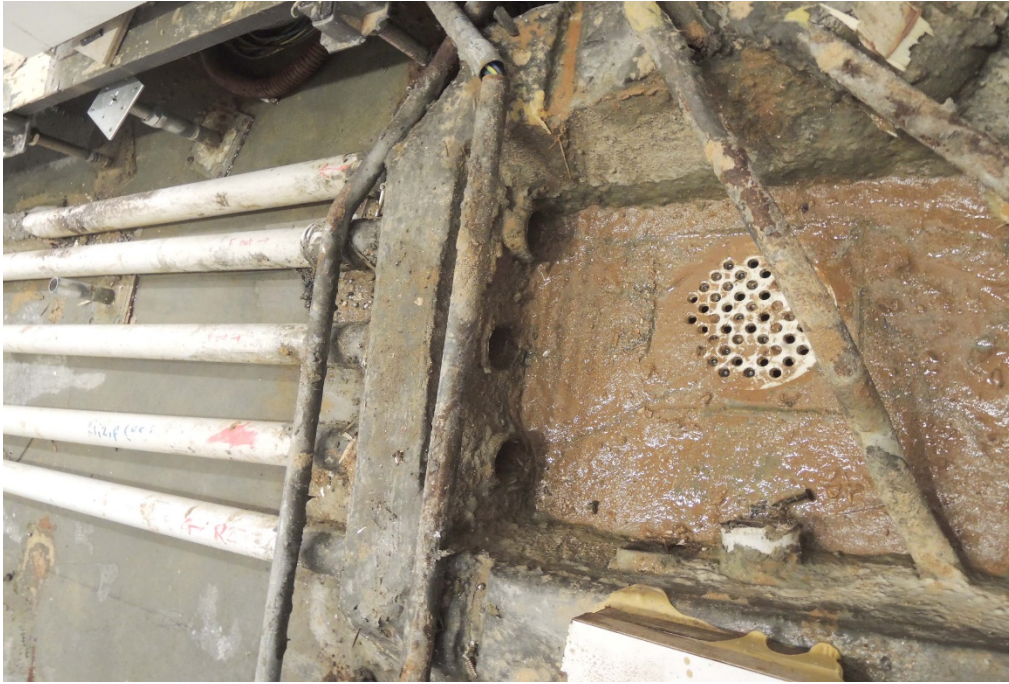
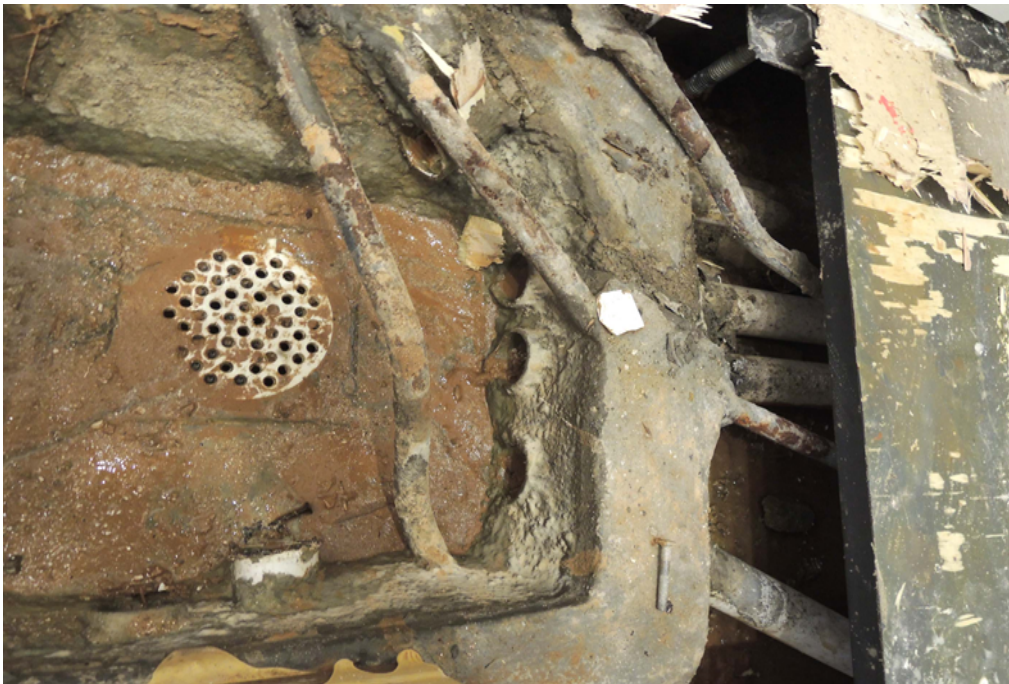
(b) The drainage downpipe for water to be discharged out of the Suntec Clinic (the “Drainage Downpipe”) was situated in a raised bunded area (the “Bunded Area”). The Suntec Clinic produced debris, which clogged up the white circular plastic floor grating (the “Floor Grating”) that covered the Drainage Downpipe. This caused water to overflow the Bunded Area. (The Bunded Area is 340mm in length and 300mm in breadth, and is enclosed by a bunded concrete wall 65mm in thickness and 100mm in height. The photographs in Annex A to this judgment show the Bunded Area.)

raised floor that the discharge pipes took, or how they were joined *before* reaching the Bunded Area, but in the design of the Bunded Area itself. In particular, as I explain below, the design was defective because the discharge outlets of the discharge pipes ended *above* the Floor Grating, and because the Floor Grating was included to begin with.

107 For the reasons stated above, I agree with the plaintiff’s submission that terminating the nine discharge pipes *above* the Floor Grating, and at the raised Bunded Area, was a serious design flaw, which was the primary cause of the 1st and 2nd Floods. I find that no reasonable contractor would have provided for such a drainage system, which Dr Liew likened to a “death certificate signed” for flooding to occur.⁶³

111 For all these reasons, I accept the plaintiff's submission that the flooding was primarily caused by (a) the termination of the outlets of all nine discharge pipes above the Floor Grating; and (b) the presence of the bunded walls, which prevented water outside the Bunded Area from draining into the Drainage Downpipe.

115 Further, Dr Liew also observed that, on the whole, the construction was shoddy. The walls and floor of the Bunded Area should at least have been tiled for hygiene purposes, instead of being left with rough unfinished cement surfaces. Tiling up the Bunded Area would have helped to prevent mould growth and would not have been very costly.

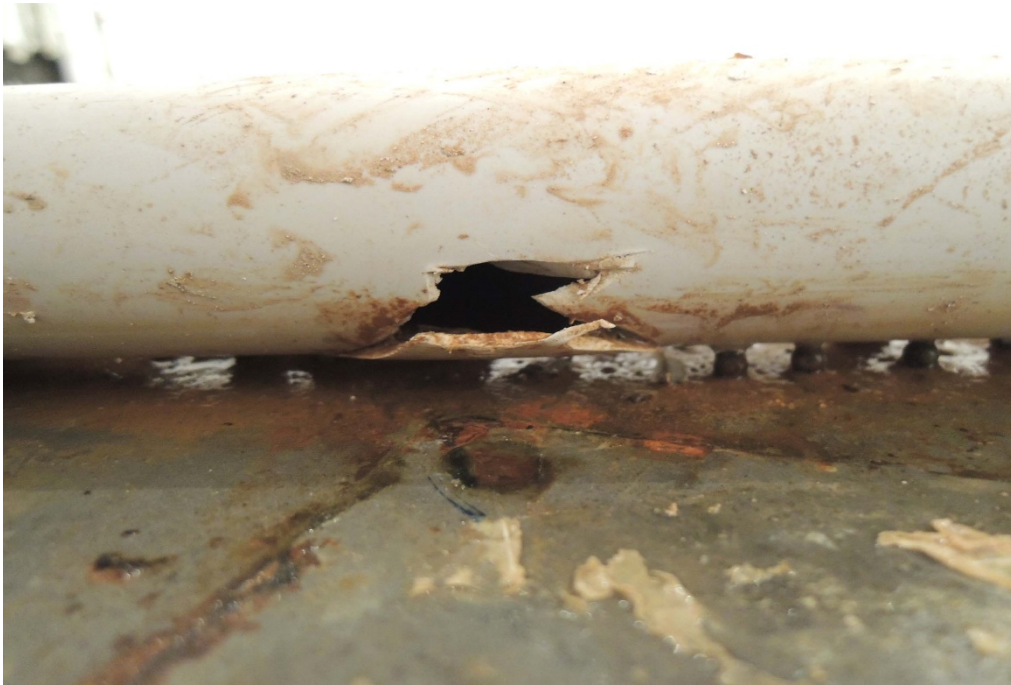
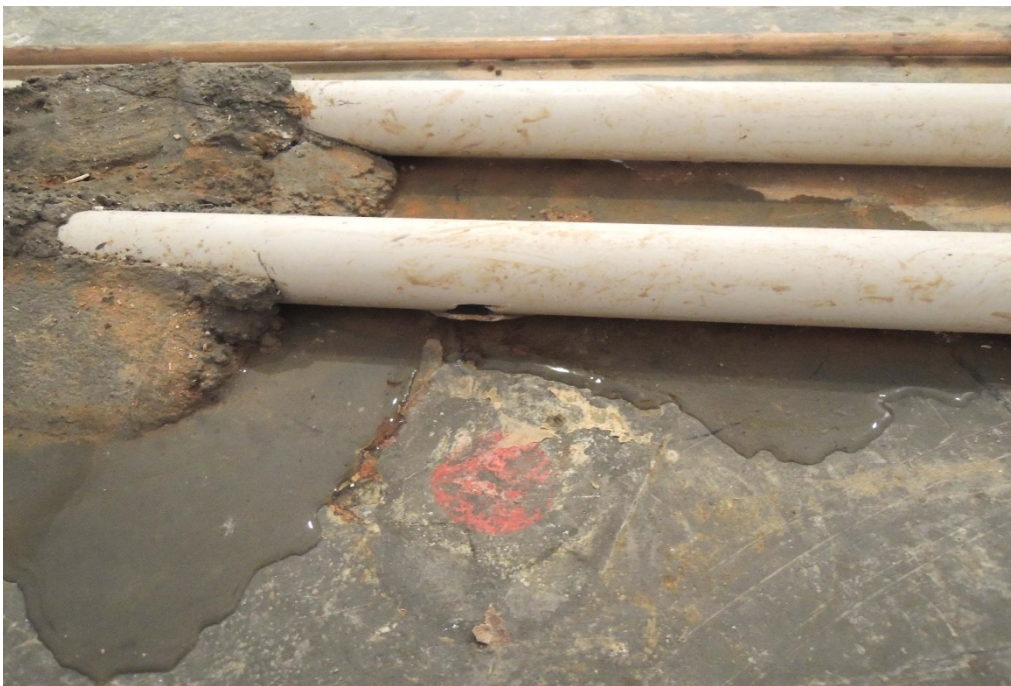
- (a) leakage of water through the hole (see the photographs attached in Annex B to this judgment) in the waste water discharge pipe (the “Drainage Pipe”) from the dental chair in Surgery Room No 3 of the Suntec Clinic;
- (b) the design and installation of nine discharge pipes (the “discharge pipes”) whose discharge outlets were situated above the Floor Grating (see the photographs in Annex A to this judgment); and
- (c) the design and construction of the raised bunds, which prevented water that had overflowed the Bunded Area from draining into the Drainage Downpipe.

48 For the following reasons, I do not accept the plaintiff's allegation, set out in [46(a)] above, that the repeated flooding was caused by damage to the Drainage Pipe (attributable to the defendant). I find that the defendant did not damage the Drainage Pipe.

51 I therefore find that the water leakage test performed using the hydrostatic test method, which were conducted *prior to* the removal of the floor boards after the 2nd Flood, eliminates the possibility that there was a hole or puncture in the Drainage Pipe when the defendant *first* handed over the Suntec Clinic to the plaintiff. The Drainage Pipe, as shown in the photographs at Annex B, was thus not damaged by the defendant during its installation of the raised platform for the floor. I conclude that the Drainage Pipe must have been damaged during the removal of the pedestals and the raised floor platform *after* the 2nd Flood, by the plaintiff's own contractors. The flooding was accordingly not caused by leakage of waste water through the hole in the Drainage Pipe, as postulated by the plaintiff.
