IN THE HIGH COURT OF THE REPUBLIC OF SINGAPORE

[2017] SGHC 246

[Building and Construction Law] – [Contractors’ duties]

Smile Inc Dental Surgeons Pte Ltd
v
OP3 International Pte Ltd

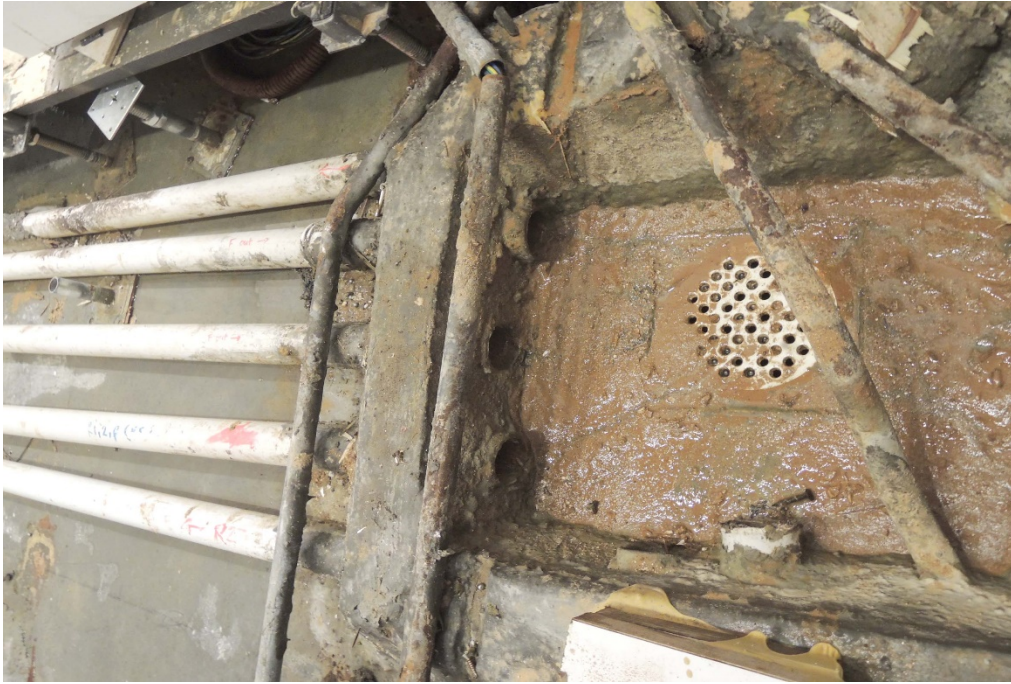
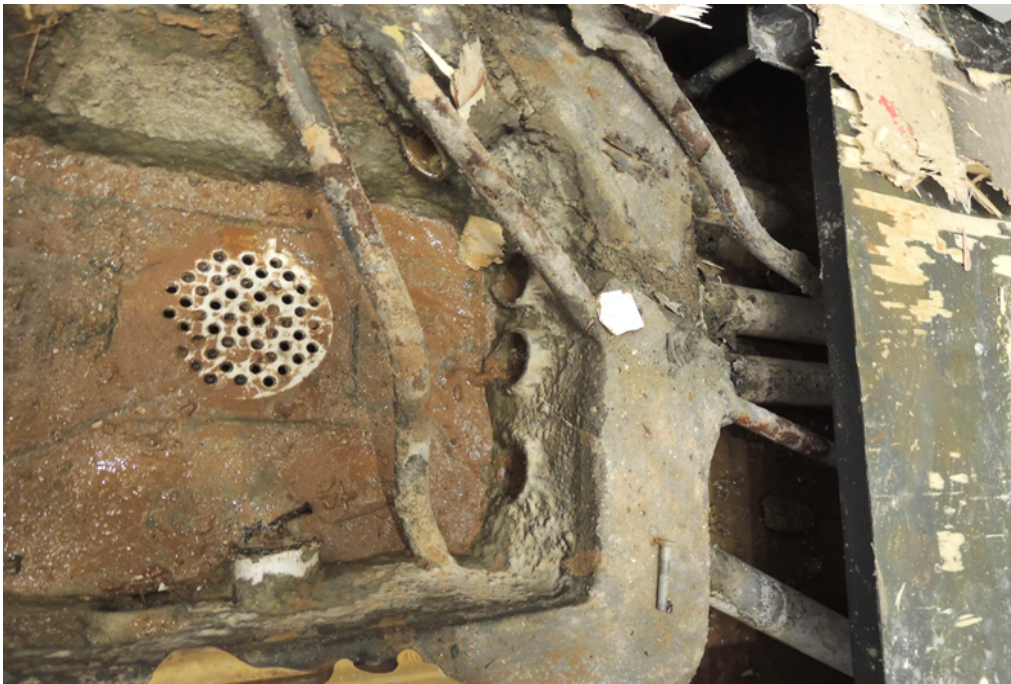
(b) The drainage downpipe for water to be discharged out of the Suntec Clinic (the “Drainage Downpipe”) was situated in a raised bunded area (the “Bunded Area”). The Suntec Clinic produced debris, which clogged up the white circular plastic floor grating (the “Floor Grating”) that covered the Drainage Downpipe. This caused water to overflow the Bunded Area. (The Bunded Area is 340mm in length and 300mm in breadth, and is enclosed by a bunded concrete wall 65mm in thickness and 100mm in height. The photographs in Annex A to this judgment show the Bunded Area.)

111 For all these reasons, I accept the plaintiff's submission that the flooding was primarily caused by (a) the termination of the outlets of all nine discharge pipes above the Floor Grating; and (b) the presence of the bunded walls, which prevented water outside the Bunded Area from draining into the Drainage Downpipe.

105 Dr Liew explains that it is not a good idea to build a raised bunded area.⁶¹ I accept his evidence that a sump, *ie*, a depressed rectangular reservoir created below the level of the floor screed, would have been a better solution. This is because, if there was any pipe leak or water spillage on the floor of the Suntec Clinic, water could still flow back into the sump and into the Drainage Downpipe within the sump. This would have prevented water from accumulating on the cement floor beneath the raised floor of the Suntec Clinic.

115 Further, Dr Liew also observed that, on the whole, the construction was shoddy. The walls and floor of the Bunded Area should at least have been tiled for hygiene purposes, instead of being left with rough unfinished cement surfaces. Tiling up the Bunded Area would have helped to prevent mould growth and would not have been very costly.
