Airtrust (Hong Kong) Ltd v PH Hydraulics & Engineering Pte Ltd  
[2015] SGHC 307

**Case Number** : Suit No 219 of 2013  
**Decision Date** : 30 November 2015  
**Tribunal/Court** : High Court  
**Coram** : Chan Seng Onn J  
**Counsel Name(s)** : Tan Chuan Thye SC, Avinash Pradhan, Alyssa Leong and Arthi Anbalagan (Rajah & Tann Singapore LLP) for the plaintiff; Daniel John and Kevin Cheng (Goodwins Law Corporation) for the defendant.  
**Parties** : AIRTRUST (HONG KONG) LTD — PPH HYDRAULICS & EENGINEERING PTE LTD

*Commercial Transactions – Sale of Equipment – Breach of Contract*

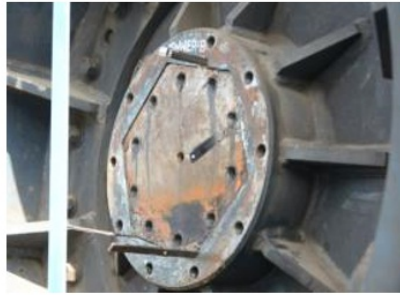
Gear side of Tower B

87 The shaft end plates provide attachment of both the main gear and the hub drive insert to the main driveshaft between the gear and the reel hub. Ten M20 x 55 mm, grade 8.8 bolts attach the plate to the hub/gear, with a further ten bolts of the same specification attaching the same plate to the shaft.

88 Dr Eccles explained in his AEIC from pp 9 to 33 why the bolting arrangements on the shaft end plates were inadequate. At the hot-tubbing, Dr Eccles calculated that if the brakes were applied to slow down the 300 tons reel spinning at 0.29 rpm, corresponding to a lay speed of 500 m per hour, it would cause the bolts at the drive shaft end plates to be overloaded. With the clearances present, measuring about 1.3mm to a maximum of 2.5mm, between the hexagonal shaft and the gear on the one end and the reel insert on the other, the bolts would come loose. Mr Hooper disagreed with Dr Eccles and asserted that the hexagon in the hexagonal shaft took the shear load/torque transmission and not the bolts which merely held the gear hub in place. However, the hexagonal shaft would be able to take the shear load only if the clearances were absent and the hexagon fitted tightly within the hub. Mr Hooper then speculated that *"it may have been that on the end of the hexagon, there was a slight taper put on in order to get the hub to fit on..."*, which then took up all the clearance on the hexagonal section.

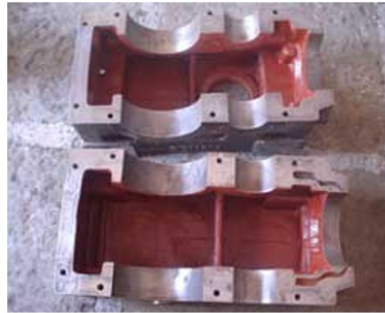
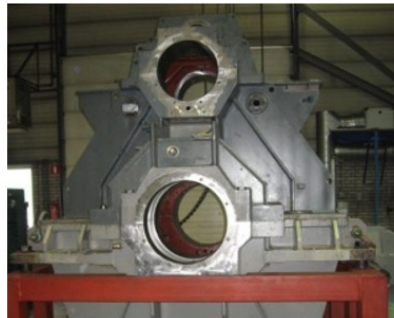
116 Mr Moore noted that the RDU's bearing housings were being supported and located by the bolts. In his view, heavy-duty fabricated structures are normally used to support such a drivetrain. The bearing housing is usually designed to be an integral part of the fabrication. This negates the need to rely on the bolts to attach the bearing housing to the main fabrication. In such cases, the item would be designed and manufactured as a casting or heavy-walled fabrication and would also incorporate strengthening members as part of its design. This ensures sufficient local rigidity and support of the loading experienced by the pinion bearing and provides a means of load transfer into the sub-frame fabrication which in turn transfers its load into the main support towers. Further, the bearing is normally located directly into the heavy walled structure via a very tight clearance fit. This

provides a rigid base to seat and support the bearings whilst under load and provides an accurate machined datum, consequently giving better alignment of the bearing to the outboard mounting of the pinion. A similar arrangement is also appropriate for the bearing housing for the main driveshaft. This is critical to ensure correct alignment of the pinion gear to the spur gear. A similar arrangement appropriate for the bearing housing for the main driveshaft is also critical to ensure correct alignment of the pinion gear to the spur gear. In his report, he showed the following examples of correctly designed bearing and gearbox housings.
