## Volume 9 Paper 15

# The application of impressed current cathodic protection to historic listed reinforced concrete and steel framed structures

J. P. Broomfield

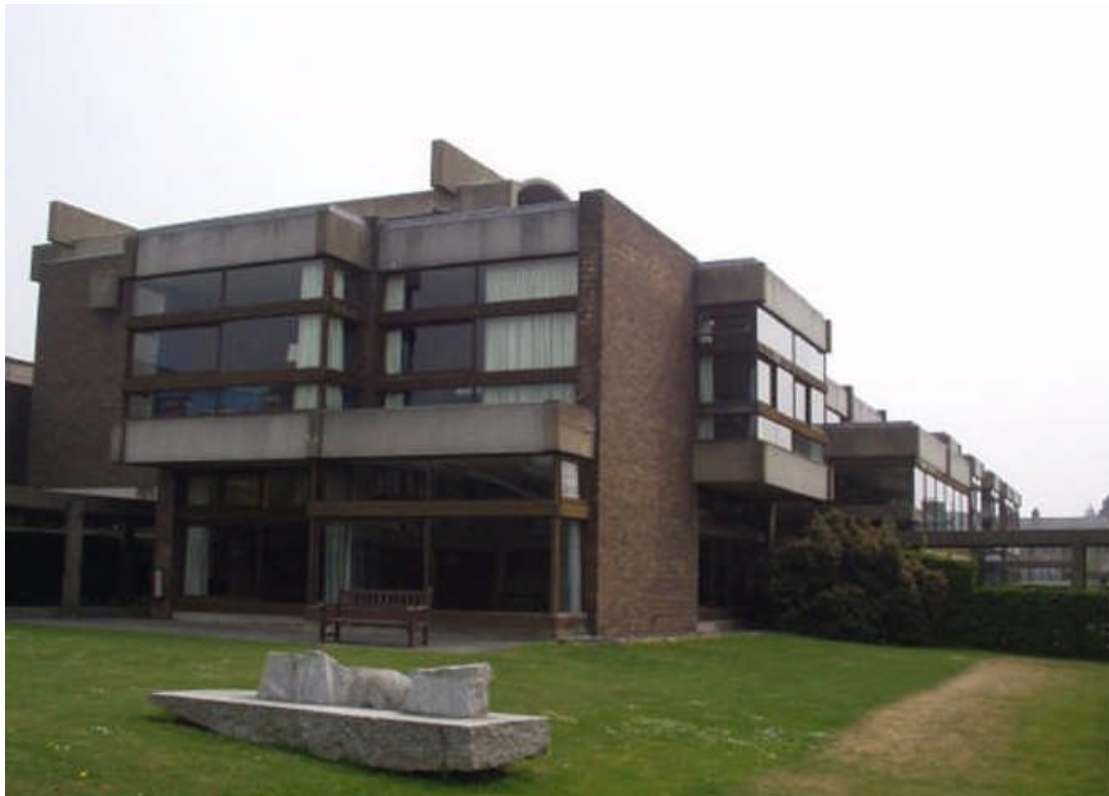
**Figure 1** – Typical elevations of Churchill College showing precast panels at 1<sup>st</sup> floor and roof level.

Churchill College Cambridge was designed by architect Richard Sheppard of Robson and partners, and built from 1959 to 1968. The construction is of low level (mainly 2 storey) buildings with main elevations of structural precast concrete beams connected to a concrete frame and supporting glasswork. Investigation of cracking and spalling of the concrete beams in past few years has revealed sufficient levels of chloride in the concrete to cause reinforcement corrosion on some of the buildings with precast fascia beams. This is almost certainly due to the use of calcium chloride as a set accelerator in the casting yard to speed production rates. Figure 1 shows typical elevations.

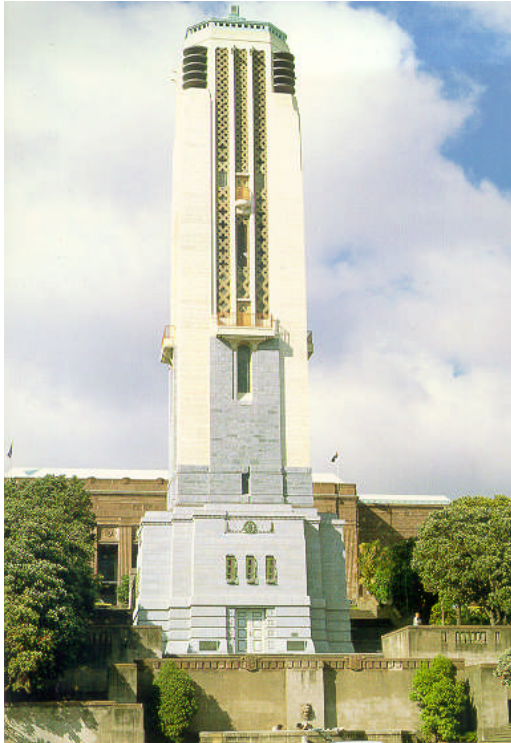
**Figure 3 – The New Zealand National War Memorial Carillon is a 50 metre high reinforced concrete structure that contains 74 bells which each range in weight ranging from 10kg to 12.5 tonnes. Their total weight of 70.5 tonne and 6 octave range makes it the third largest carillon in the world.**

A survey identified that the reinforcement corrosion was limited to the mullions and the area around the openings as the Carillon faces the bay. Trials of anode spacings were conducted. An impressed CP system was installed consisting of 570 discrete internal anodes. There were 3 mm diameter MMO/Ti rods in carbonaceous backfill at 600 mm centres.

The anodes were 100 mm or 150 mm long as required from the results of the trial. There were 25 zones each with its own embedded Ag/AgCl reference electrode to permanently protect approximately 170 square metres of at-risk structural concrete. 12mm diameter holes were drilled on the required 600 mm centres. Holes were checked with a “down hole cover meter” to ensure they were not too close to reinforcement. They were then filled with the carbonaceous backfill and the anode rod inserted. A titanium wire was connected between the anodes and wired into a junction box and then connected back to the power supply. A remote monitoring system was installed to monitor the 25 zones. The system was commissioned in June 1999 [Ref04].

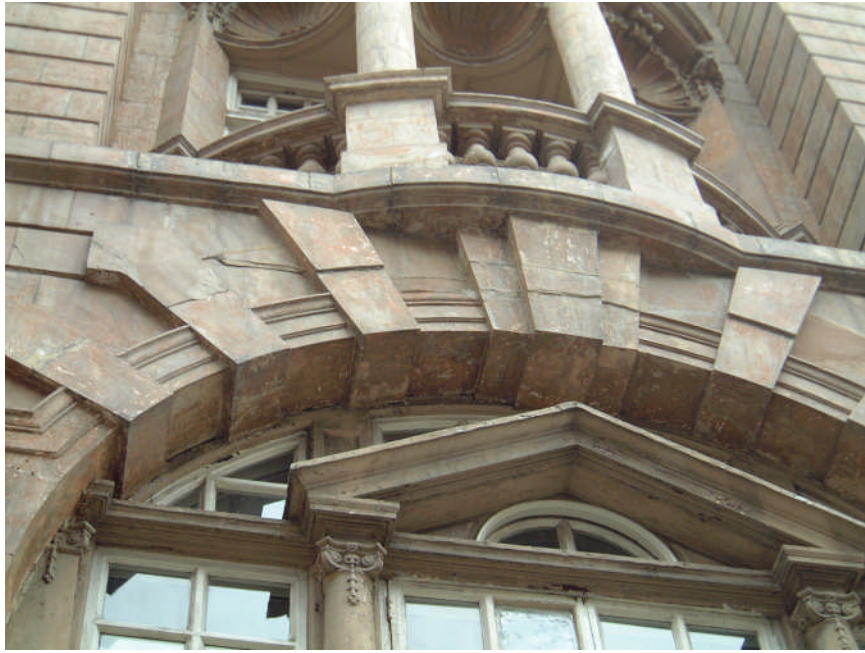
Figure 4 shows the balcony with horizontal cracks in the terracotta stones due to corrosion of the steel beam. Two vertical steel columns have also caused cracking of the terracotta columns. Figure 5 shows the installation of ribbon anode in the joints between stones and a reference electrode being installed.

Figure 4 – The balcony showing damage

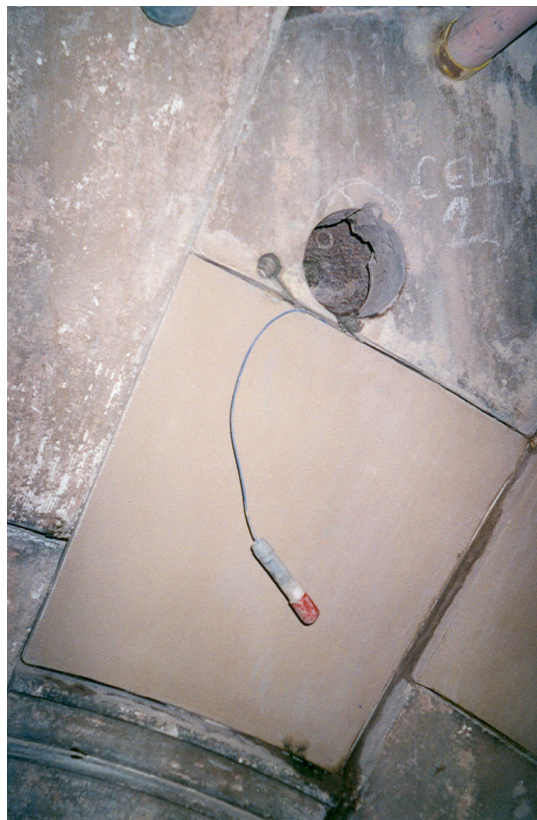
Figure 5 – Close up of ribbon in joints, new stone and installation of a reference electrode

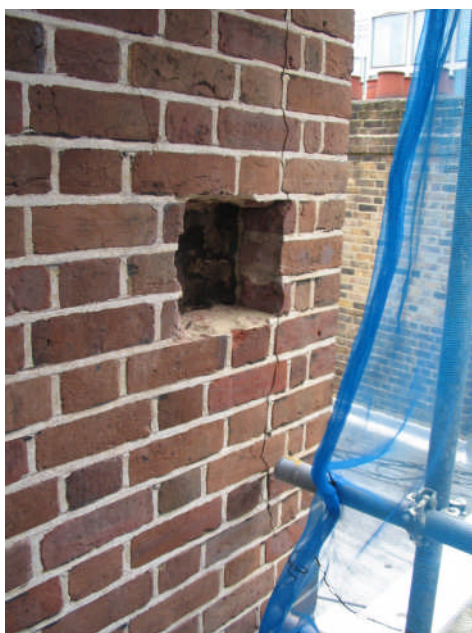
Figure 6 – Example of cracking of brick work due to the expansive corrosion of the corner steel column.

This is reflected on all four corners of the building.

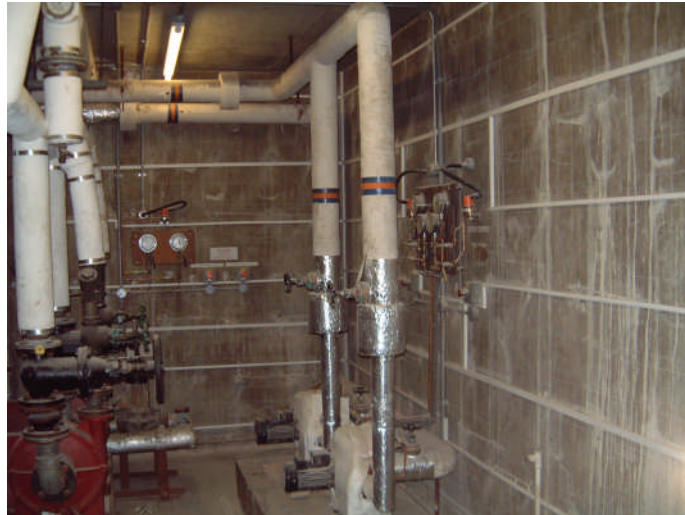
Probe anodes of MMO/Ti and conductive ceramic were installed in the stair wells and the roof level plant rooms. Figure 8 shows the probe anodes in the roof level plant room where the cables were kept at surface level for easy identification and repair. Figure 9 shows “before and after” photographs from the back of the Biotower.

Figure 8 – Biotower Plant Room showing Anode wires on surface

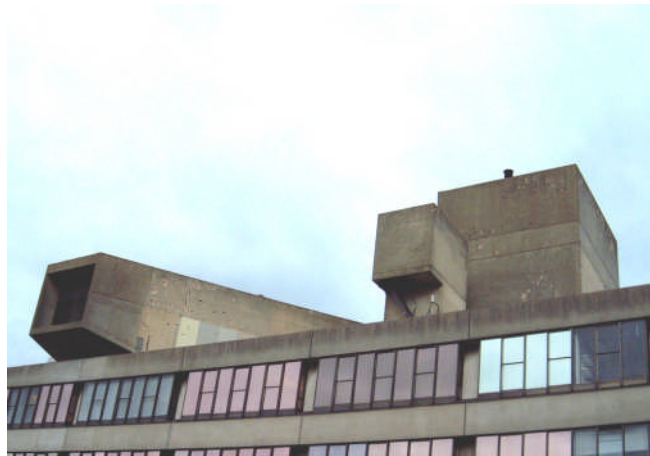
Figure 9a – Biotower before repair showing coating trials and exposed reinforcement

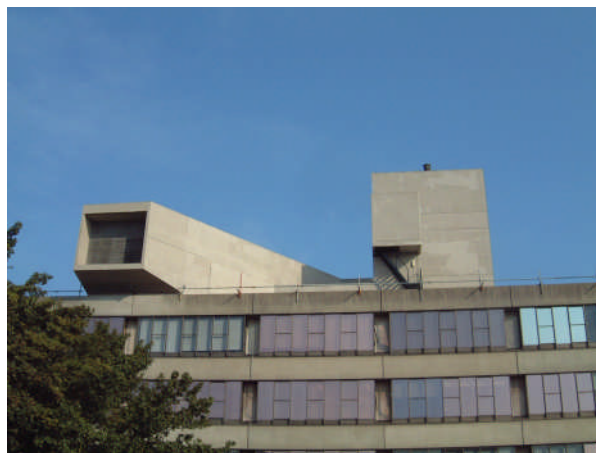
Figure 9b – Biotower after Concrete repair and coating application minimising “patchwork” appearance.

The silicate based penetrating sealer type coating blends in the repairs to the original concrete and should weather in such a way as to minimise the risk of the patchwork appearance developing with time.
