CATHODIC PROTECTION CONFERENCE

Cathodic Misconceptions

C.G. Googan

This paper describes some cases where elementary errors in the design, installation or operation of cathodic protection systems have subsequently lead to underperformance, or even failure.

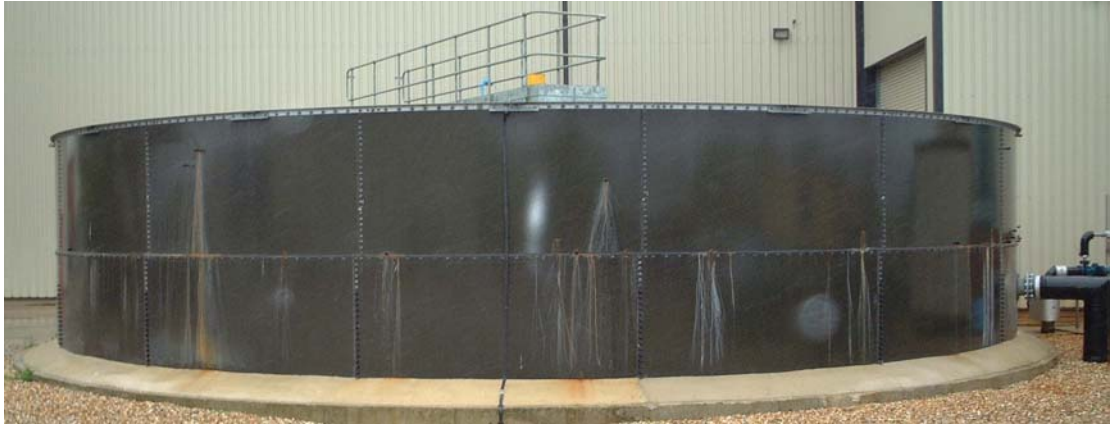
Figure 1 shows a painted steel effluent water treatment tank at a meat processing factory. The tank contained an internal weir structure fabricated in stainless steel (Figure 2). The water had a high conductivity and was well aerated (as indicated by the growth of algae). This design led to a classic case of galvanic corrosion, with a large cathode (the stainless steel weir) coupled to a small area of anode (the areas of damaged paint on the tank wall). Localized penetration of the tank soon occurred.

Figure 1 Effluent Water Treatment Tank

The owner sought advice from the tank manufacturer, and was informed (quite correctly) that the problem could be remedied by the installation of sacrificial anodes. A request to procure anodes was then passed over to the accountant who saved money by dispensing with the cost of involving a CP design engineer. Instead he ordered four “suitable” anodes from a yacht chandler. These were installed by the company’s own maintenance fitters. Sadly, however, there was no discernable reduction in the frequency of leaks (Figure 3).

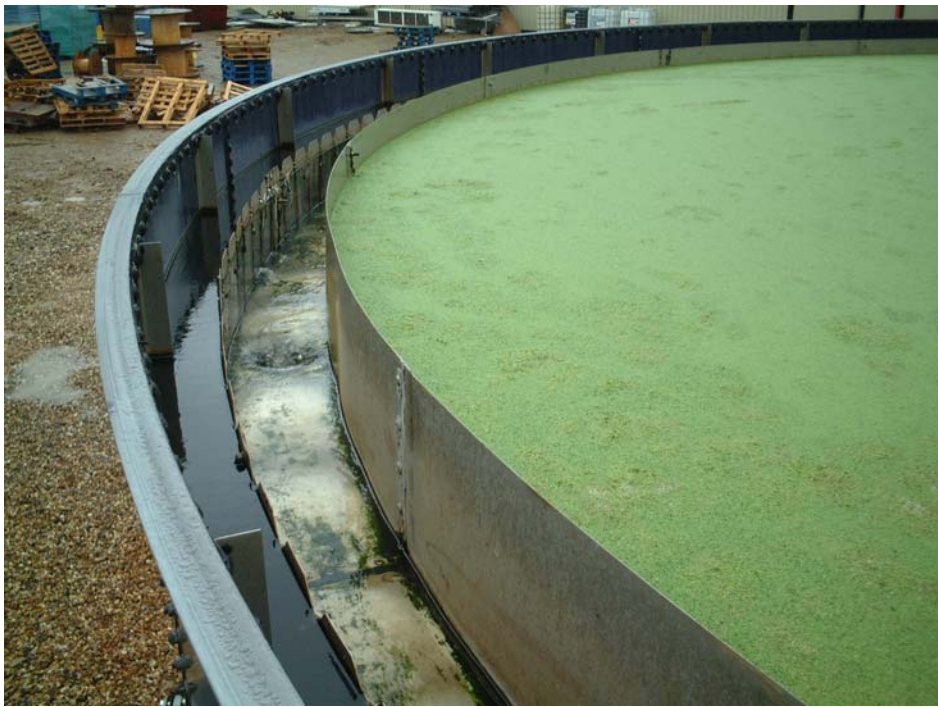
Figure 2 Stainless Steel Weir in Tank

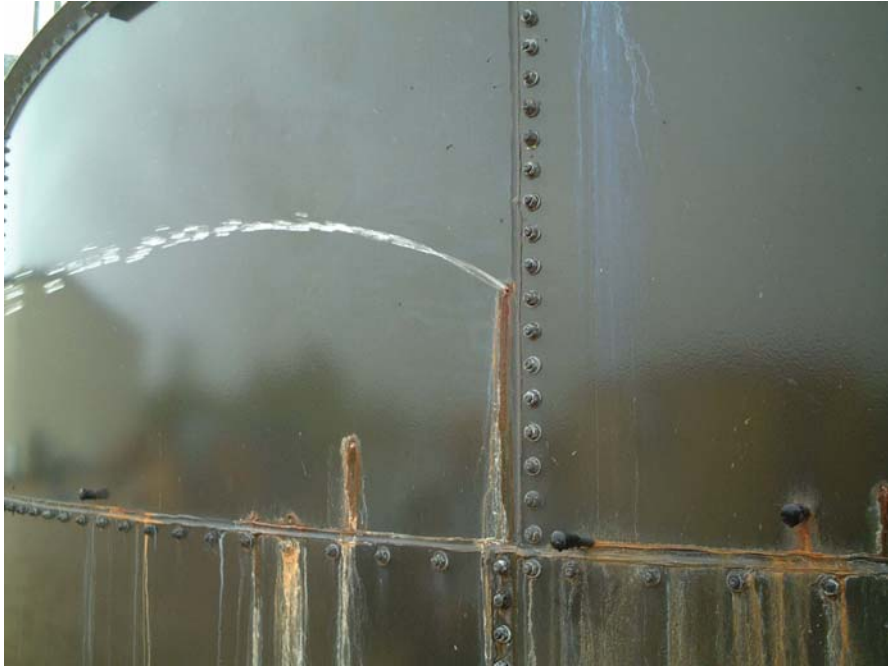
This author’s subsequent potential measurements confirmed that the undersized anodes were failing to exert any useful effect on the galvanic corrosion.

Figure 3 Result of Inadequate Internal CP

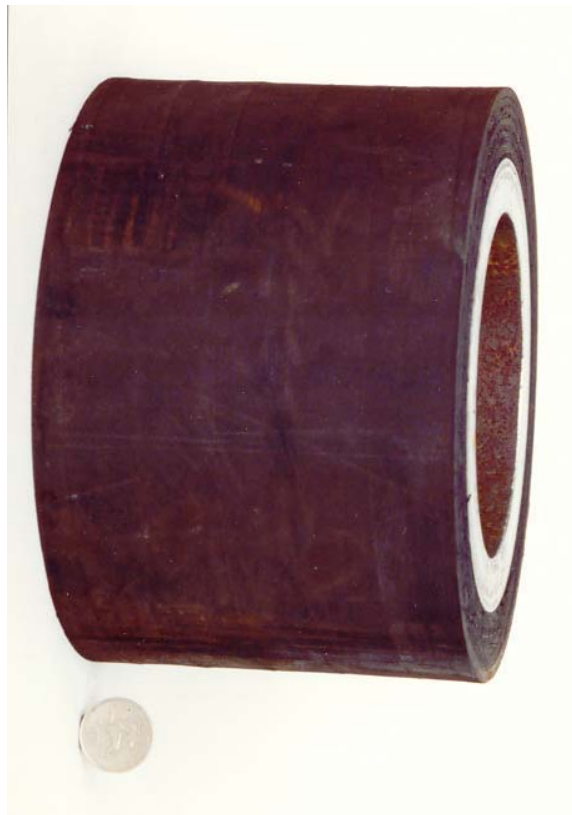
Figure 4 shows a section of 6-inch EPDM rubber coated flowline installed in the North Sea some fifteen years ago. The CP was provided by sacrificial anode bracelets which had been designed according to the accepted guidelines of the day. However, a survey carried out two years after installation showed that, despite the anodes yielding more than the design current, the line had failed to polarize to its protection potential.

Subsequent investigations revealed that the cause of the problem was the carbon black used as a filler in the rubber coating. Laboratory measurements showed that, although the polymer itself was expected to have a specific electrical resistivity of $10^{14} \Omega\text{m}$, the value for the carbon-loaded coating was $10 \Omega\text{m}$ at atmospheric pressure, falling to $2 \Omega\text{m}$ at 16 bar (the water pressure at the installation depth). What is more, as expected from the galvanic series, the carbon was acting as a cathode: draining current from the anodes and potentially putting the pipeline at risk.

Figure 4 Section of 6-inch nb flowline with 25 mm EPDM rubber coating

Even before the cause of the problem could be fully elucidated it was clear that there was a need to install additional CP. This necessitated a costly retrofit using the (then) innovative approach of magnesium anode arrays connected to the pipeline via voltage limiting diodes^[11].

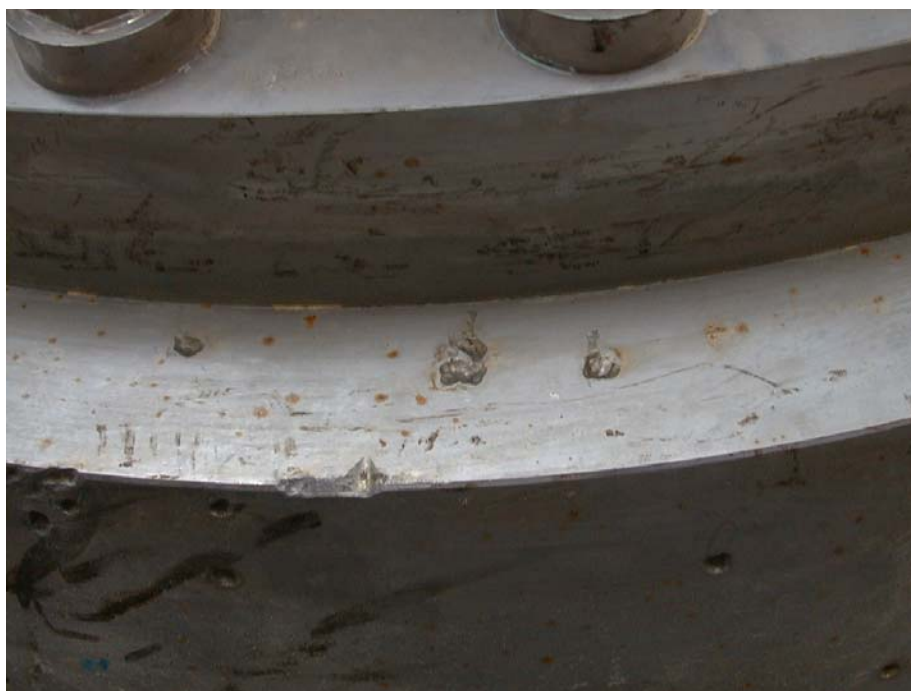
However, what the designers either failed to appreciate, or else failed to communicate to the builders, was that the stainless steel was at risk during the period between launch and the commissioning of the CP. In the event, the vessel lay afloat with the CP system inactive during the four month fitting out period. Unfortunately, although this period was relatively short in shipbuilding terms, it was sufficient for pitting corrosion to initiate on the propeller hubs (Figure 5). This caused a delay in the delivery of the vessel, and an acrimonious dispute between the shipyard and the buyer.

Figure 5 Pitting damage to a stainless steel propeller hub – fast ferry newbuilding

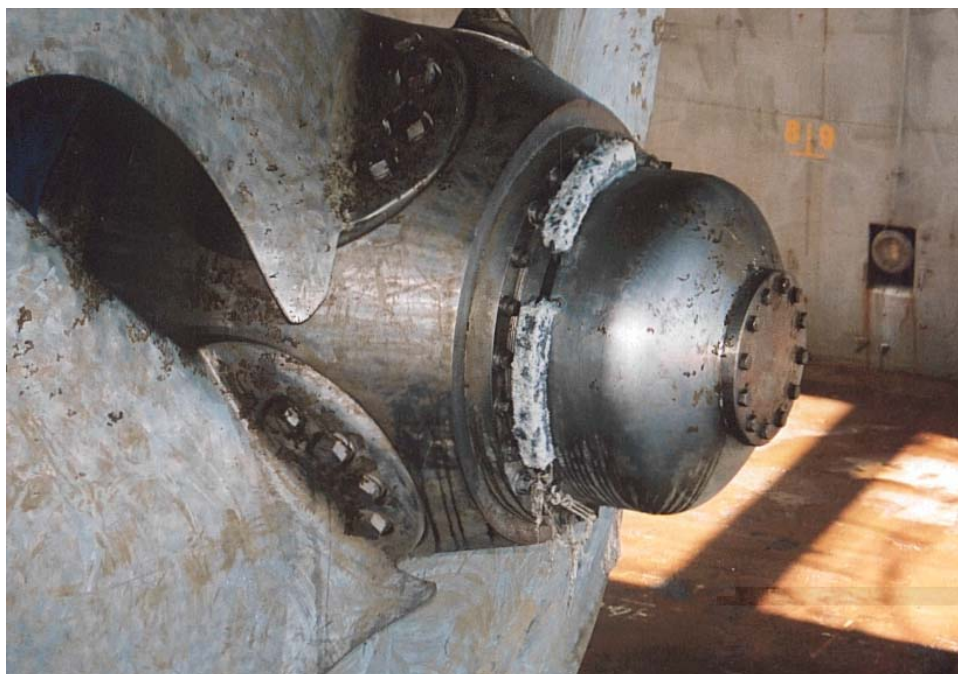
Figure 6 sacrificial anodes to protect stainless steel propeller during outfitting

The lesson was learned in time for the launch of the sister ship, for which temporary sacrificial anodes were provided to protect the propeller during outfitting (Figure 6).

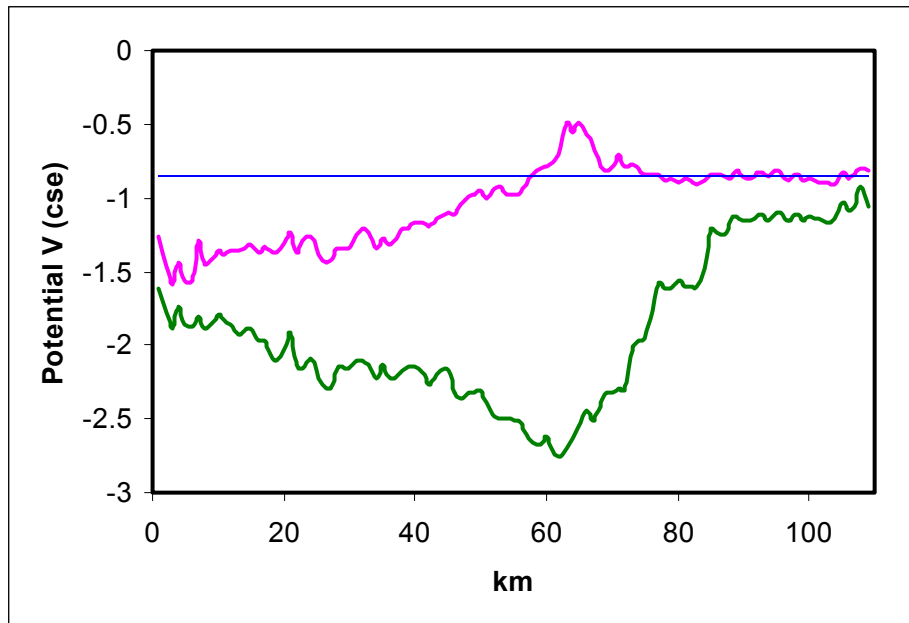
Figure 7 shows the results of a close interval potential survey (CIPS) along a high pressure gas pipeline. In the original survey the data were collected at 1 m intervals and plotted on sheets each showing 500 m of line. In Figure 7, however, the data for each kilometre have been averaged so that the condition of the entire 112 km of the pipeline can be seen in a single plot.

Prior to the CIPS, the operator had only ever measured on-potentials at test posts 5 km apart; and was of the opinion that the line was well protected. It was only when the CIPS was carried out, and the on-potentials (green line in Figure 7) compared with the off-potentials (purple line) did it become apparent that the line was suffering a dangerous stray current interference problem. (This is revealed by the off-potentials in the region of km 60).

Figure 7 Potential distribution along a high pressure gas transmission line

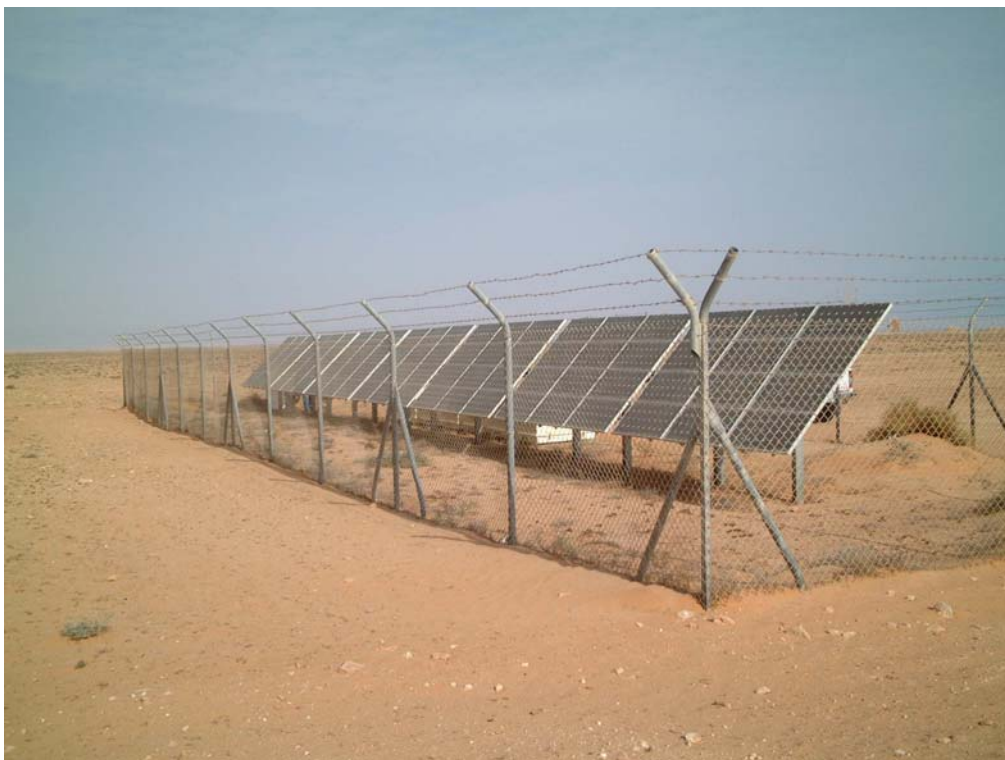
Solar power units of the type illustrated in Figure 8 provide a convenient source of electrical power for CP systems in remote

Figure 8 Solar Panel Array

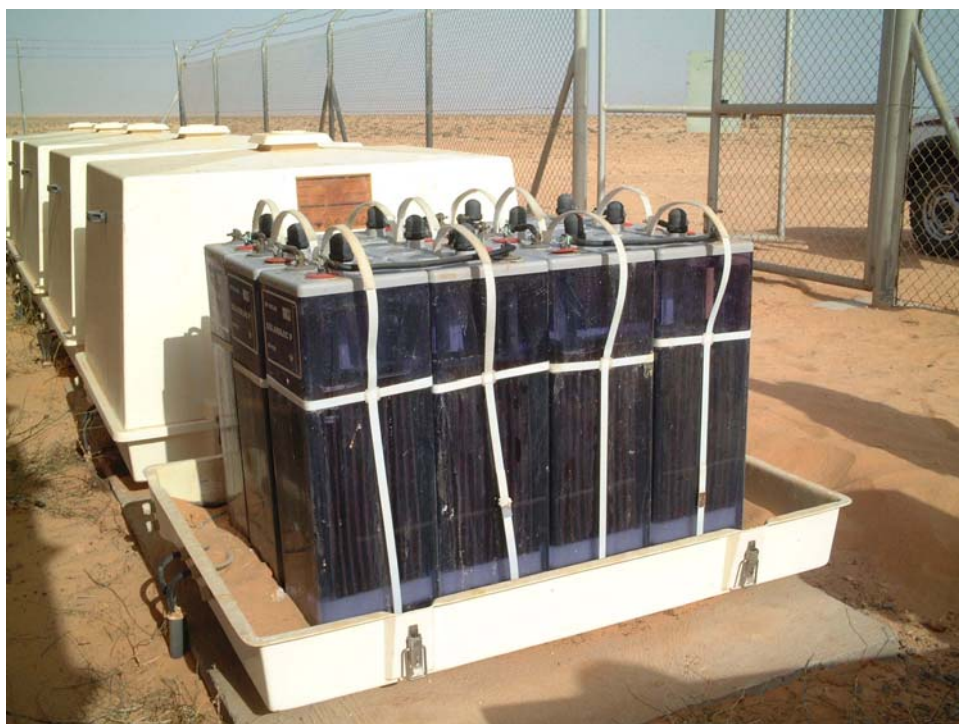
desert locations. However, it is not always appreciated that the function of the solar panels is not only to provide the CP current but, more important, to charge the batteries (Figure 9).

In one case involving a solar powered CP system for an oil trunk line, it appears that the batteries had never been topped up. Inevitably, they eventually became completely dry. However, the problem went unnoticed for a long time; possibly several years. This was because the (infrequent) CP inspections were only carried out in the day-time, when the solar units were delivering current. Moreover, the inspectors only recorded on-potentials, which gave an unrealistically optimistic indication of the level of protection.

Figure 9 Storage batteries

Unfortunately, the remote locations of these CP stations mean that it is all too easy for routine maintenance, including the topping up of battery electrolyte, to be overlooked.
