Influence of Protective Coatings on Corrosion Resistance in Transmission Line Tower Foundations

Abstract:

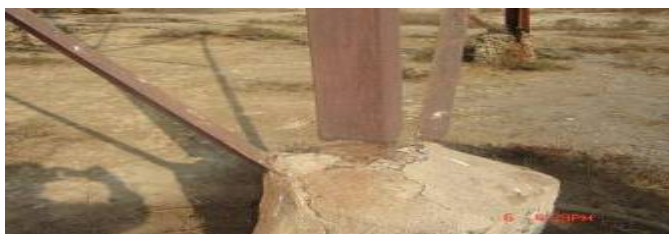
Fig.1. Transmission stubs exhibiting a form of pitting/ crevice corrosion.

A mechanism of pitting or crevice corrosion as in the fig. 1. will initially occur in the presence of aggressive ions such as chlorides. These ions are responsible in the formation of pits on the surface, which accelerates corrosion attack. An important consequence of pitting is that the localized attack may be very severe which may lead to structural catastrophe.

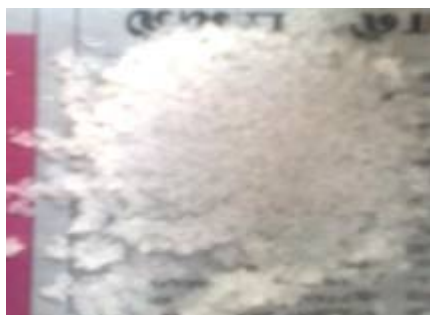
Fig 2: Calcium Nitrate(Salt Form)

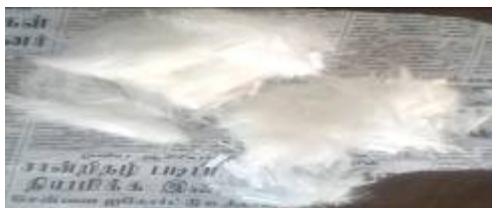
*Fig:3 Recron 3S Fibre***V) Epoxy Coated Angle**

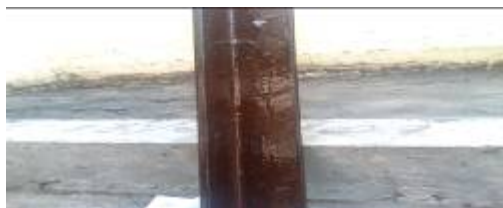
*Fig :4: Epoxy Coated Angle***Specimen Details****Coated Specimen Details:**

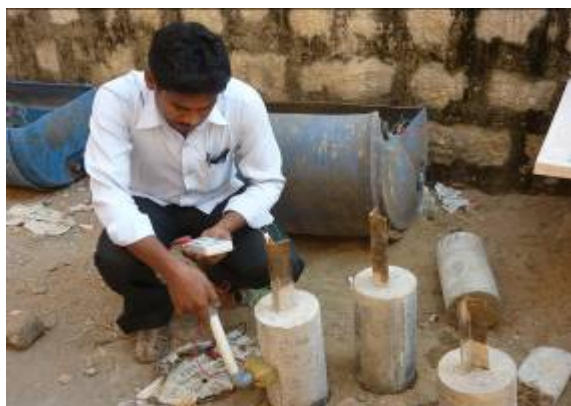
*Fig:5: Half Cell test in Specimens*

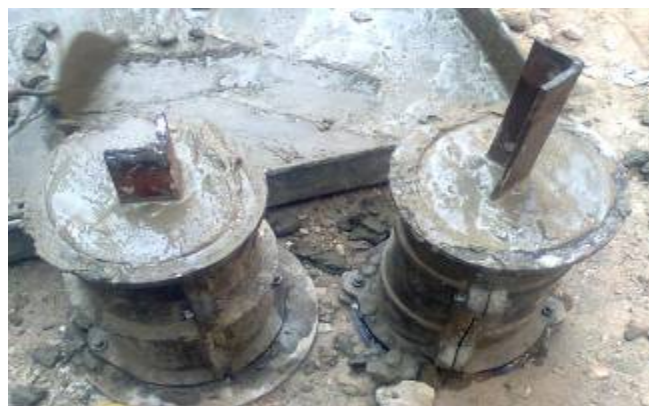
*Fig:6:Cast Specimen*

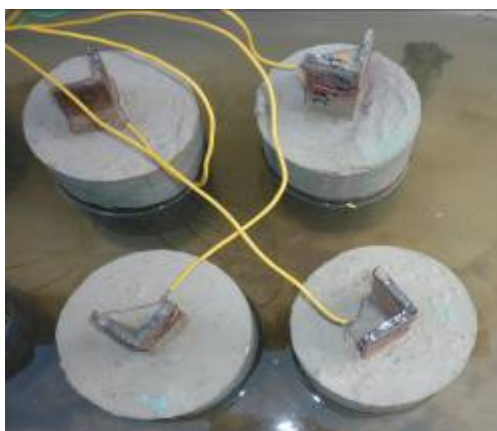
Fig: 7 Externally Coated by FACSR Specimens

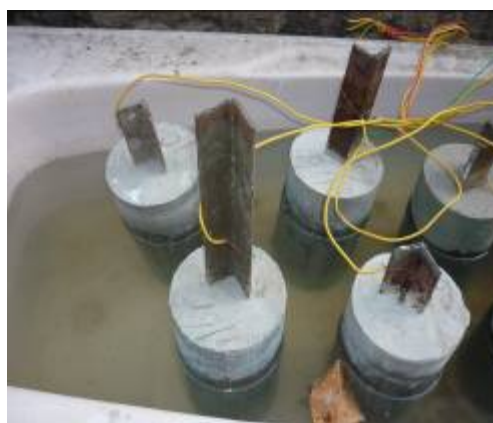
Fig:8 FACSR & Epoxy Coated Specimens

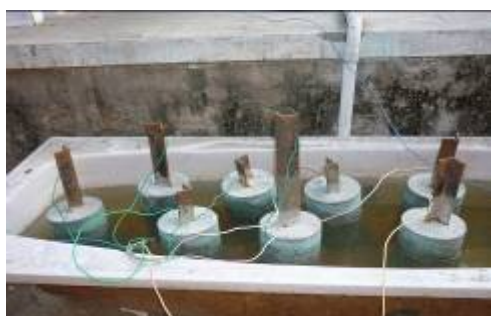
Fig :9: Corrosion Acceleration(Before Corrosion)

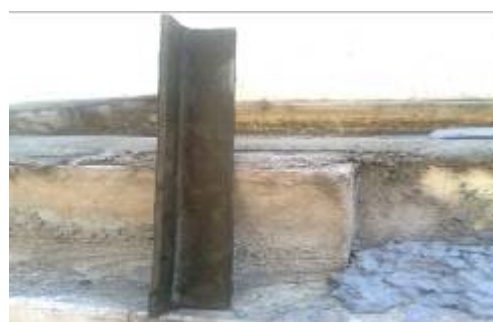
Fig :10 FACSR Coated Angle

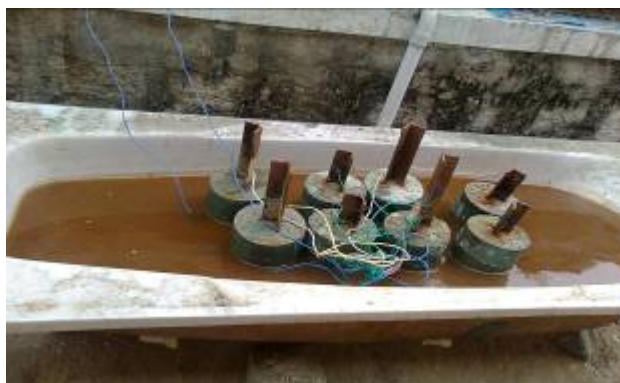
Fig :11 Accelerated Corrosion(After Corrosion) Fig:12 FACSR Coating Technique

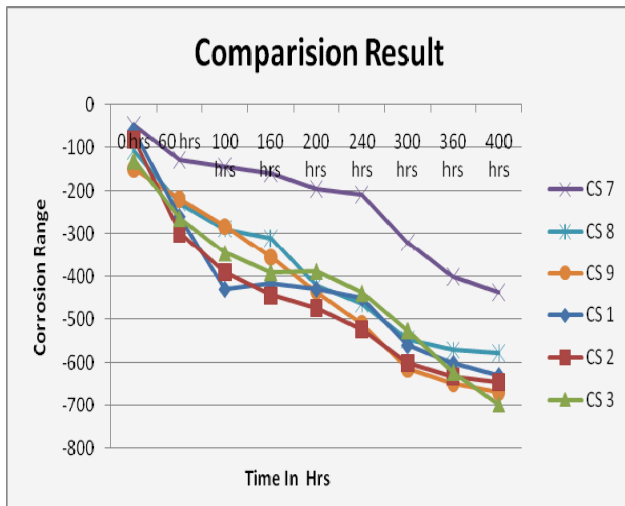
Fig : 14 : Half Cell Comparison Value

Fig: 15: Half Cell Comparison Valu

Fig:16: Half Cell potential Value Comparison

Half cell potentiometer readings were taken on specimen every 50 hours. The experimental set up is as shown in the *figure13* . *Table 2* and *Figure14,15,16* shows the variations of half cell potentiometer readings with accelerated time.

The **Figure14,15,16** shows the Time vs corrosion potential behavior of coated specimens in the Half CellPotentiometer test. It can be seen that there is a reduction in corrosion potential for Flexibond ACSR coated specimens compared to other specimens. This observation is due to a higher resistance of these coating materials against chloride ingress. The longer initiation period of Flexibond ACSR Coating is due to the Barrier nature of the Coating.

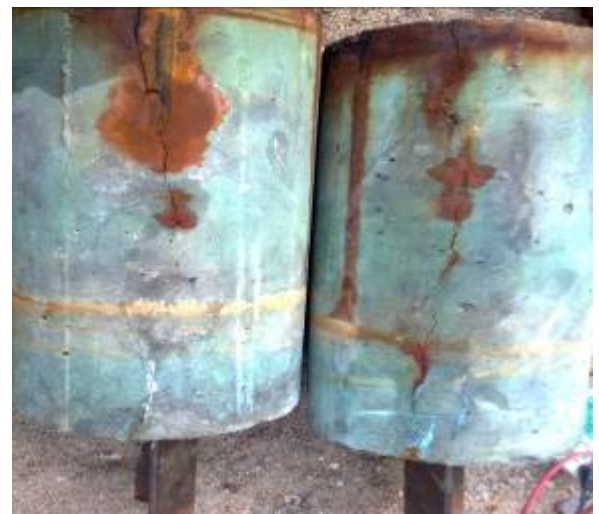
Fig : 17: Cracked Specimen

Figure 17 shows that , the crack propagation which occurred in Corrosion inhibitor mixed concrete specimen. The Specimen get cracked after 280 hrs.

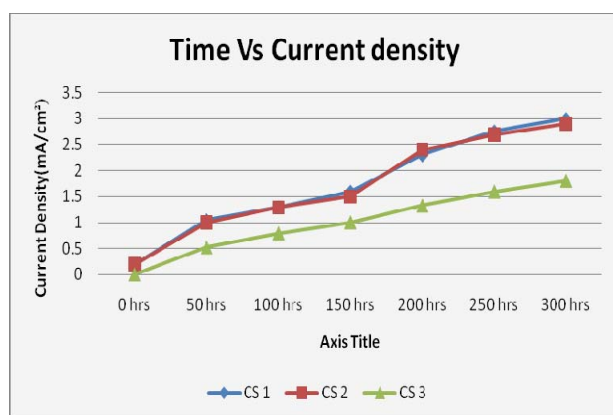
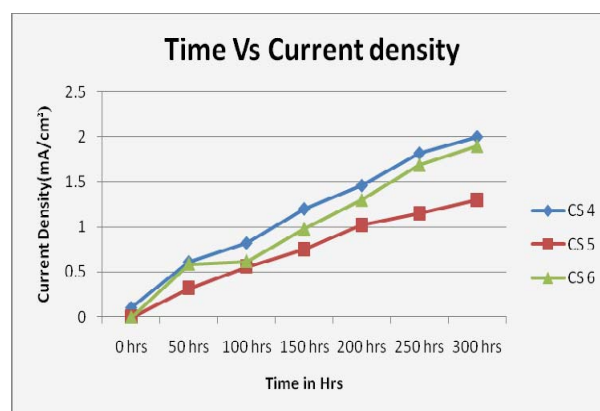
Fig:18: – Current Density Value of CS 1,2,3

Fig: 19: – Current Density Value of CS 4,5,6

Fig: 20: – Current Density Value of CS 7,8,9

Impressed Voltage readings were taken on specimen every 50 hours upto 300 hrs. *Table 3 and Fig 18,19,20*, shows the variations of Impressed Voltage readings with accelerated time

The Figure 18,19,20 shows the Time vs Current density behavior of coated specimens in the impressed voltage test. It can be seen that there is a reduction in current density for coated specimens compared to other specimens. This observation is due to a higher resistance of these coating materials against chloride ingress. The longer initiation period of Flexibond ACSR Coating is due to the Barrier nature of the Coating. Incase of Un coated specimens as well
