**Pitting Corrosion Susceptibility of AISI 301 Stainless Steel in Chloride Environments*****IKPESENI, S.C.<sup>1</sup> AND ONYEKPE, B.O.<sup>2</sup>***

**Abstract**

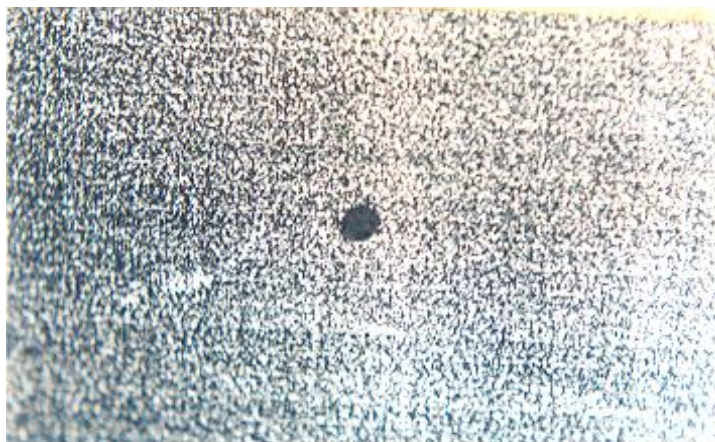
**x400**

Figures 3 and 4 showed that the number of pits on the specimen increased with increased concentration and time. Plates 1 – 6 revealed the pits covered by the corrosion products (dark spots).

**Plate 1: Optical Micrograph of A<sub>20</sub> (i.e the Sample in 0.1M NaCl solution at the 20<sup>th</sup> day)**

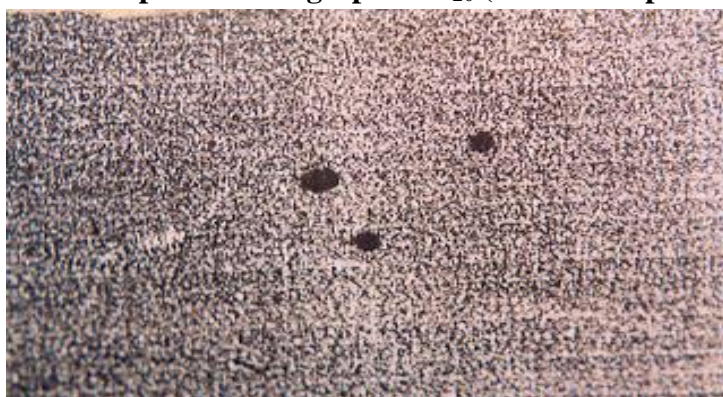
**x400**

**Plate 3: Optical Micrograph of C<sub>40</sub> (i.e. the sample in 0.3M NaCl solution at the 40<sup>th</sup> day)**

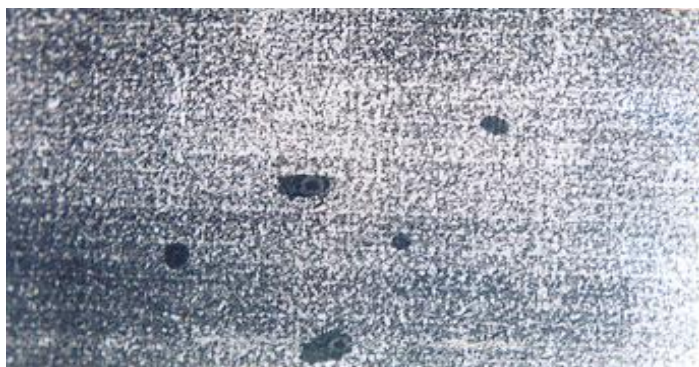
**x400**

**Plate 5 Optical Micrograph of E<sub>50</sub> (i.e. the sample in 0.7M NaCl solution at the 50<sup>th</sup> day)**

Inclusions act as stress raisers for pit initiation. This could be verified from plates 5 – 6, which revealed that some of the pits were formed around inclusions as shown by the white ring – like structures enclosed in the pits.
