The Electrochemical Performance of Flame Sprayed & High Velocity Oxy-Fuel Sprayed Aluminium Coatings In Simulated Splash Zone Service Conditions

The operating performance of thermally sprayed aluminium (TSA) coatings in seawater environments has been very well documented. However, the performance of flame sprayed aluminium (FSA) and high velocity oxygen fuel (HVOF) sprayed aluminium coatings in accelerated marine splash zone service conditions has not been previously investigated. Such data is useful for offshore structures requiring protection in the splash zone. Twelve-month exposure tests were conducted in artificial seawater (ASW) under laboratory conditions in a purpose built accelerated splash zone test chamber. The corrosion rate of mild steel in this environment was found to be 0.40 mm/yr by weight loss measurements. The performance of TSA coatings was quantified in terms of their ability to adequately cathodically protect a small area of bare mild steel, by determining their corrosion rates and their corresponding service life in this environment.

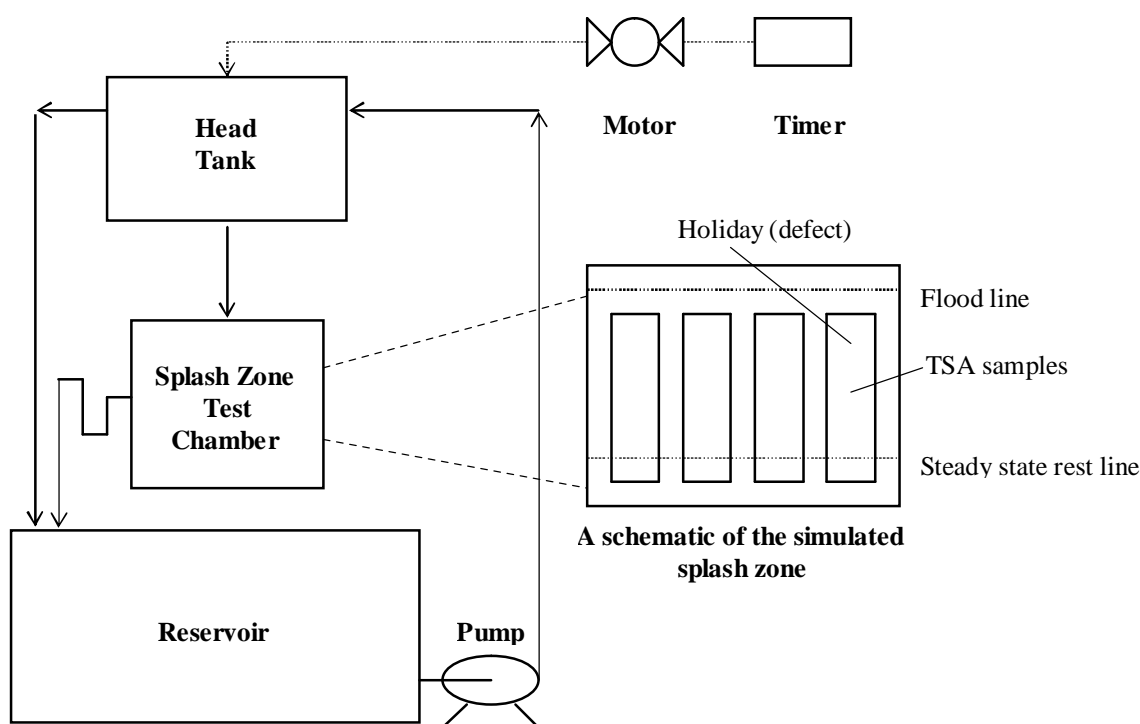
Figure 1: A simplified schematic of the marine service test chamber showing TSA sample configuration in the simulated splash zone.

The exposure tests were conducted in ASW under laboratory conditions at the Corrosion & Protection Centre, UMIST, Manchester, UK. The splash zone test chamber (figure 1) set-up and operational procedure is identical to that reported by Hussain^[20]. Control of the exposure test conditions included routine pH adjustment with a change of ASW at the six-month interval.

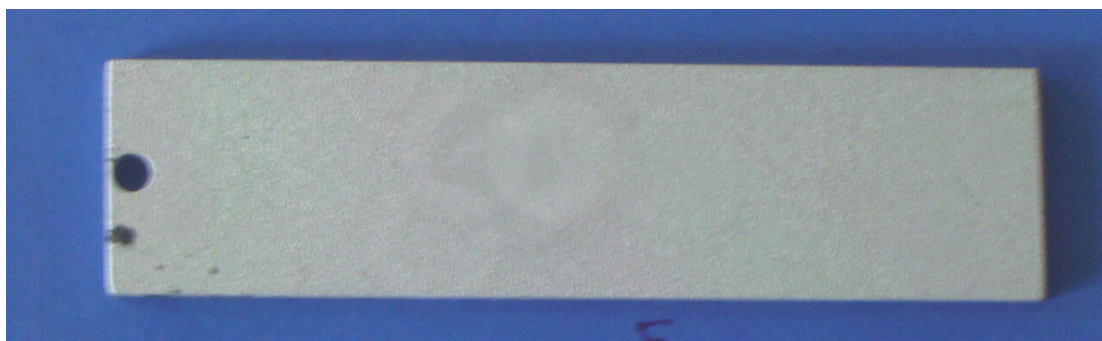
Figure 2: FSA coated mild steel specimen.

Aluminium wire (99.5% Al) consumable was fed through a computerised spray control system and thermally sprayed onto two 25 cm² (10 cm x 2.5 cm x 0.4 cm), abrasively blasted mild steel coupons (figures 2 & 3). The mild steel coupons were new, bright, uncorroded and free from millscale. The coatings were applied in a series of spray passes, using a rotating turntable lathe to obtain a nominal 100 µm aluminium coating thickness for both application processes. Coating thickness was verified by digital micrometer on site and at a later stage by scanning electron microscopy (SEM) (figures 4 & 5). The mild steel panels were prepared in lots with detailed measurements of surface finish and profile, FSA & HVOF coating parameters, coating thickness and porosity for each lot. The coating process parameters and characteristics together with surface preparation characteristics are

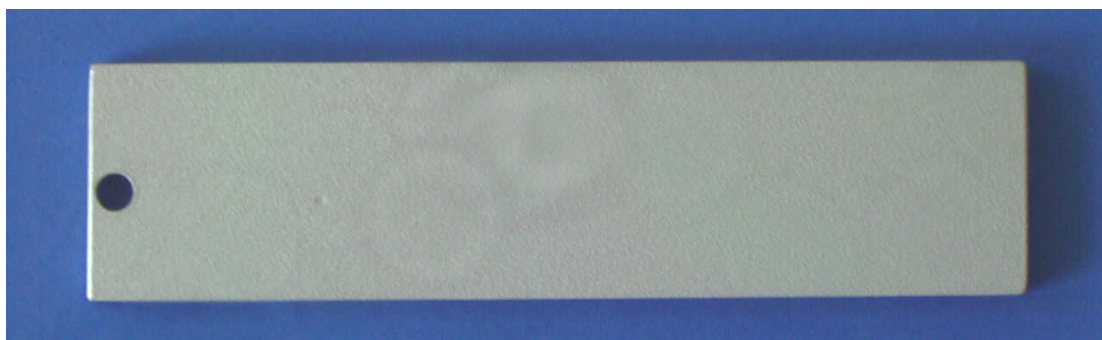
Figure 3: HVOF coated mild steel specimen.

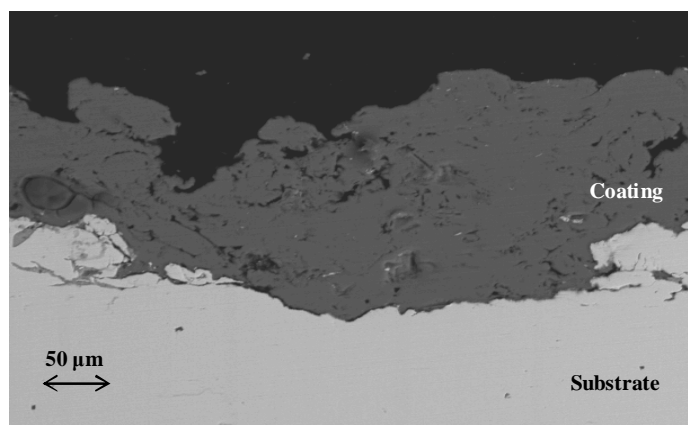
Figure 4: SEM micrograph (BSE x250) of the FSA coated mild steel coupon.

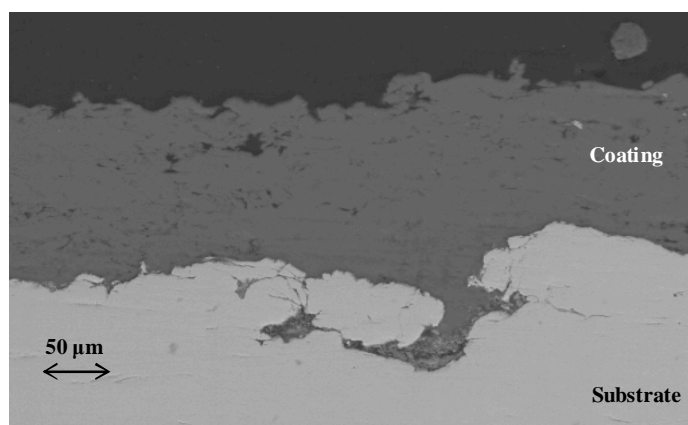
Figure 5: SEM micrograph (BSE x250) of the HVOF coated mild steel coupon.

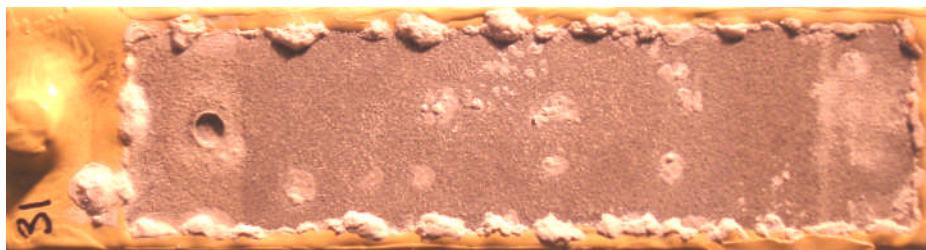
Figure 6: FSA coated mild steel specimen at the end of the 1-year exposure period.

Visually examining figures 6 and 7, it is clear that both coated specimens are covered with surface scales, which were initially assumed to be aluminium corrosion product - aluminium oxide/hydroxide. The formation of these surface scales on these coated specimens is attributed to the corrosion of the aluminium coatings and an in depth discussion on the formation of such scales can be found elsewhere^[23-24].

Figures 6 and 7 also show that aluminium corrosion product had formed quite voluminously at the interface to the epoxy paint coating and the TSA coated specimens. This is probably most likely due to the formation of crevices between the TSA coatings and the epoxy paint thus inducing crevice corrosion and the subsequent precipitation and formation of aluminium corrosion product. These thick 'crusty' white scales were initially assumed to be $\text{Al}_2(\text{OH})_3$ (aluminium hydroxide), which is known to age with time to form $\text{Al}_2\text{O}_3 \cdot 3\text{H}_2\text{O}$ ^[25]. This was later verified by energy dispersive x-ray analysis (EDX) to be just as assumed, containing high levels of aluminium and oxygen. Nevertheless, it would appear that both coated specimens have not suffered any form of degradation in the form of blistering and/or breakdown from the rigours of the splash zone test chamber.

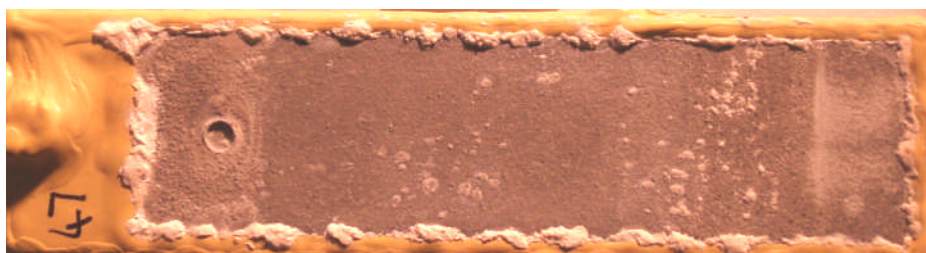
Figure 7: HVOF coated mild steel specimen at the end of the 1-year exposure period.

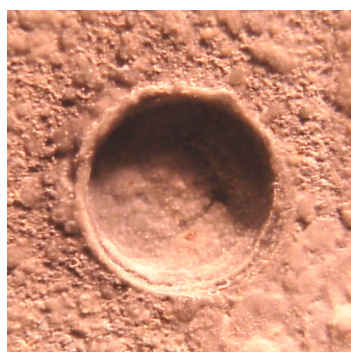
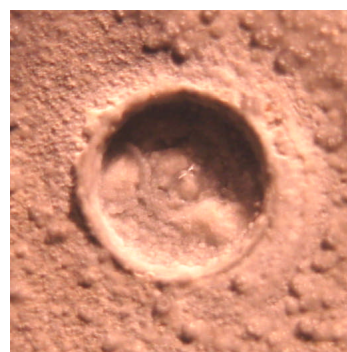
Figure 8: FSA specimen.

Figure 9: HVOF specimen.

Figures 8 & 9: A close-up of the exposed bare steel (holiday) areas at the end of the 1-year exposure period (~ magnification x10).

Visually assessing figures 8 and 9, it would appear that protection had been afforded to the bare steel areas (holidays) on both coated specimens. The exposed bare steel areas appeared to be covered with surface scales. However, as mentioned above, a similar blocking of the exposed bare steel areas by aluminium corrosion product appears highly unlikely. The most probable anodic reaction at the exposed bare steel surfaces would be the dissolution of iron and the amount of ferrous oxide compounds visible on these particular areas of the panels would not appear to be of the required quantity and nature to have a significant effect on the resulting corrosion potential of the coated specimens. Nevertheless, all exposed bare steel areas appear to be protected with no damage to the surrounding coatings.

A closer analysis of the scales found on the exposed bare steel areas of coated specimen shows a deposit of a different kind to that observed and analysed on the general surface areas of the coatings. An SEM study with EDX analysis thus showed the presence of calcareous deposits, consisting mainly of calcium and magnesium carbonates, oxides and hydroxides. The formation of such deposits (calcareous scales) are due to a local increase in pH, caused by the reduction in oxygen at cathode areas^[23-24]. These precipitates formed on exposed bare steel areas have been shown to be sufficiently dense and resilient to effectively block the cathode thus effectively slowing down the corrosion reaction that consumes the anode, provided that the

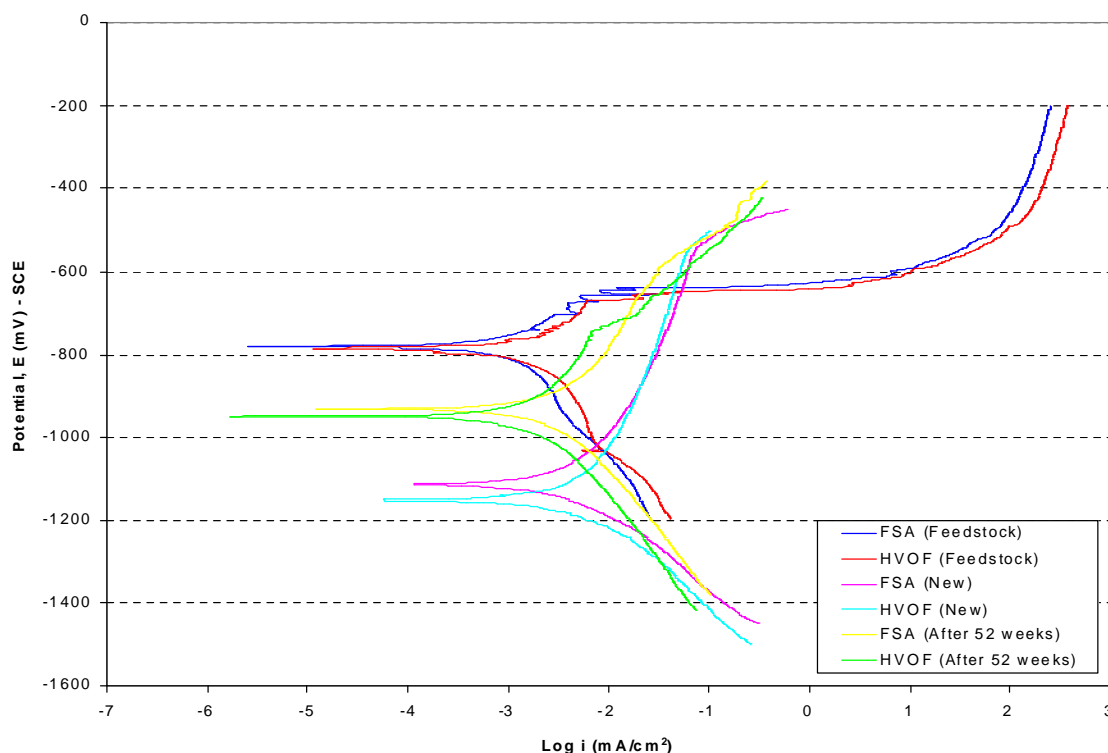
Figure 10: Polarisation curves for aluminium feedstock materials and for both types of thermally sprayed coating before and after exposure to the test conditions.

Figure 10 shows polarisation curves for the FSA/HVOF feedstock consumable materials together with polarisation curves for new as sprayed FSA/HVOF coatings and polarisation curves for the FSA/HVOF coated specimens after 52 weeks of exposure to the test conditions. All polarisation scans were obtained with the aid of 'Autotafel' ^[31] software at a scan rate of 1 mV/s using a saturated calomel reference

Figure 10 thus shows that both consumable aluminium feedstock wires exhibit a characteristic corrosion potential for aluminium in seawater, ~ -750 mV (SCE). However, upon thermal spraying, the new freshly sprayed coatings exhibit a new and a more active corrosion potential of around -1100 mV (SCE). This change in potential is considered to be due to changes in the oxide film caused by the thermal spraying process^[21,32]. It is not entirely clear how these changes in the oxide film are brought about, as it is believed that there is no mechanistic or qualitative information available in literature. However, it is thought that these changes are mainly due to rapid cooling/quenching and subsequent rapid solidification (constitutional supercooling) of the aluminium molten spray particles upon thermal spraying^[17]. An in depth discussion of the mechanistic aspects of thermal spraying can be found elsewhere^[17].

After 52 weeks of exposure to test conditions, the corrosion potential of both coatings shift in the positive direction by almost 200 mV and exhibits a decrease in current density by approximately one order of magnitude as compared to that of a freshly applied coating. Thus, the polarisation curves as shown in figure 10, especially for the FSA coated specimen, before and after exposure to the test conditions seems to be fairly representative when compared to previous studies^[11,26,30,33] for similar exposure time periods under marine service conditions. Figure 10 also shows that after the exposure test period, there is a decrease (approximately half an order of magnitude) in the anodic current density in the passive region for both coated specimens. This would indicate a slight improvement of the corrosion protection properties. However, this decrease in anodic current density in the passive region may have taken place well before the latter stages of the exposure test period. Vreijling^[30] has shown that significant changes in the anodic current density in the passive region especially for FSA coatings take place well within the first twelve weeks of exposure to marine service test conditions after which there is minimal change.

The decrease in current density and the shift of the corrosion potential in the positive direction is most likely to be attributed to the coatings becoming less active in the sense that the pores in the coating are becoming blocked by aluminium corrosion product, effectively shielding the steel substrate and perhaps the coating from the corrosive electrolyte^[10,30]. Initially, the freshly applied coatings are expected to exhibit a large number of open pores, resulting in the direct exposure of the substrate to the corrosive electrolyte and therefore the subsequent rapid corrosion of the adjacent aluminium coating through galvanic interaction. This will result in the localised development of insoluble aluminium corrosion product (aluminium oxides), which will settle in the pores thus blocking the exposure of the steel substrate to the corrosive electrolyte^[10,26,30,34]. Ultimately, this process will prevent the flow of ions to the steel substrate, eliminating the driving force for galvanic corrosion^[26,30]. A more extensive discussion on the 'blocking' action of corrosion products can be found elsewhere^[26,30].

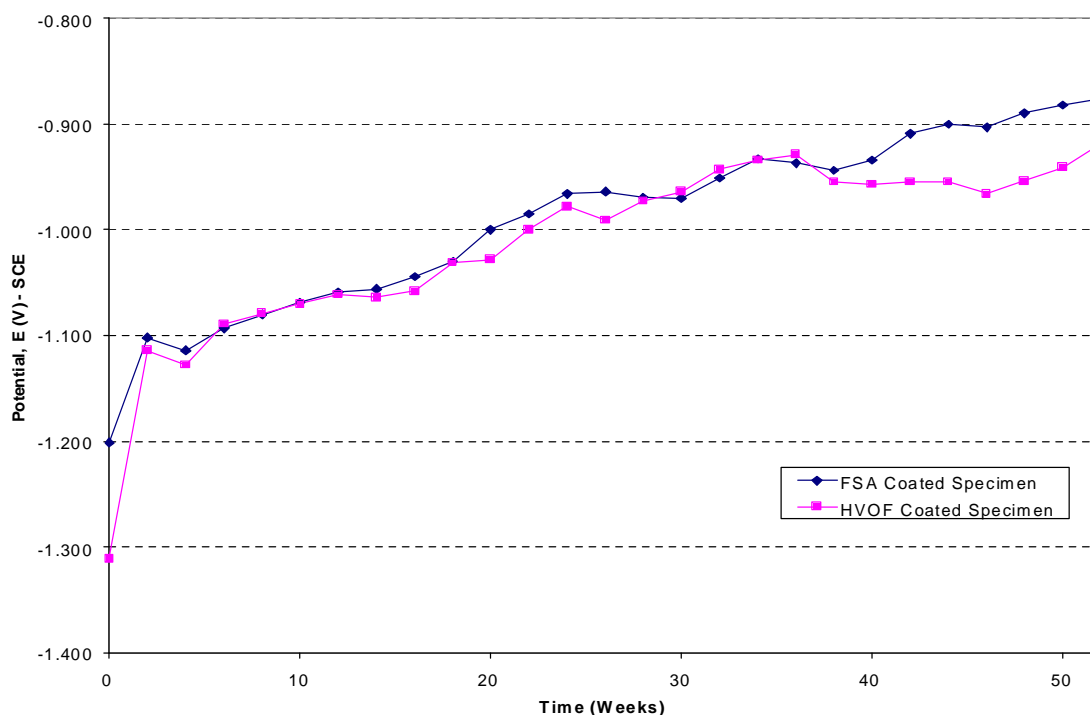
Figure 11: Potential measurements for both coated specimens throughout the entire exposure test period.

Figure 11 shows the potential measurements for both coated specimens, obtained under de-oxygenated conditions in ASW. De-oxygenated ASW was used so that the variability of dissolved oxygen concentration could be removed from the experiment, since dissolved oxygen concentration is highly susceptible to potential measurements [21,32]. The potential measurements were monitored with respect to a SCE using a high impedance digital voltmeter.

Figure 11 thus shows that the corrosion potential for both coated specimens change with time and seem to behave quite similarly over the entire exposure period with a continuous trend towards less negative potentials. During the first four weeks, the corrosion potentials of both specimens appear slightly unstable and it is only after week four that a continuous trend towards less negative potentials takes hold. Thus, for prediction of long-term behaviour, only data after week 4 should be used. The unstable changes in potential that occurred during the initial exposure period are considered to be due to changes in the area ratios for the cathode and anode reactions [7,10,14]. These changes are thus mainly due to the exposed mild steel (holiday) on each

Figure 11 also shows that the corrosion potential for both coated specimens are similar to that reported by others ^[10,13] for marine service conditions and are well within the NACE potential criterion of -0.780 V (SCE) for adequate cathodic protection ^[36] by the end of the exposure period. However, the potential measurements reported in this study were obtained under de-oxygenated conditions and Hussain *et al* ^[20] have shown that for almost identical FSA/HVOF sprayed aluminium coated specimens and identical exposure test conditions but with potential measurements conducted under oxygenated conditions with dissolved oxygen concentration being maintained at 8 ppm, potentials tend to be more electropositive by approximately 100 mV.

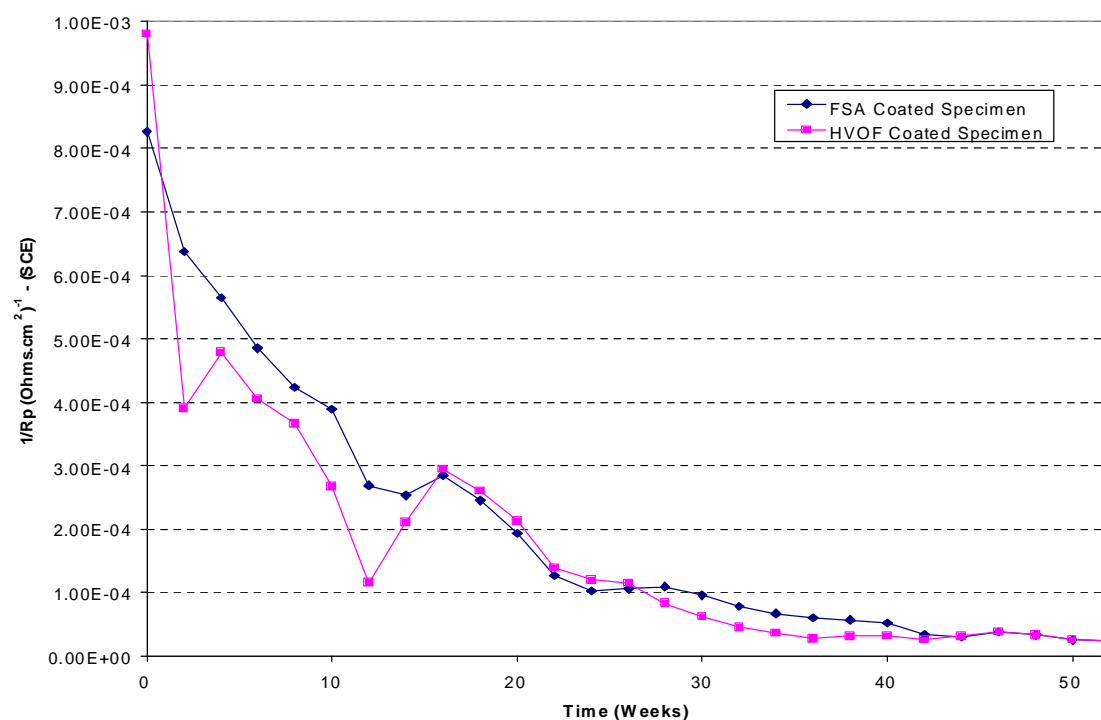
Figure 12: LPR measurements for both coated specimens throughout the entire exposure test period.

Figure 12 shows the results of linear polarisation resistance measurements ($1/R_p$) obtained under deoxygenated conditions for both coated specimens in which an indication of the corrosion rates for both coated specimens can be obtained. Figure 12 thus shows that during the initial stages of exposure, the corrosion rates for both coated specimens are relatively high, in which defects (if any) and pores in the coatings are being blocked. This initial phase is then followed by a second phase, in which the substrates and perhaps some parts of the surfaces of the coated specimens are effectively shielded from the corrosive electrolyte.

For the FSA coated specimen, the complete shielding of its substrate and perhaps part shielding of the coated surface take place approximately after approximately forty-two weeks of exposure to the test conditions. The transient as shown by figure 12 for the FSA coated specimen thus shows that no further improvement of the corrosion protection properties was achieved after week forty-two and that all open pores and micro-pores exhibited by the FSA coated specimen during the initial phase of exposure were subsequently blocked before the start of the second phase. For the

HVOF coated specimen, this transition in phases took place at approximately week thirty-six, after which there is minimal change.

Nevertheless, it would appear that the corrosion rates for both coated specimens are identical after the exposure test period. The generally low corrosion rates exhibited by both the coated specimens at the end of the exposure test period may therefore be attributed to the blocking of the pores in the coating by aluminium corrosion product, $\text{Al}(\text{OH})_3$ (aluminium hydroxide) and the stifling action of an aluminium oxide (Al_2O_3) film formation on the surfaces of the coated specimens.

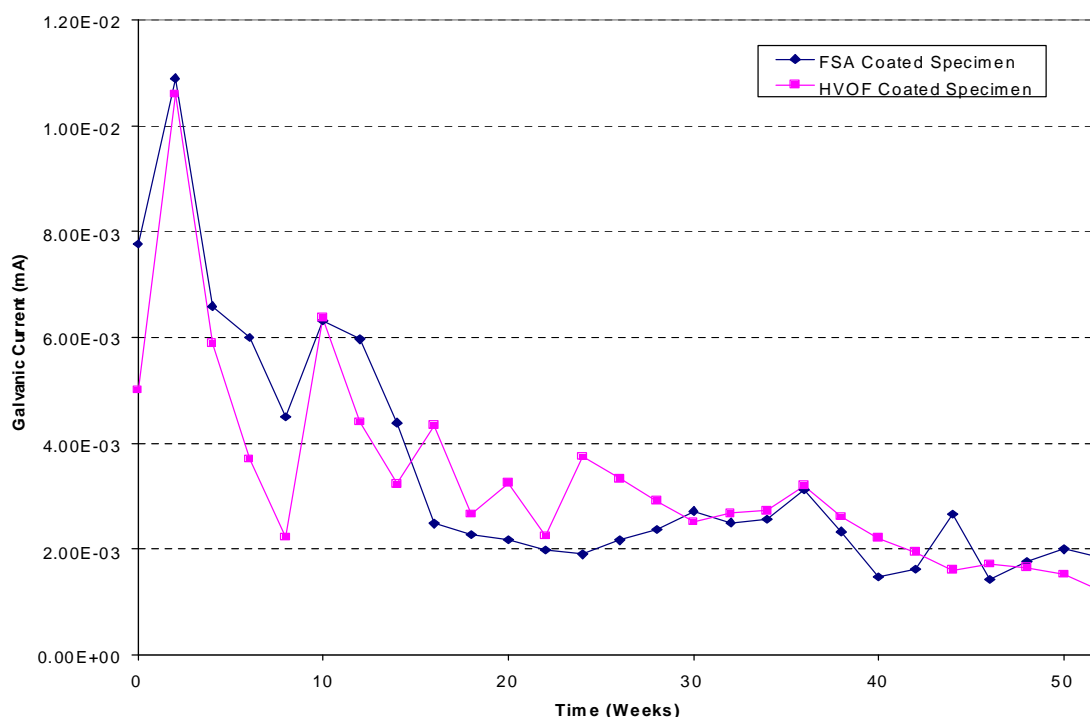
Figure 13: Galvanic current measurements for both coated specimens throughout the entire exposure test period.

Figure 13 thus shows the variation with time of the galvanic current for TSA coated specimens (anode) and the separate mild steel electrodes (cathode). The transients for both coated specimens show an initial sharp decrease in galvanic current exhibited by both coated specimens followed by a more steady, but erratic decrease in the galvanic current. The decrease in galvanic current exhibited by the coated specimens throughout the exposure period is likely to be attributed to the steady build-up of aluminium corrosion product on the surfaces of the coated specimens as a result of the corrosion of the TSA coated surfaces.

Figure 13 also shows that there are variations in the galvanic current flow throughout the entire exposure period. These variations in galvanic current flow may possibly be explained by the vigorous nature of testing in that the development of surface scales (aluminium corrosion product) on the surfaces of the coated specimens may have gone through cycles of forming, dislodging and re-forming, thus resulting in the variations of current flow between the TSA coatings (anode) and the separate mild steel electrodes (cathode). Nevertheless, throughout the entire exposure period, the galvanic current between the TSA coatings and the separate mild steel electrodes was considered adequate as the separate mild steel electrodes showed no signs of rust or any other form of degradation. It therefore appears that even after 52 weeks of exposure to the vigorous test conditions, both types of coating can still provide adequate cathodic protection to freshly exposed bare mild steel areas of at least that size.
