Investigation of corrosion in evaporator syrup pipes in sugar plant - Case Study

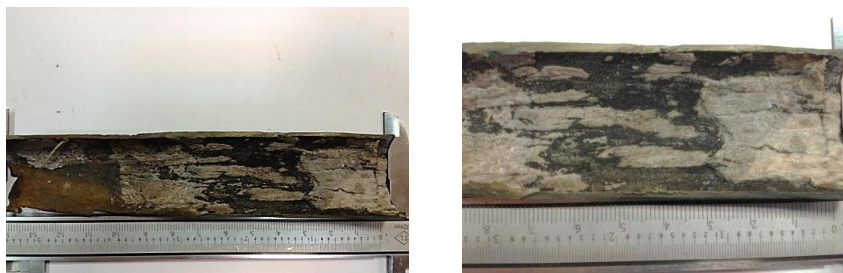
Figure 3- The internal picture tube after removing sediment

Sediment removal and imaging was performed with a stereo microscope. In the pictures, holes and roughness caused by corrosion are marked with circles. Pictures can be seen in Figures (3-4) with different magnifications.

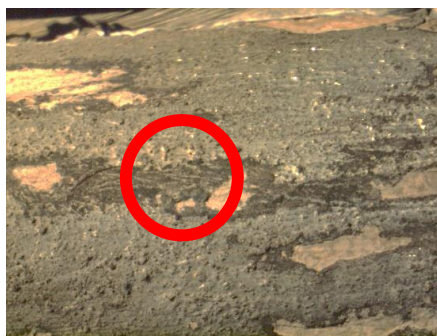
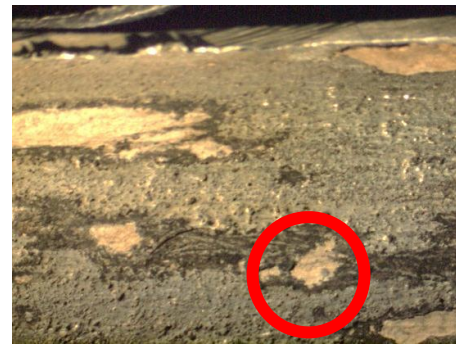
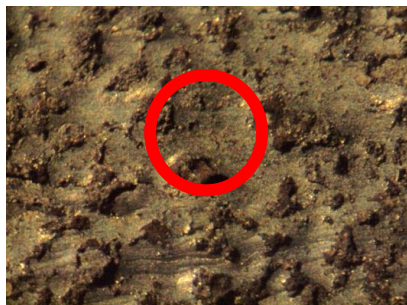
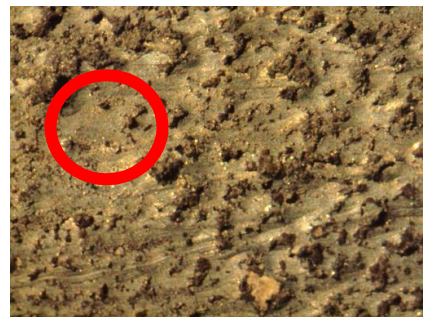
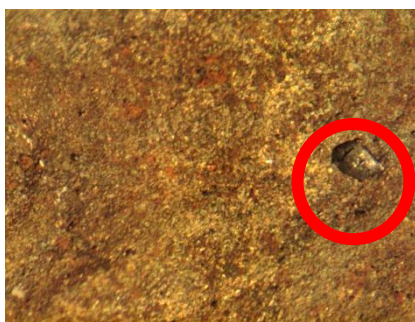
Figure 4. The internal picture tube with three zoom stereo microscope after removing sediment

1=0.7 mm

1=3 mm

1=5 mm

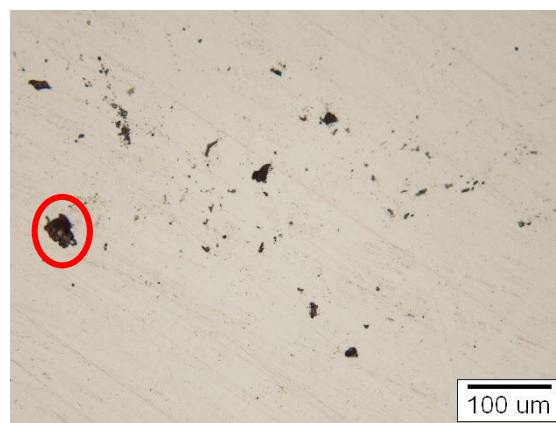
Figure 5 - metallographic image before etching

Before etching, black holes were found in it. Etched and examined under a microscope, we observed that the microstructure of the tube, ferrite - perlite and has not seen any major structural changes. It is well known that the type of corrosion leads to perforations in the pipe deposits, was the pitting and Crevice corrosion. In the figures(5-6) holes caused by corrosion are marked with circles.

The cause of this type of corrosion, forming sediments are thick around the pipe. This reduces the amount of oxygen in the sediments and the formation of the oxygen concentration cell. In the sediments, forming the anode region. Where the iron oxide layer formed is weaker, a small anode is composed of a large cathode and causing severe localized corrosion pitting that would be continues until perforations tube. Due to penetration and retention of the corrosive under deposition , the Crevice corrosion occurs

A - Corrosion leads to the destruction of the pipes, Was pitting under the sediment

B- Solution, replacing the pipe materials, inhibitors materials and also removing sediment deposits made periodically by the water pressure, recommended

C- With respect to syrup pH, the amount of chloride and oxygen, welding parts and with regard to economic issues and costs, replacement of stainless steel 304 L was proposed.
