Carbonate Coatings as Protective Barriers for Pipe Borne Water Transport Material

Umoru, L.E., Oladipo, A., and Ige, O.O.

Department of Materials Science and Engineering,

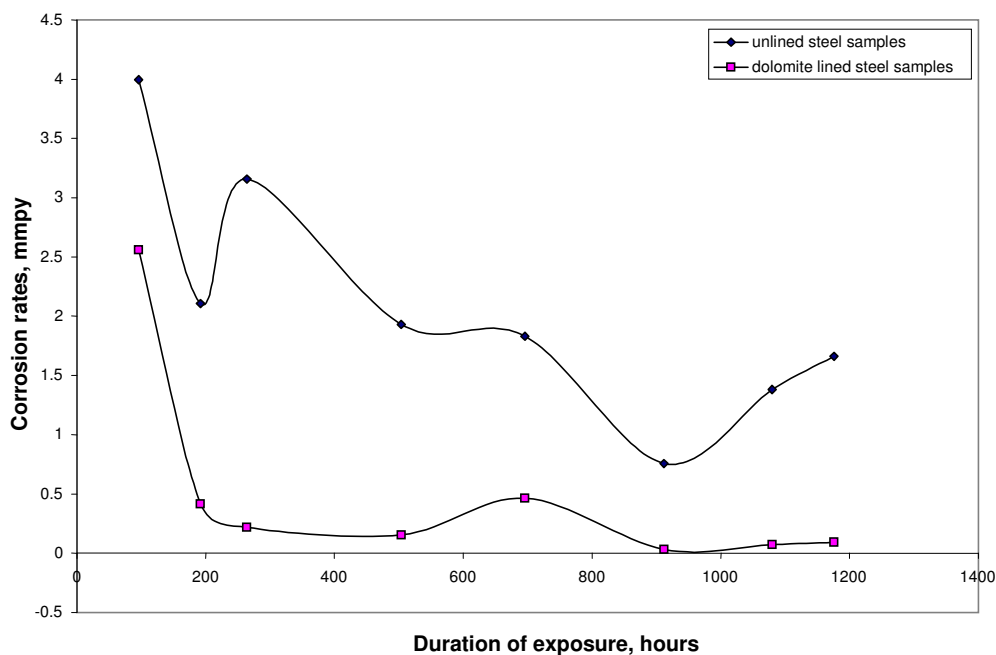
Fig.3 Graph showing the effect of dolomite lining on the corrosion resistance of a plain carbon steel.

Figures 1-3 show the effects of the calcite, magnesium carbonate and dolomite linings respectively on the corrosion rates of the plain carbon steel. The unlined steel exhibited higher corrosion rates than the other ones. Comparing the three figures, it is clear that dolomite conferred the greatest corrosion resistance on the lined steel. This is corroborated by the relative corrosion rates of lined and unlined steel as contained in the composite representation of the overall results of the study.

Dolomite (MgCO₃.CaCO₃) offered the best corrosion protection (least corrosion rate) when compared to the other lining materials – calcite (CaCO₃) and MgCO₃. Samples coated with dolomite initially had a sharp decrease in their corrosion rate from above 2.5 mm/yr to below 0.5 mm/yr within the first 192 hours of exposure time and the corrosion rate remained stable below this value for the remaining time of exposure. In the case of MgCO₃, the corrosion rate remained on the high side of the 0.5 mm/yr mark all through the entire time of exposure. While for calcite lined samples, the corrosion rates fluctuated above 0.5 mm/yr for the first 911 hours; dropped below this mark at the 912th hours and returned above the mark after this time. The unlined samples (control) shows the highest degree of corrosion rate which stood at about 0.8 mm/yr.

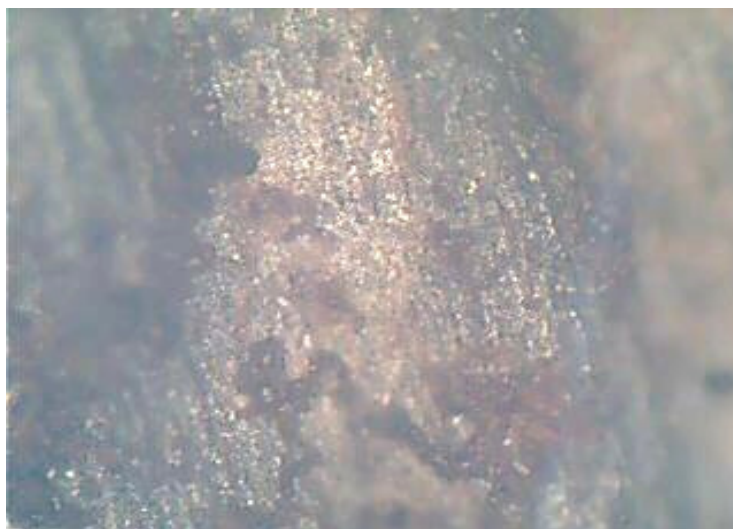
Plate 2: Micrograph of calcite lined sample after 21 days of exposure. 100X

Plate 2 shows the micrograph of calcite lined sample exposed after 21 days. The corrosion attack were severe and highly localized while the corrosion product is scanty. The attack occurred along the grain boundaries with characteristic of deep pit which may be as a result of high energy associated with the region or it may be attributed to dissimilar corrosion. The microstructure of dolomite lined samples exposed after 21 days is as shown in Plate 3 and it revealed almost uniform corrosion product and localized

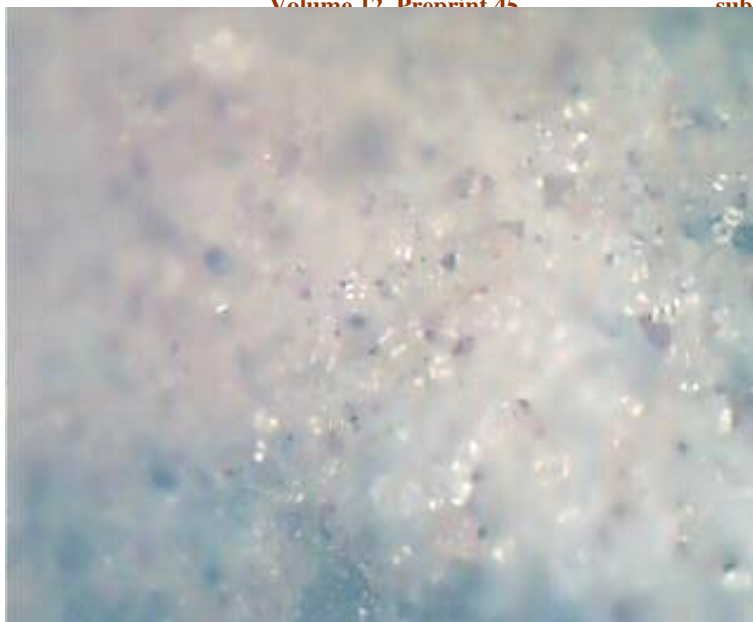
Plate 3: Micrograph of dolomite lined sample after 21 days of exposure. 100X

attack. The corrosion product is also widespread but the attack is not served and the size of the pit is small. Plate 4 illustrates the corroded surfaces of MgCO_3 lined sample after 21 days exposure in the pipe borne water. The cavities as found on the surface are smaller in size but are more widespread.
