Volume 6 Paper C042

Corrosion in Hot Gas Converters of Sulphuric Acid Plant

M.B. Ives, K.S. Coley and J. Rodda

Walter W. Smeltzer Corrosion Laboratory, McMaster University, Hamilton, Ont. L8S 4L7

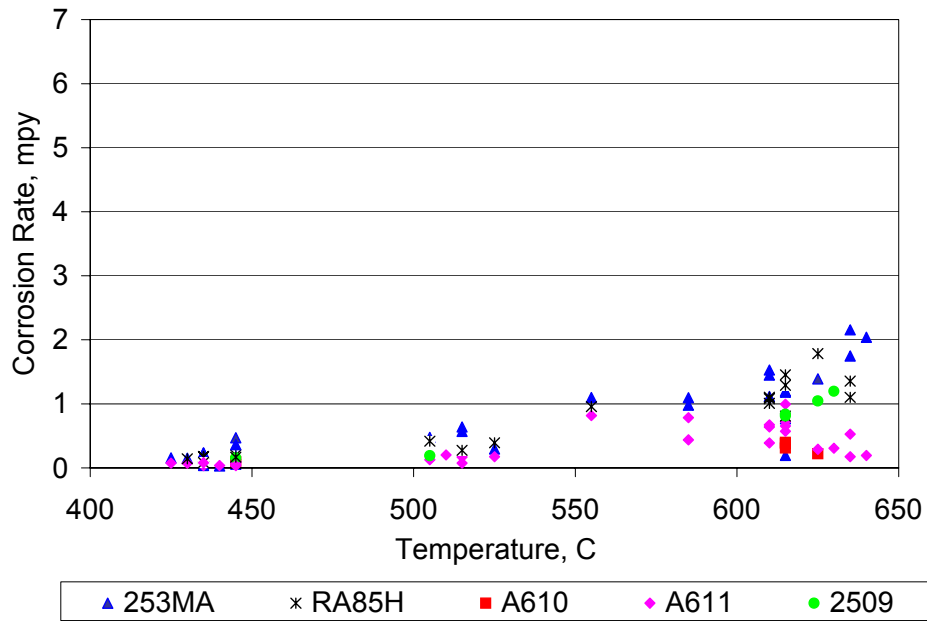
The corrosion rates of the alloys containing more than 1% silicon are substantially better at the higher temperatures, as seen in Figure 5. The influence of the amount of alloyed silicon in the alloys is shown in Figure 6.

Figure 5,
Corrosion of high Silicon alloys, 1 year exposures.

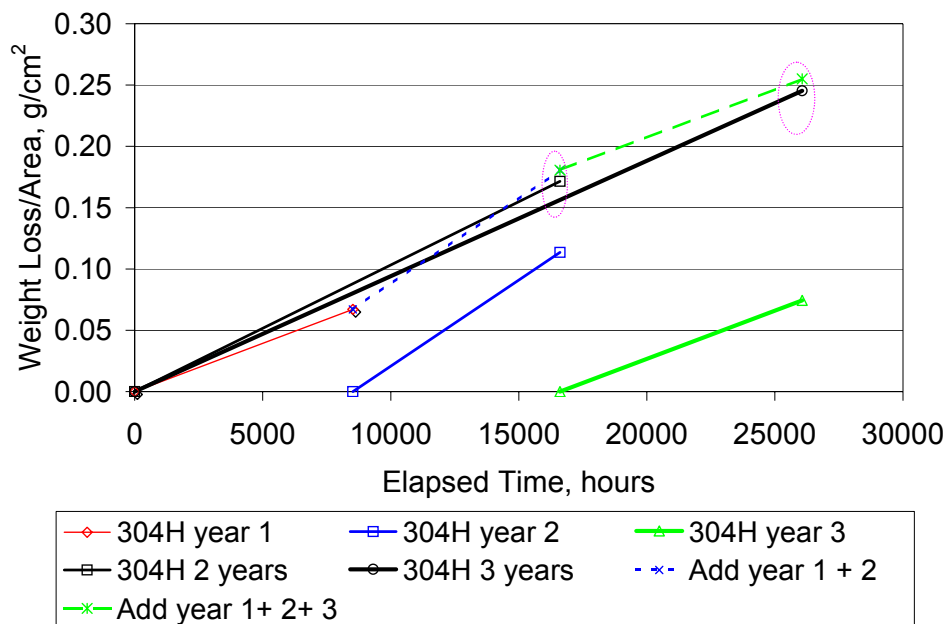
Figure 8, Multiple years analysis for S30409 at 620°C, below bed 1

In order to clarify the time dependence of corrosion rates, it is instructive to superimpose the rate measurements from 1, 2, and 3 year exposures in a given plant. These are shown graphically in Figures 7 (for samples placed at the lower temperature, 420°C) and Figure 8 (for samples at

The multiple-year comparisons suggest that at the lower temperatures, corrosion rates decrease with time over a 3-year period such that superpositioning the rates for the individual years sum to much less than the measured rate of the 2- and 3-year samples (Figure 7). However, at the higher temperature (Figure 8) the superpositions indicate a better correlation among the multi-year samples. One conclusion² from this observation is that spalling of the scales occurs within one year at the higher temperature so that each sample is regularly reduced back to “bare” metal, whereas at the lower temperature, the scale is more adherent. The topic of scale spalling will be discussed further below.

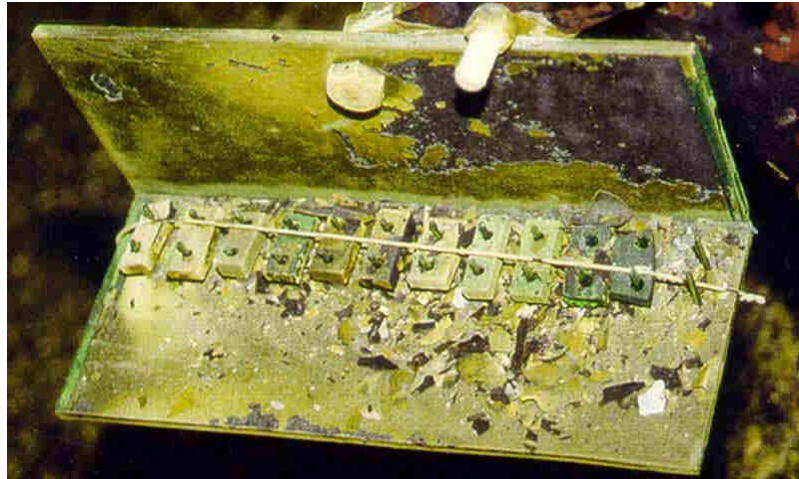
Figure 19. Rack of “metallographic” samples after exposure for 1 year above Bed 2 (high temperature) in Plant A

In an effort to retain the scale on the alloys at the end of a campaign, a set of small samples were installed on the rack shown in Figure 19. Immediately on removal from the converter the samples were potted in curable resin to permit sectioning and metallographic examination back in the laboratory. As is seen from the Figure, significant scaling still occurred, although some of the scale seen above originated from the holder plate.

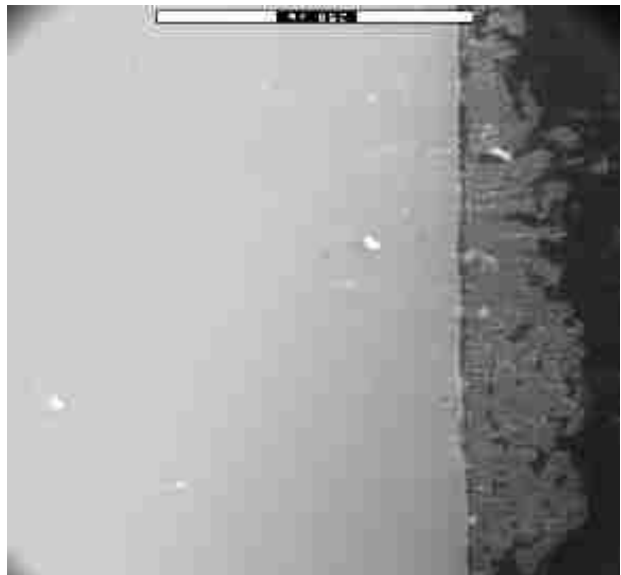
Figure 21. Scale structure on S30601 after 1 year at 625°C (marker is 200: m)

Despite difficulties in retaining the scale, conditions within the wet acidic atmosphere within the potting, and in moisture pickup on transfer to the scanning electron microscope, some complete scale structures were observable. Typical scales are seen in Figure 20, for S30409 and Figure 21, for S30601.

Recalling the significant difference in corrosion rate for these two alloys at this temperature, the scale on the high silicon alloy (Figure 21) is compact, probably with an unresolved barrier layer close to the metal. The scale on the low alloy sample (Figure 20) is much thicker and shows a clear gap at the scale/alloy interface, suggesting spalling – probably during the cool-down period.

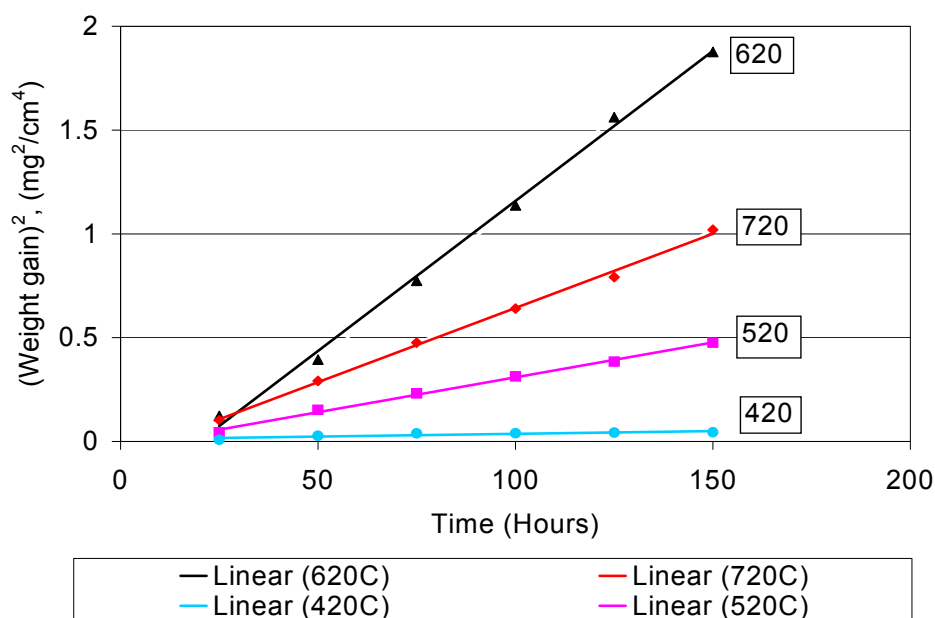
Figure 22 summarizes the weight gain data for S30409 at four temperatures, plotted on scales to demonstrate parabolic kinetics. The largest oxidation was observed at 620°C. At 720°C the rate has been reduced.

Figure 22,
Parabolic plot of the weight gain for S30409 at four temperatures in 7% SO₂

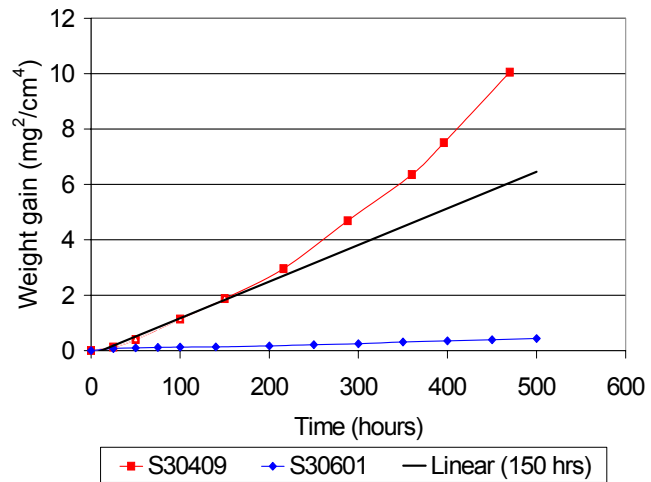
Figure 23 shows the kinetic data² in 7% SO₂ at 620°C for the two alloys of interest. The S30409 alloy shows an initially linear rate followed by an increase (“breakaway”) after 150h. The S30601 alloy exhibits a significantly lower reaction rate, consistent with the observations of scale structure.

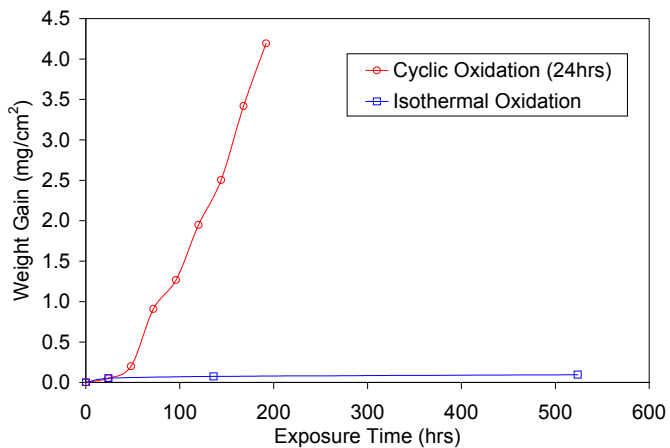
Figure 24 shows oxidation kinetics obtained from three samples of S30409 alloy placed in a tube furnace with 7% SO₂ and a gold catalyst. One sample was removed and weighed after 120h, and another after a total exposure time of 520h. The third sample was removed from the furnace every 24h, cooled to room temperature and mass determined before being replaced into the furnace. The first two samples provide the “isothermal oxidation” kinetics, and the other (eight) measurements provide the “cyclic oxidation” curve after successive removals and reheats.

It is clear that temperature interruptions significantly increase the weight changes, supporting the importance of plant down times on the corrosion behaviour of S30409.

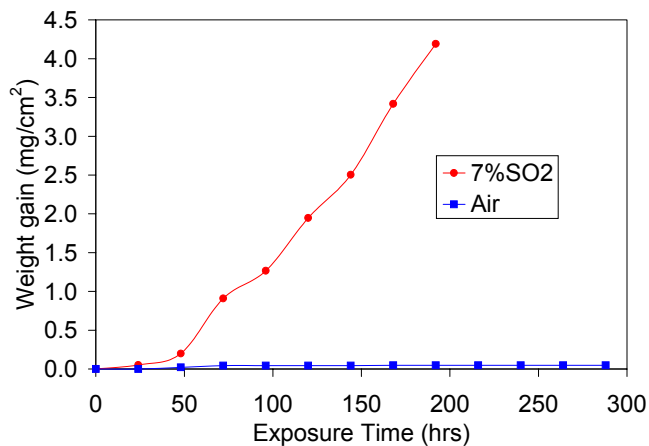
Figure 25

The observations from another cycling experiment is shown in Figure 25. All weight changes in this plot are the result of 24h thermal cycling between 620°C and ambient. This data show that SO₂ is necessary for the spalling effect. Cycling in air for 200h without sulphur-containing species causes less than 2% of the weight gain when SO₂ is present.
