Influence of Protective Coatings on Corrosion Resistance in Transmission Line Tower Foundations

R.Siva Chidambaram* **Christian Johnson Dr.G.S.Thirugnanam***

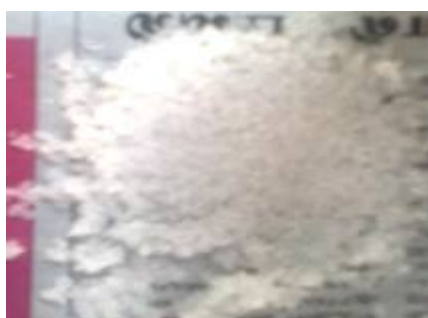
Fig 2: Calcium Nitrate(Salt Form)

III) Corrosion Inhibitor (Calcium Nitrate) (2% By weight of Cement)

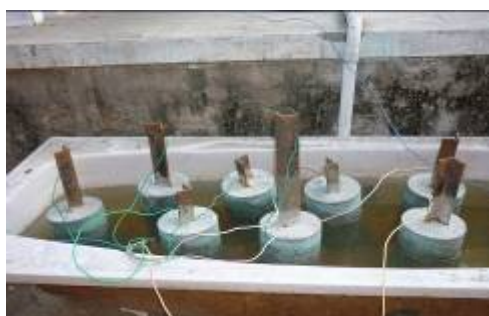
Fig :9: Corrosion Acceleration(Before Corrosion)

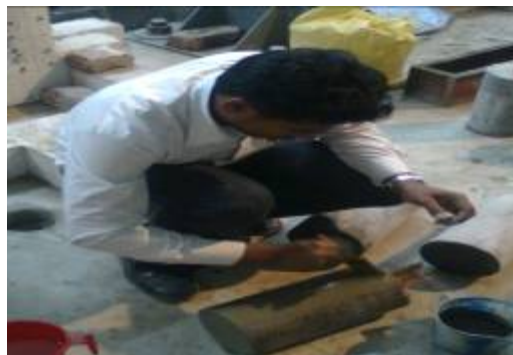
Fig :11 Accelerated Corrosion(After Corrosion) Fig:12 FACS R Coating Technique
