L. E. Umore*, A. Oladipo, and O. O. Ige

This paper presents the report of corrosion prevention study carried out on plain carbon steel lined with calcite, magnesium carbonate and dolomite as coats. Eight samples each of the steel were dipped into solutions of CaCO_3 , CaCO_3 and MgCO_3 , and MgCO_3 . Pipe borne water obtained from Obafemi Awolowo University, Ile-Ife water works was used as the environment. The corroded sample surfaces were subject to microstructural characterization using optical microscopy technique. The results obtained showed that the steel exhibited minimum corrosion rate of less than 0.5 mm/yr in dolomite, followed by MgCO_3 and then by CaCO_3 with corrosion rate far above 0.5 mm/yr bench mark. The unlined (control) samples have maximum corrosion rate of 0.8 mm/yr. the microstructures revealed widespread localized attacks and to a uniform corrosion. The dolomite lined samples are recommended for corrosion prevention of plain carbon steel in pipe borne water.

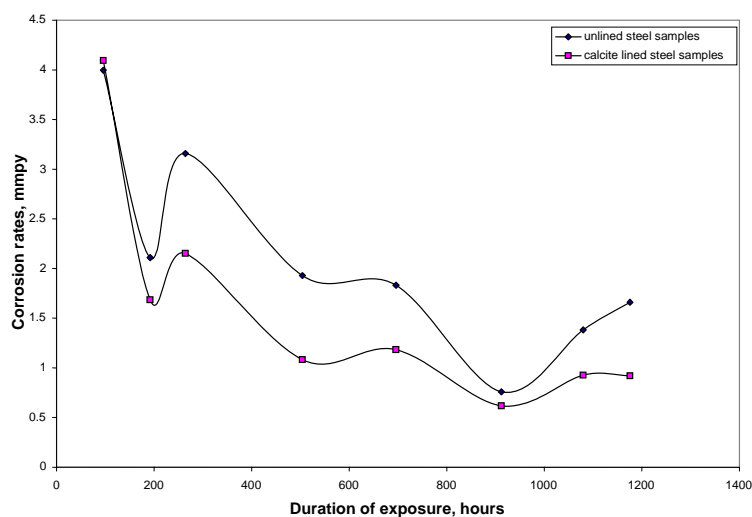
Fig.1 Graph showing the effect of calcite lining on the corrosion resistance of a plain carbon steel.

Figures 1-3 show the effects of the calcite, magnesium carbonate and dolomite linings respectively on the corrosion rates of the plain carbon steel. The unlined steel exhibited higher corrosion rates than the other ones. Comparing the three figures, it is clear that dolomite conferred the greatest corrosion resistance on the lined steel. This is corroborated by the relative corrosion rates of lined and unlined steel as contained in the composite representation of the overall results of the study. Dolomite ($\text{MgCO}_3 \cdot \text{CaCO}_3$) offered the best corrosion protection (least corrosion rate) when compared to the other lining materials – calcite (CaCO_3) and MgCO_3 .

While for calcite lined samples, the corrosion rates fluctuated above 0.5 mm/yr for the first 911 hours; dropped below this mark at the 912th hours and returned above the mark after this time. The unlined samples (control) shows the highest degree of corrosion rate which stood at about 0.8 mm/yr.

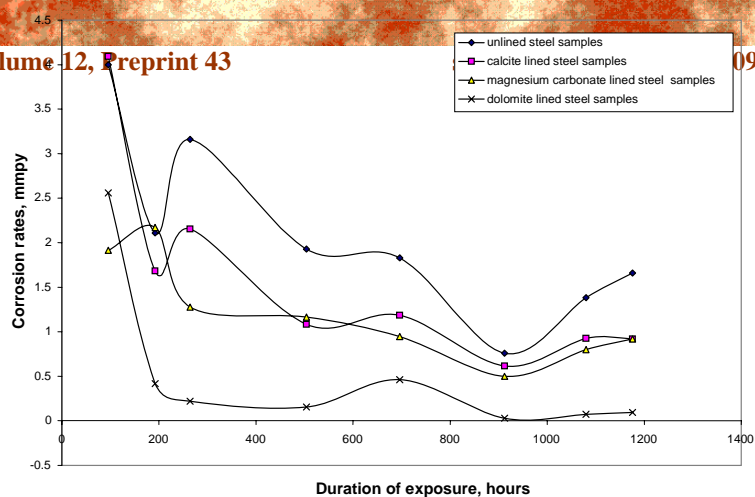
Fig.4 Graph showing the effect of different linings on the corrosion resistance of a plain carbon steel.

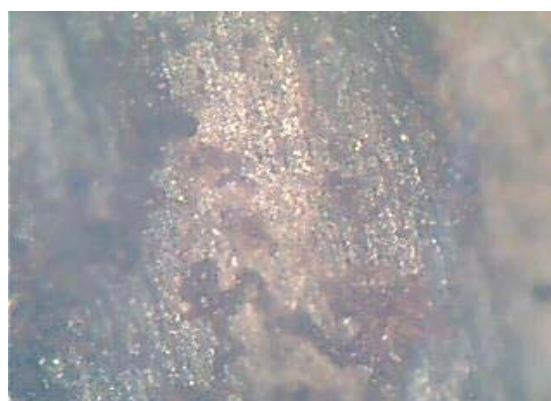
Plate 2: Micrograph of calcite lined sample after 21 days of exposure. 100X

Plate 2 shows the micrograph of calcite lined sample exposed after 21 days. The corrosion attack were severe and highly localized while the corrosion product is scanty. The attack occurred along the grain boundaries with characteristic of deep pit which may

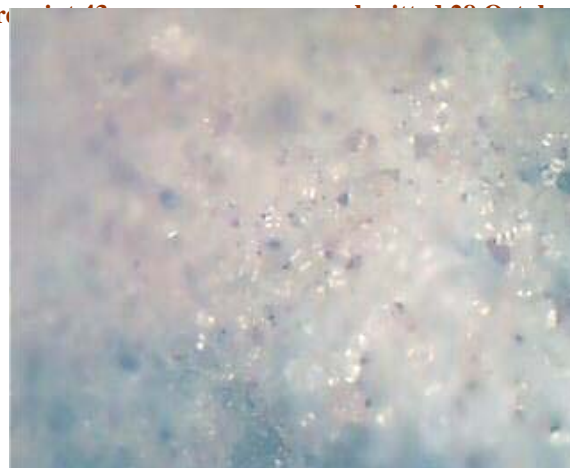
Plate 3: Micrograph of dolomite lined sample after 21 days of exposure. 100X

Volume 12, Preprint 43
The microstructure of dolomite lined samples exposed for 21 days is as shown in Plate 3 and it revealed almost uniform corrosion product and localized attack. The corrosion product is also widespread but the attack is not served and the size of the pit is small. Plate 4 illustrates the corroded surfaces of MgCO_3 lined sample after 21 days exposure in the pipe borne water. The cavities as found on the surface are smaller in size but are more widespread.
