Title:	Steps from Snowdenham Lane to Mill Pond
Description	The steps at the top of Snowdenham Lane that lead down to the Mill Pond and Mill Lane have become dangerous.
Owner:	TBD
Area:	Maintenance
Status	Owner to be determined
Last Updated:	16/03/2023

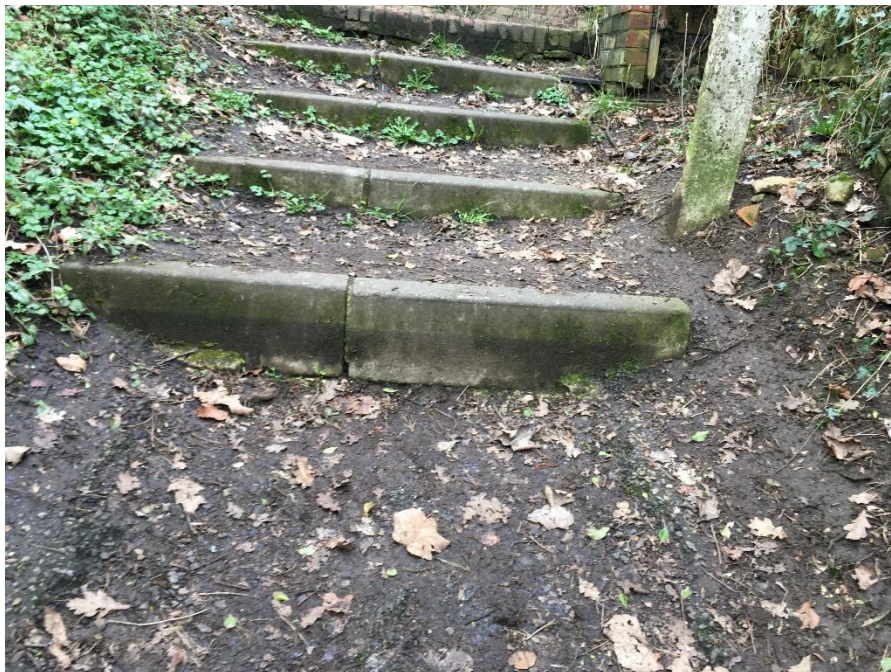
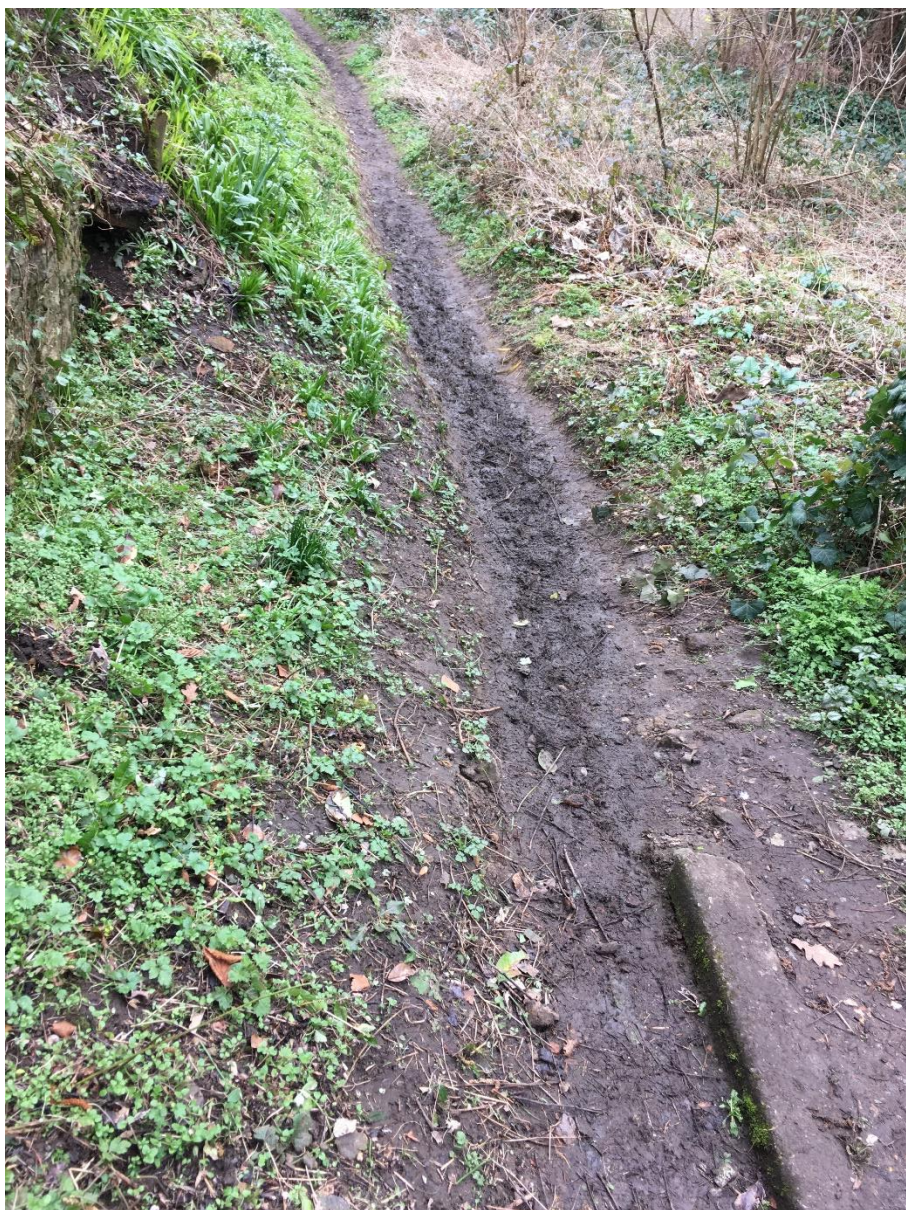
The path has been eroded by rainwater such that the depth of the last step is double that when it was initially installed.

This make the step extremely dangerous for anyone who is not sure footed or who hasn't noticed the drop! The path beyond the steps has also eroded exposing a concrete beam; another trip hazard
