# Impact of floods 2010 in coastal area of Pakistan – a case study of Kharo Chann, Thatta District

Kaif Gill<sup>1</sup>, Naeem Shahzad<sup>1</sup>, Irfan Ashraf<sup>1</sup>, Urooj Saeed<sup>1</sup>, Farooq Laghari<sup>2</sup>

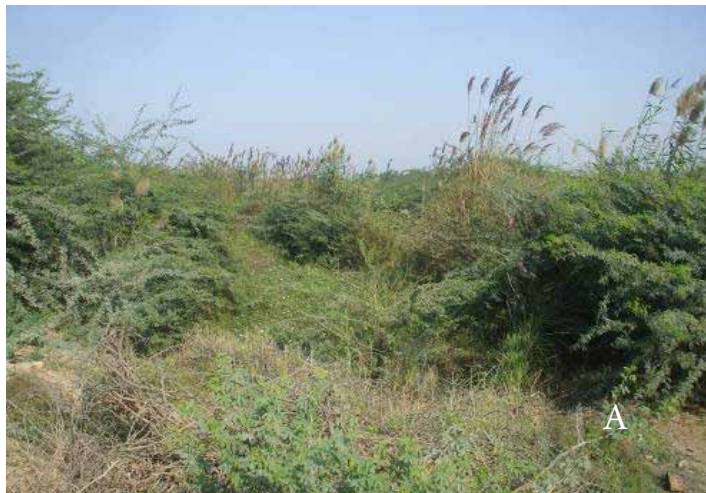
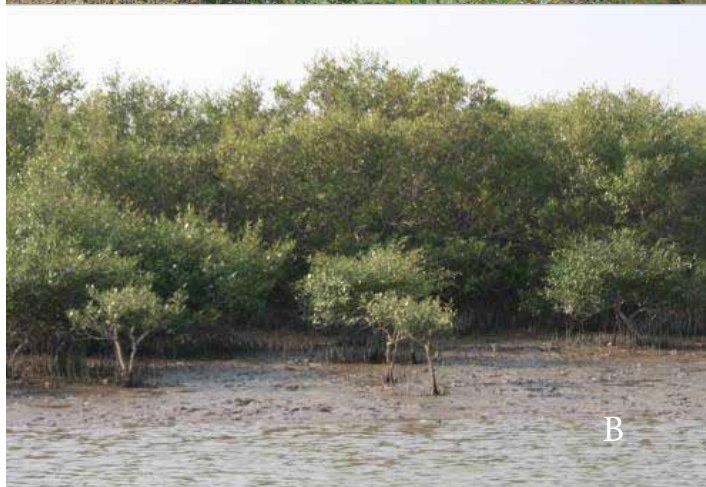
**Figure 2:** (a) Field photographs of Mixed *Mesquite* spp. and *Tamarix* spp. (b) Mangroves

In order to collect Global Positioning System (GPS) coordinates of the land cover classes and its correlation with the spectral values of the satellite images, different hotspots and confusion areas were identified on satellite image and verified on the ground. Garmin 76CSX GPS receiver was used to collect 81 GPS points. Land vehicle and boat were used to navigate in the study area. During the ground truthing, it was observed that inland area, along the Indus river, consists of *Tamarix* and *Mesquite* spp. along with *Saccharum* and *Typha* spp., whereas, mudflat areas consist of dense patches of mangroves mostly *Avicenna marina* (Fig. 2a & 2b).

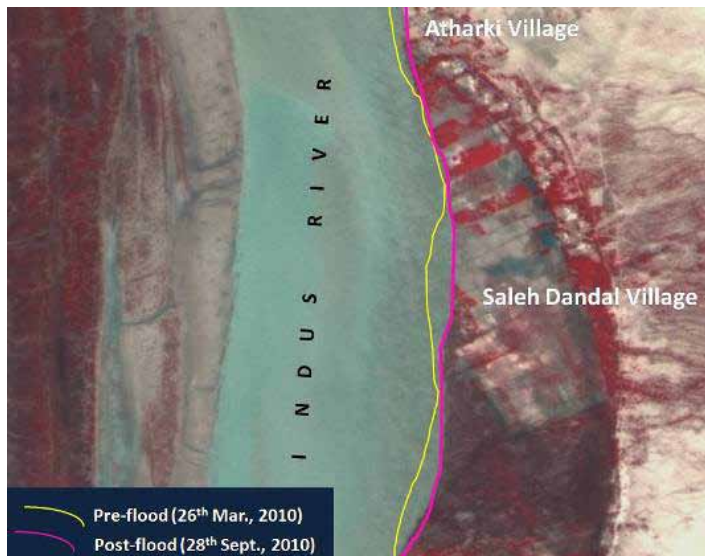
Figure 6: Land erosion status due to flood 2010

The flood intensity was reduced when it reached the study area, not much negative impact was observed (Fig. 6). However, the land cover changes observed during the temporal change analysis are mentioned in Fig. 5 and Table 2. The analysis of the thematic maps reveals an overall increase in the extent of the density classes of '*Mesquite/Tamarix* spp./Reeds' (Table 2). The increase appears to be due to the positive impact of flood on this class especially on *Tamarix* spp. *Mesquite* spp., which is an exotic and perennial weed was present in the river bed and adjoining areas along with *Tamarix* spp. In low depression areas, where the flood water remained stagnant, *Mesquite* has been damaged.

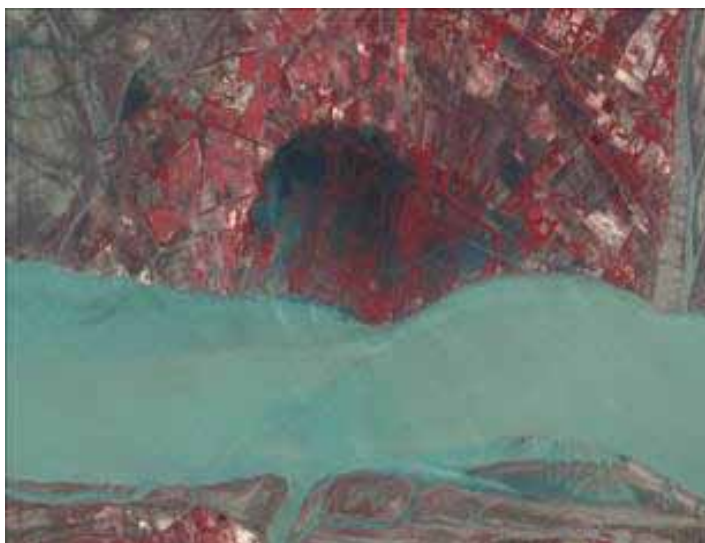
Figure 7: Pre and post flood image – *Mesquite* in low lying areas

These vegetative blocks have been taken away by flood waters in some of the areas. The dense patch of *Mesquite* spp. near Saleh Dandal village that appears as a maroonish red tone in the pre-flood satellite image has been dried and appears as blackish red tone in the post flood image. Although *Mesquite* spp. has been damaged in some low lying areas, but the overall contribution of the damaged class is minute compared to the healthier impact of floods on riparian vegetation.

2010, an increase in land cover classes of bushes and grasses has been observed. This is mainly due to the seasonal variation/post monsoon impacts. It was analysed by comparing pre (26<sup>th</sup> March, 2010) and post (28<sup>th</sup> September, 2010) flood satellite images and the land cover maps that recent floods have resulted in land erosion in some of the areas of Kharo Chann. The land cutting due to water pressure was high near Atharki, Saleh Dandal, Jamnagar and Chor Goju villages. Approximately, an area of 38 ha has been lost around these villages during the flood period. The areas near Atharki and Saleh Dandal villages have been facing land erosion since year 2000 but the floods of 2010 washed away some of the agricultural fields and houses as shown in Fig. 7.

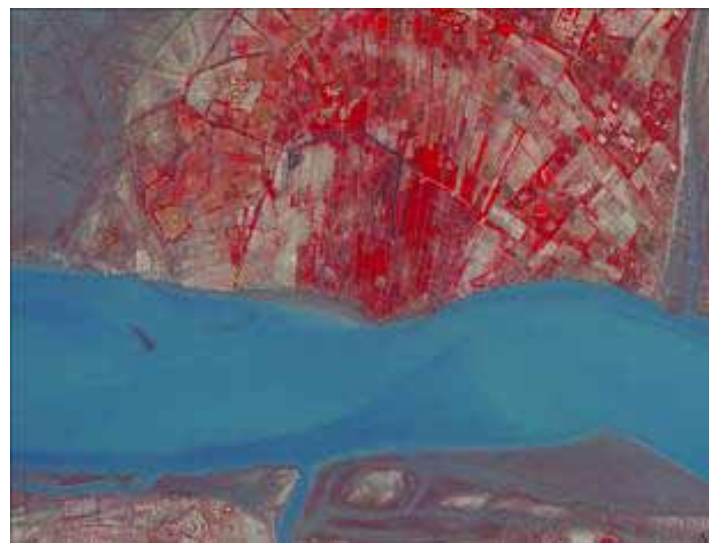
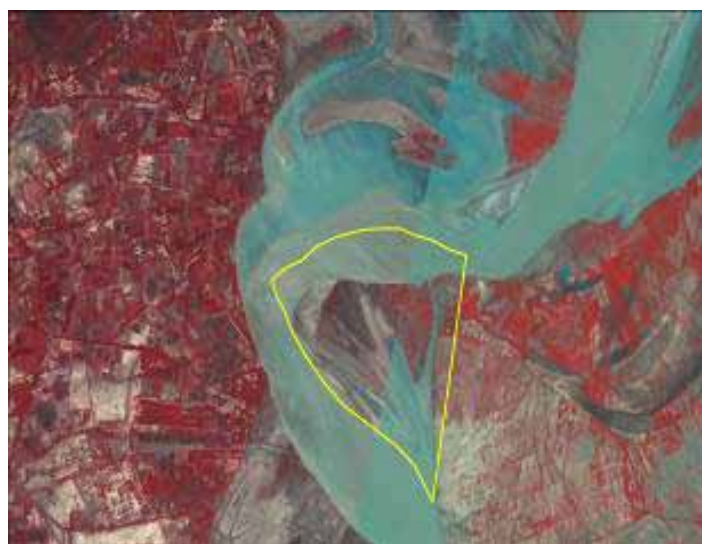
Figure 8: Pre and post flood images - Agricultural fields submerged after the floods

The study area, once heaven for the agriculturalists has now been transformed into the saline pools due to the imbalance between the fresh and brackish water. During 2010 floods, the agricultural fields were submerged with flood water and resulted in economic loss. Despite the fact, communities have greeted the 2010 flood with the belief that agriculture land will become fertile due to the dilution of salt by freshwater flooding.
