# Bridge Damage and Repair Costs from Hurricane Katrina

**Abstract:** Hurricane Katrina caused significant damage to the transportation system in the Gulf Coast region. The overall cost to repair or replace the bridges damaged during the hurricane is estimated at over \$1 billion. This paper describes the observed damage patterns to bridges, including damage attributed to storm surge, wind, impact from debris, scour, and water inundation, as well as examples of repair measures used to quickly restore functionality to the bridges and transportation system. Using the data from the 44 bridges that were damaged, relationships between storm surge elevation, damage level, and repair costs are developed. The analysis reveals that, in general, regions with higher storm surge had more damage, although there were several instances where this was not the case, primarily due to damage resulting from debris impact. It is also shown that a highly nonlinear relationship exists between the normalized repair cost and the damage state. The paper concludes with a brief discussion on the efficacy of using typical seismic design details for mitigating the effects of hurricane loads, and potential desi

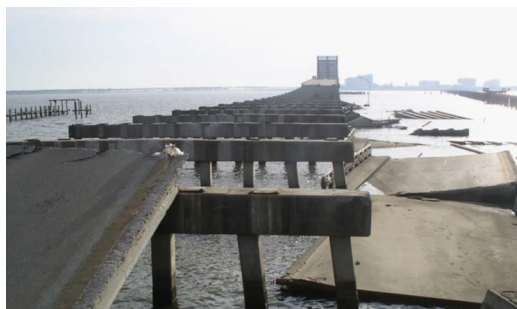
**Fig. 1.** US-90 Biloxi-Ocean Springs Bridge showing the primary mode of failure in severely damaged bridges: span unseating due to storm surge-induced loading

The most common severe failure mode for bridges was the unseating of individual spans, as seen in Fig. 1. This failure often occurred in low elevation spans as a result of excessive longitudinal or transverse motion of the bridge deck. The deck displacement is attributed primarily to the severe storm surge, which led to a combination of buoyant forces and pounding by waves. Similarly, many bridge spans were shifted but did not experience a complete loss of support at the bents or abutments. Bearing damage typically accompanied span unseating or deck displacement, as shown in Fig. 2. The bearings often provided no apparent positive connection between the superstructure and substructure. Some bridge spans, however, which were intended to have a fixed connection through doweling, still experienced complete loss of connectivity. Once the connectivity was lost, lateral wave and wind forces led to displacement of the bridge decks. The shifting of spans sometimes resulted in pounding and excessive transfer of forces to other members in the bridge, which then sustained damage, including the abutments, bent caps, or girders, as illustrated in Fig. 3(a). The loss of, or damage to, parapets on the bridge decks was also a consequence of the storm surge coupled with wave and wind loading [Fig. 3(b)].

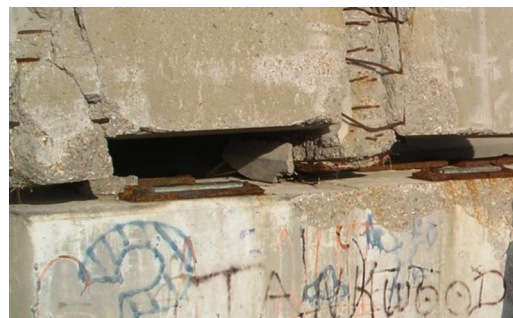
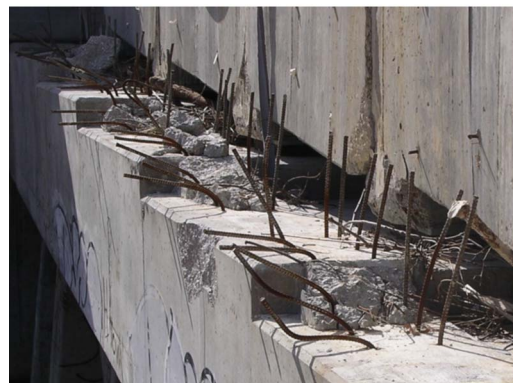
**Fig. 2.** Bearing damage that accompanied span shifting or unseating (a); loss of fixed connection (b) in two different bridges

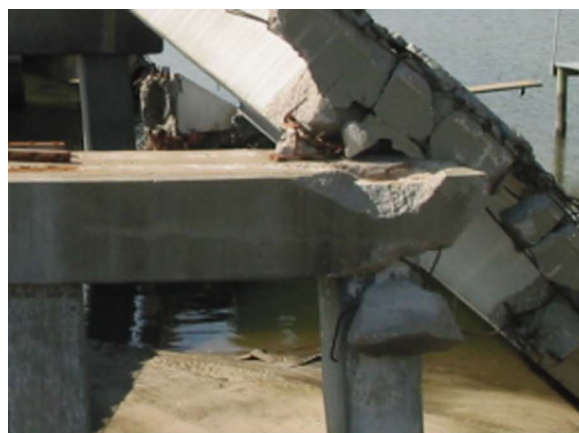
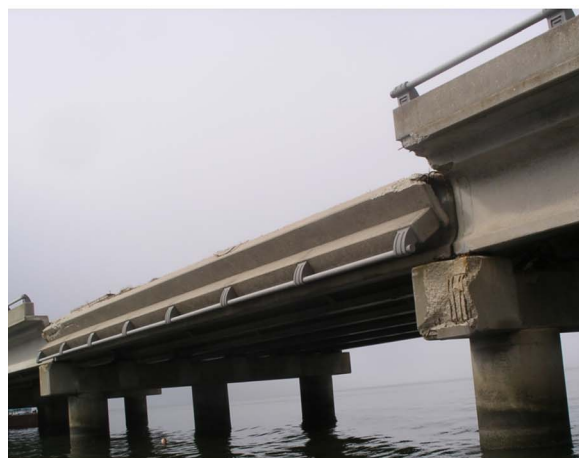
**Fig. 3.** Damage to bent caps (a); bridge parapet (b) due to storm surge

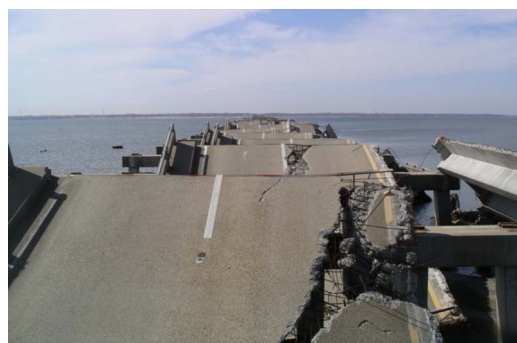
**Fig. 4.** Loss of bearing connectivity and span unseating on the US-90 Bay St. Louis Bridge. Estimated cost for replacement of this bridge is \$267 million.

to a combination of surge and wind/wave-induced loading, which led to strong transverse forces, sufficient to unseat a majority of the spans. This bridge is a four-lane, 3.06 km (1.9 mile) long, concrete girder bridge with parallel decks simply supported by high-type steel bearings. The spans are low lying with water navigation permitted through the use of a movable bascule. The bearings were severely damaged due to the surge-induced loading and nearly all connections between the deck and bent caps were lost, resulting in free movement of the decks, as seen in Fig. 4. All of the spans on the western half of the bridge completely unseated and were submerged in the Bay. On the eastern half, the north decks (westbound) were submerged and the south decks (eastbound) had drifted north and were partially submerged.

The damage to the Bay St. Louis Bridge will require complete replacement, which is estimated to cost \$267 million. The high-rise replacement bridge will have peak vertical clearances of 25.9 m (85 ft) with approach spans having clearances in excess of 10.7 m (35 ft) to try to avoid future storm-surge issues. The estimated completion date for this project is June 30, 2007—nearly two years after Hurricane Katrina.

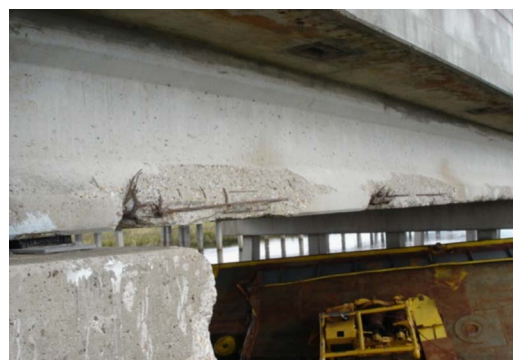
**Fig. 5.** Damage to girders (a); piers (b) due to impact from tugboat and barge (courtesy of MDOT)

Impact damage also occurred to bridges during Hurricane Katrina. Barges, which are common along the waterways in the Gulf Coast, often impacted bridges, along with oil drilling platforms, tug boats, and other types of debris. The impact damage manifested itself in the form of span misalignment and fascia girder, fender, and pile damage (Fig. 5).

The impact damage required repair or replacement of some girders, replacement of the six-span unit, bent cap repair or replacement, and installation of new precast piling. Extensive work was also performed to excavate, pump, and remove the barge. Because a crossover was built 8 days after bridge closure, traffic was maintained in both directions using the westbound bridge during the repair of the eastbound structure. The subsequent repairs were performed in 20 days at a total cost of \$5.8 million.

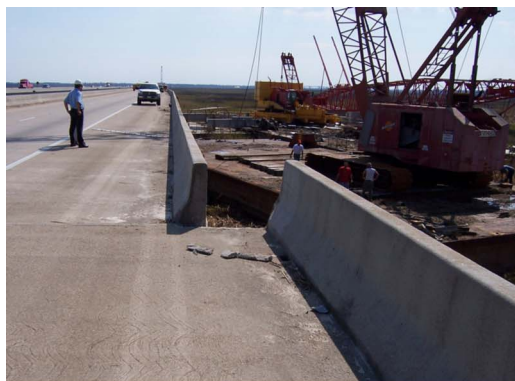
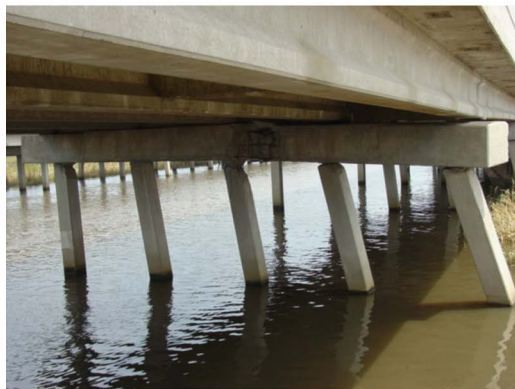
**Fig. 6.** Misaligned span due to barge impact on the I-10 Bridge at Pascagoula, Miss. (a); resulting pier damage (b) (courtesy of MDOT)

tensive damage to the bridge. This bridge is one of a set of twin-span prestressed concrete girder bridges with over 300 spans that carries I-10 over the Pascagoula River at Moss Point, Miss. The barge impact resulted in over 1.14 m (45 in.) of transverse displacement of a 95.1 m (312 ft) six-span unit, as seen in Fig. 6, and shearing of piles in the bents supporting these spans. Damage to fascia girders including spalling of concrete or exposure and breaking of prestressing strands occurred in other spans due to the tugboat collision.

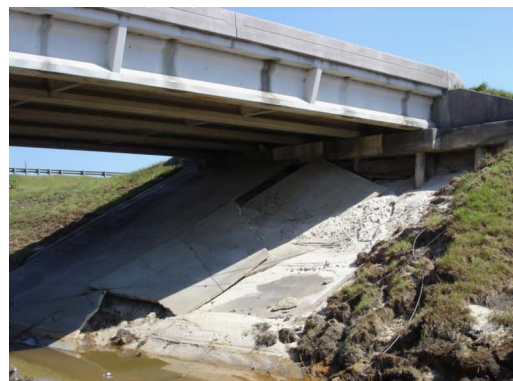
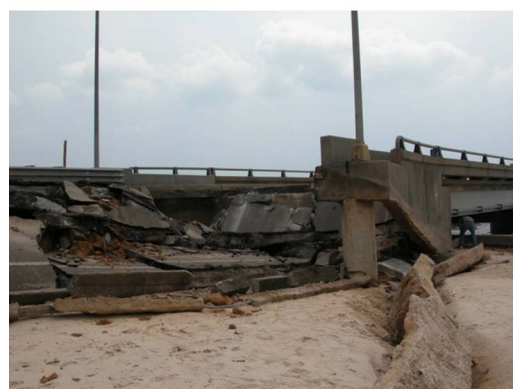
**Fig. 7.** Abutment and approach damage from scour and erosion [(a) courtesy of MDOT; (b) courtesy of LADOT]

Another failure mode was due primarily to scour. Observations revealed that this damage type may or may not accompany the other damage modes inherent to storm-surge loads. The scour damage that was readily visible to inspectors included scour and erosion of the abutment, slope failure, and undermining of the approach (Fig. 7).

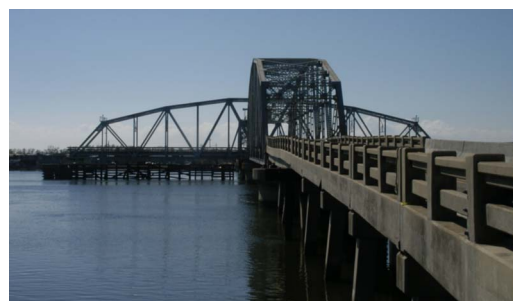
**Fig. 8.** Chef Menteur Bridge with fixed spans compromised by scour and slope failure at the foundations

The Chef Menteur Bridge, which carries US-90 over Chef Menteur Pass in Orleans Parish, is one of the bridges that suffered severe damage from scour (Fig. 8). Although this bridge is a movable bridge and suffered damage to the electrical and mechanical systems in the movable span, the most significant damage to the bridge structure was in the simply-supported concrete approach spans. The estimated total cost of repairs is \$3.6 million. A large portion of the emergency repair budget for the Chef Menteur Bridge was devoted to removal of five north approach spans, which were affected by slope failure attributed to scour. This repair includes removal of the supporting bents whose foundation has been compromised, replacement of the bents with piles driven to a depth 12.2 m (40 ft) below the original piles, and

replacement of the five 6 m (20 ft) spans with a single, 61 m (200 ft) girder-supported span to place the bent beyond the projected failure plane (Gautreau 2006).

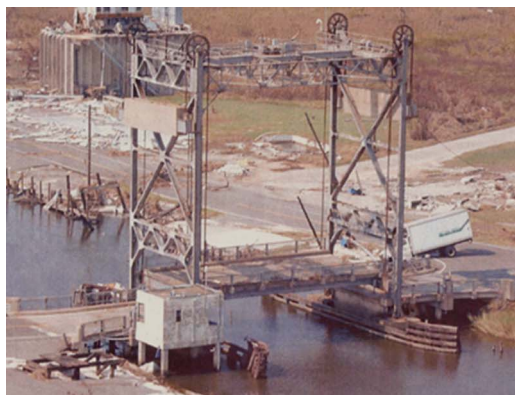
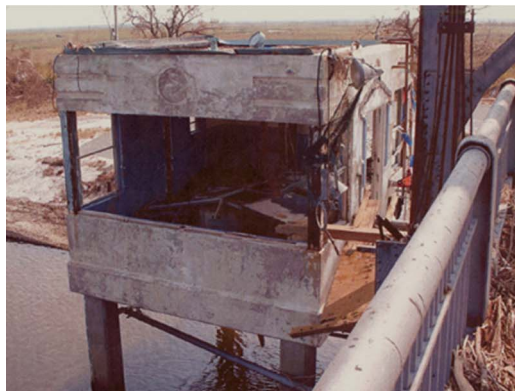
**Fig. 9.** Yscloskey Bridge damaged by water inundation: movable span immobile (a) due to elevation from surge and submersion of mechanical system; damaged operator house (b)

The Yscloskey Bridge on Route LA 46 in St. Bernard Parish, Louisiana is a lift bridge that sustained damage due to water inundation (Fig. 9). Lift bridges are one of three typical movable bridges found in the Gulf Coast region that permit channel navigation by vertically lifting a central deck by mechanical systems on two supporting towers. The high waters at the location of the bridge submerged the electrical and control systems in the operator house and completely damaged the system. In addition, the

surge itself elevated the movable deck approximately 2.4 m (8 ft) and caused it to be skewed and stuck in the lifted position. Emergency repairs of the Yscloskey Bridge cost \$900,000—80% of which was for the replacement of electronics damaged by water inundation. Other repairs included resurfacing the road, replacing electronic traffic control gates, and repairing barriers and the operator house.

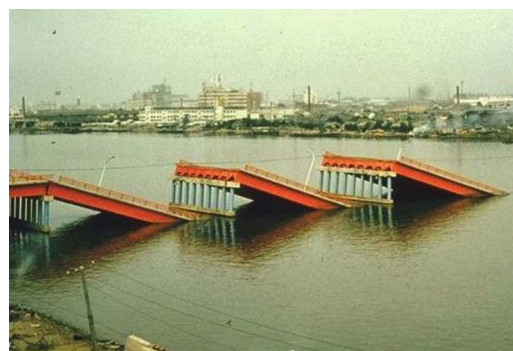
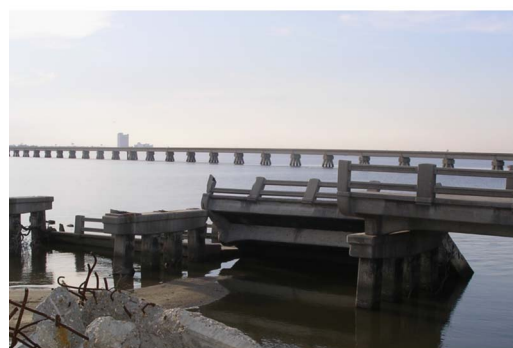
**Fig. 14.** (a) Unseating of spans from an earthquake (a) (NISEE 2006); (b) damage during hurricane Katrina (b). Note distant railroad bridge with shear keys is still intact.

While the nature of the loading and load transfer mechanisms in hurricanes and earthquakes are considerably different, the observations from Hurricane Katrina indicate that there are similarities in the types and patterns of bridge damage resulting from the two hazards. The unseating of bridge spans during Katrina, which resulted in a considerable amount of damage, disruption, and losses, has been a common problem in earthquake events (Jennings 1971; Moehle 1995; Comartin et al. 1995). During a seismic event, superstructure displacements are induced by inertial loads from the earthquake. Collapse of the deck spans occurs if the seat width is not adequate to accommodate the excessive displacements, as shown in Fig. 14(a). During a hurricane, the loads from storm surge and/or wind results in forces that could displace the bridge deck, both longitudinal and transverse to the bridge centerline [Fig. 14(b)].

In the seismic design or retrofit of bridges, shear keys are often used to limit the transverse displacement of the decks. As evidenced in Hurricane Katrina, bridges with adequate shear keys were often spared the level of damage suffered by neighboring bridges without such details. For example, the CSXT Biloxi Bay railroad bridge having 38.1 cm (15 in.) high shear keys had no unseated spans, while the adjacent Biloxi-Ocean Springs Bridge

carrying US-90 had little transverse restraint and suffered complete damage [Fig. 14(b)]. Other superstructure retrofits, which are common in seismic zones, include the use of vertical tie downs or longitudinal restrainers (Saiidi et al. 1996; DesRoches and Fenves 2000) to limit deck movement. The use of such design or retrofit techniques, which have traditionally been used for earthquake design, may be potentially viable to improve the performance of bridges in hurricane or storm-surge events, and are being considered by transportation officials in these regions.
