# Effects of Notable Natural Disasters from 2005 to 2011 on Telecommunications Infrastructure:

## Lessons from on-site Damage Assessments

**Abstract**— This paper discusses lessons from notable relatively recent disasters that had significant impact on communications infrastructure. The discussion will be based on field damage assessments and will be supported by extensive photographic evidence. In particular, the following disasters are discussed: from 2005, Hurricane Katrina; from 2008, hurricanes Gustav and Ike, from 2010 Chile's earthquake and tsunami, from 2011 New Zealand's earthquake in Christchurch, and the Great Earthquake and Tsunami in the Tohoku Region of Japan. This paper perspective focuses on basic questions addressed during field damage assessments that lead to identify potential ways for improving power supply availability during extreme events. Main failure modes are discussed, and similarities and differences observed from all these extreme events are commented. Predominant restoration strategies are also examined. Finally, this paper concludes with a summary of recommendations, including potential use of micro-grids as a powering option for communication sites

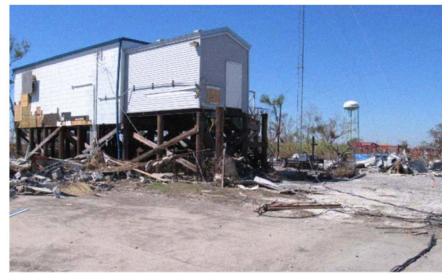
Fig. 1. Yscloskey CO after Hurricane Katrina.

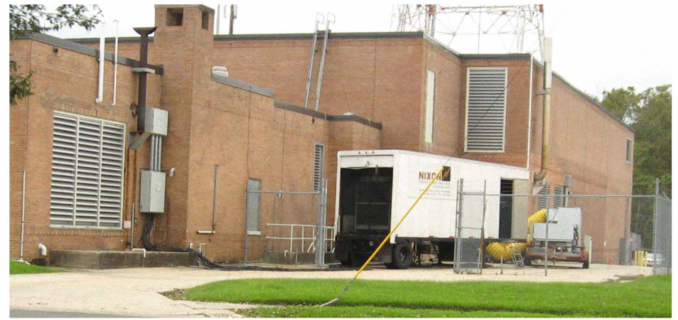
Fig. 3. A large portable generator outside Goodwood central office in Baton Rouge, Louisiana, less than a week after Hurricane Gustav.

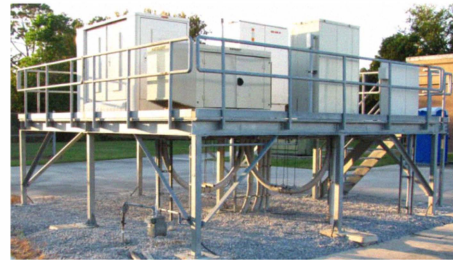
Fig. 4. A DLC RT with a natural gas genset located outside St. Bernard CO destroyed by Hurricane Katrina.

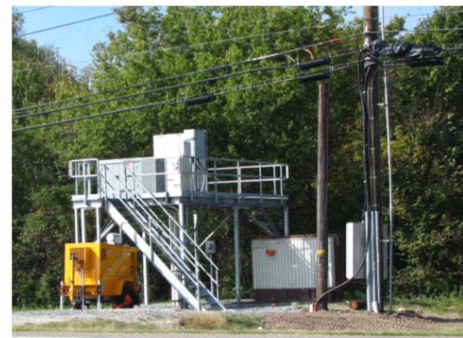
Fig. 5. A new DLC RT with a permanent genset installed on a platform after Hurricane Katrina next to another DLC RT installed on the ground before Hurricane Katrina.

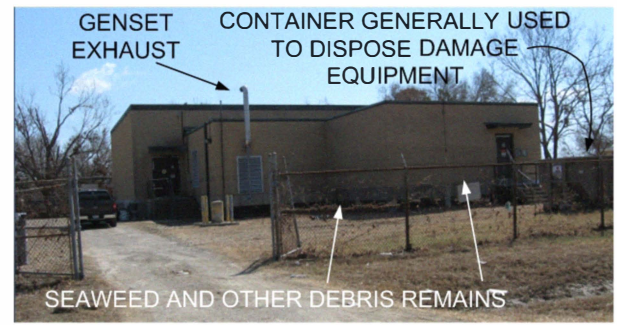
Fig. 6. Port Bolivar CO.

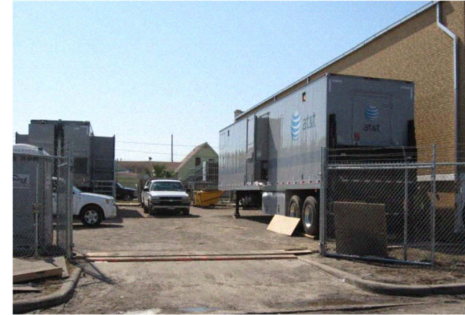
Fig. 7. Emergency mobile switches outside Sherwood CO after Hurricane Ike.

plants based on micro-grids [11], such as the one tested by NTT in the city of Sendai. One of the advantages of micro-grids is enabling a more reliable power supply through functional diversity [11]. Moreover, they allow integration of renewable sources such as photovoltaics which do not depend on lifelines. As such, micro-grids become true sustainable power systems in the sense that they sustain operation amid extreme conditions. Furthermore, use of combined heat and power generation address issues due to air conditioners low power supply availability [12]. Other design approaches imply the use of extended local energy storage through fuel cells (Fig. 22) or alternative local power standby systems [7]. The set of questions #2 allow to address the aforementioned failure modes, too. In this case, in addition to design and operation issues, the MDT is also related with maintenance policies and logistical operations. For example, as already discussed, failure modes A and B are typically addressed through the deployment of portable generators. Failure mode C can be addressed by deploying mobile power plants. Unfortunately, in some severe events, Failure Mode D is inevitable (Figs. 15). In these cases, some of the discussed solutions include deploying digital loop carrier systems (Fig. 4) or containerized solutions (Fig. 23) or switch-on-wheels to restore a damaged central office (Fig. 7), or cell-on-wheels to restore service to damaged base stations (Figs. 20.a).

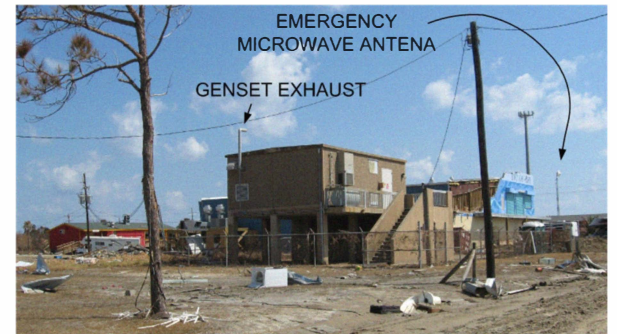
heights of 28 ft produced by Katrina in Mississippi [5]. Although the outages caused by Ike on communication networks were not as extensive as Katrina's they were nevertheless significant. The fixed telephony outages peaked at close to 340,000 [6]. AT&T lost service in 5 central offices with one of them, Sherwood (Fig. 1 in [2]), been destroyed. Although the damage assessment allowed to identify Sherwood CO's failure mode as communication site damage due to storm surge waters—all the equipment at the site was located no more than a meter above ground level—the failure mode of the other central offices was not completely clear. Although water marks in Fig. 6 suggests that Port Bolivar's CO may have been affected similarly than Sherwood CO by storm surge waters, it was possible to observe during the damage assessment that the onsite genset was operating. Moreover, unlike Sherwood CO where it was possible to observe "switch-on-wheels" (Fig. 7) used to restore service at the site, no equipment that could be used to potentially restore service was found outside Port Bolivar CO. The most likely failure mode in the other sites was a power related issue; perhaps diesel genset engine fuel starvation. These other central offices were likely small remote switches, like the one in Fig. 8 near Crystal Beach, which did not show any sign of damage observable during the field

reconnaissance. Another possible cause of failure was isolation due to a severed transmission link, as suggested by the emergency microwave transmission system in Fig. 4 in [2] and seen on the background in Fig. 8.

Fig. 8. A small switch facility near Crystal Beach after Hurricane Ike. restored to these sites, portable gensets were redeployed to other sites that did not receive gensets due to their lower importance. Nevertheless, service in some cell sites was only restored more than a week after the earthquake, when electricity from the power grid was once again available.

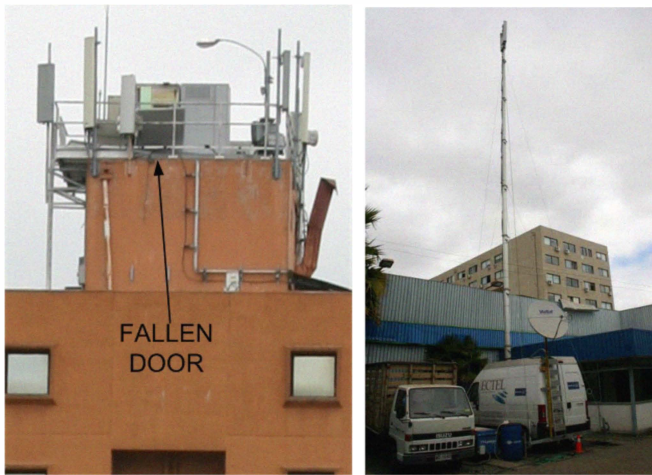
Another cause of failures in wireless cell sites—most of them located indoor, in shelters—was damage caused by the intense shacking due to improper anchoring of batteries, bended equipment frames, or some other type of vibration damage, such as the cell site in Fig. 9.a. Like in other disasters, service to damaged cell sites was restored with COWs, such as the one in Fig. 9.b. The damage assessment was also able to identify many sites where loss of service was caused by fallen or misaligned antennas. For one network operator about 50 % of its sites experienced this type of problems. Yet, cell tower damage was minor with only 2 of the towers of a major network operator collapsing. In one of these cases the failure was initiated by a fallen concrete water tank. The damage assessment was able to document a few cell sites where nearby walls collapsed on the base stations but none of these cases seemed to have led to site outages, corroborating information from network operators not including this failure mode as a cause for service interruptions. Nevertheless, some base stations located on building rooftops needed to be relocated

Fig. 9. a) Left: A damaged base station in Curico and b) Right: the COW likely used to restore service in its area. Notice the satellite link in the COW. because of the severe damage suffered by the building where they were installed.

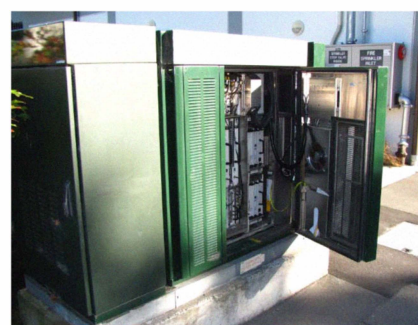
On February 22, 2011, Christchurch, New Zealand, was struck by a  $M_w$  6.1 earthquake. Although the earthquake's moment magnitude may not seem as significant as other recent earthquakes, the shallow location of the hypocenter (5 km), soil and terrain characteristics, and the close location to the city, produced significant soil liquefaction areas and one of the most intense sackings ever recorded which in some points reached twice the acceleration of gravity. The earthquake occurred less than 6 months after another earthquake with a  $M_w$  of 7.1 affected the same area although with less significant effects. Despite the significant shacking and soil liquefaction observed in the Feb. 22 earthquake, besides network congestions, the most important communication networks failure mode for this disaster was lack of power affecting distributed network elements, particularly wireless communications base stations. Power outages originated in soil liquefaction caused extensive damage to buried cables of power utilities. In wireless networks these power problems were aggravated by extensive use of micro and mini-cells (Fig. 10) which are very rarely equipped with permanent gensets. Although the damage

Fig. 10. A minicell base station cabinet showing the door heat exchanger.

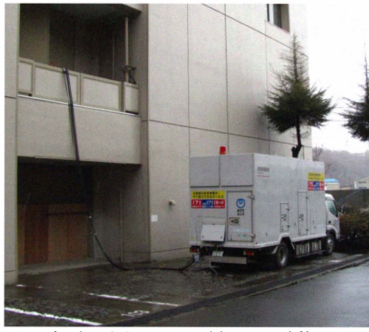
Fig. 11. Miyako CO powered by a mobile generator.

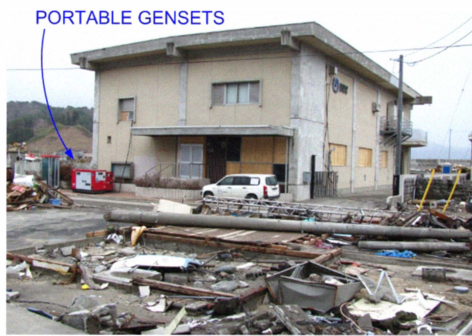
Fig. 13. Yamada CO powered by portable gensets.

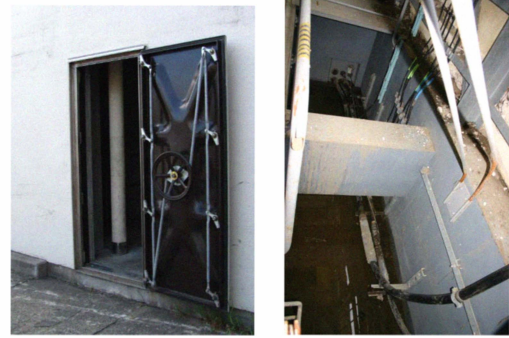
Fig. 14. a) Left: A water tight door in Kamaishi CO. b) Right: Cable entrance facility in Nobiru CO (as seen from the top).

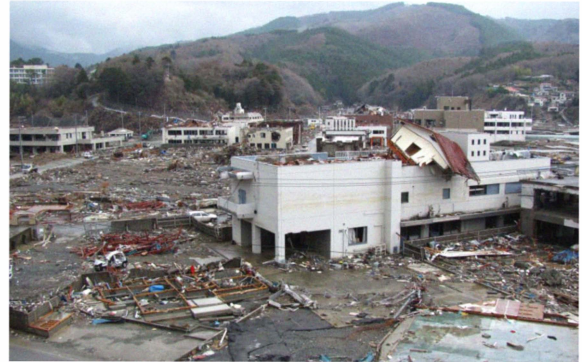
Fig. 15. Onagawa CO with a house on its roof.

issues on March 28<sup>th</sup>, 26 of them had been destroyed by the tsunami or all of their equipment had been rendered useless by the tsunami. In some of these sites, including Onagawa (Fig. 15), Rikuzentakata (Fig. 16), and Shizugawa, the COs are one of the few remaining standing buildings in the town, which suggest an adequate CO building performance considering the tremendous magnitude of the tsunami—notice that the CO building in Onagawa has the remains of a home on its roof. Such adequate performance will certainly contribute to reduce the MDT. Service restoration in the areas served by some of these COs, such as Onagawa, were similar to those implemented after Hurricane Katrina, i.e., use DLC systems to provide circuits to government facilities and emergency response sites. In other sites, such as in Rikuzentakata, service was partially restored by hosting most of its switching services in a neighboring undamaged CO.

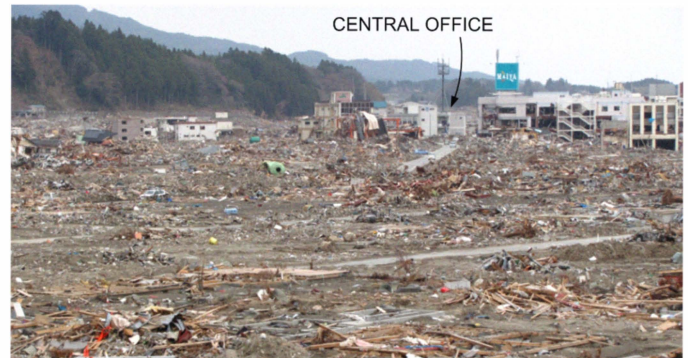
Fig. 16. Rikuzentakata.

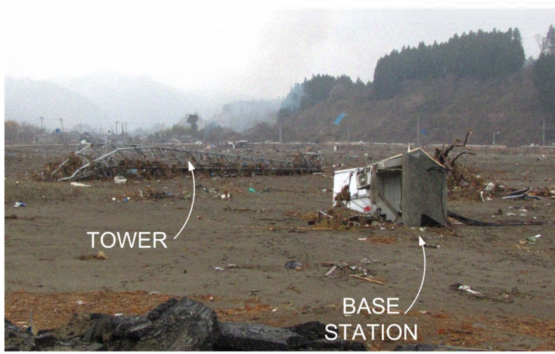
Fig. 17. A destroyed cell site near Rikuzentata.

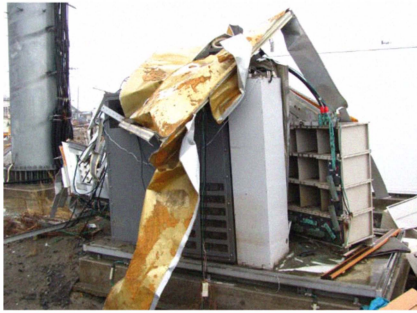
Fig. 18. A destroyed cell site in Ishinomaki.

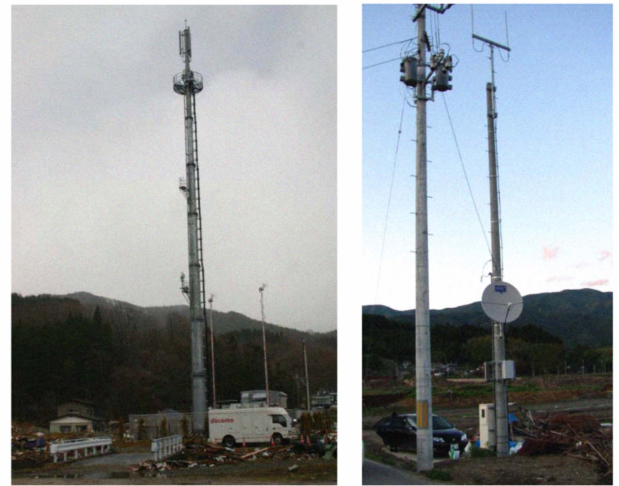
Fig. 20. a) Left: A COW in the town of Osawa. b) Right: A micro-cell used to restore service to the cell site in Fig. 17.

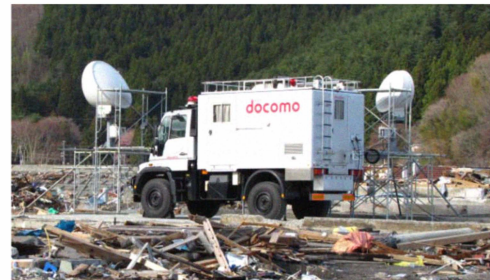
Fig. 21. An Emergency microwave transmission site in Otsuchi.

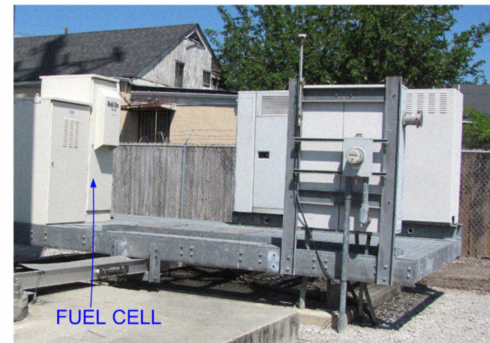
Fig. 22. A back up fuel cell for a base station in New Orleans.

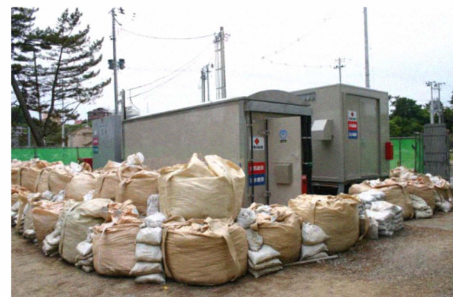
Fig. 23. Shelters with switching equipment used to restore service to Shichigahama CO. Its original building was displaced 500 m by the tsunami.
