Impact of floods 2010 in coastal area of Pakistan – a case study of Kharo Chann, Thatta District

Kaif Gill¹, Naeem Shahzad¹, Irfan Ashraf¹, Urooj Saeed¹, Farooq Laghari²

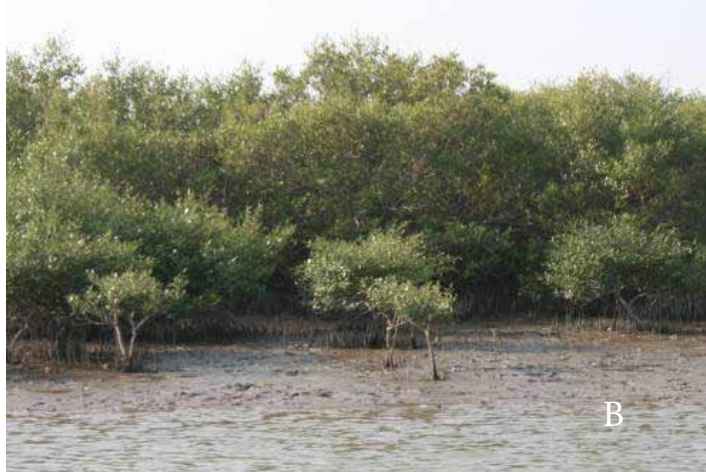
Figure 2: (a) Field photographs of Mixed *Mesquite* spp. and *Tamarix* spp. (b) Mangroves

In order to collect Global Positioning System (GPS) coordinates of the land cover classes and its correlation with the spectral values of the satellite images, different hotspots and confusion areas were identified on satellite image and verified on the ground. Garmin 76CSX GPS receiver was used to collect 81 GPS points. Land vehicle and boat were used to navigate in the study area. During the ground truthing, it was observed that inland area, along the Indus river, consists of *Tamarix* and *Mesquite* spp. along with *Saccharum* and *Typha* spp., whereas, mudflat areas consist of dense patches of mangroves mostly *Avicenna marina* (Fig. 2a & 2b).

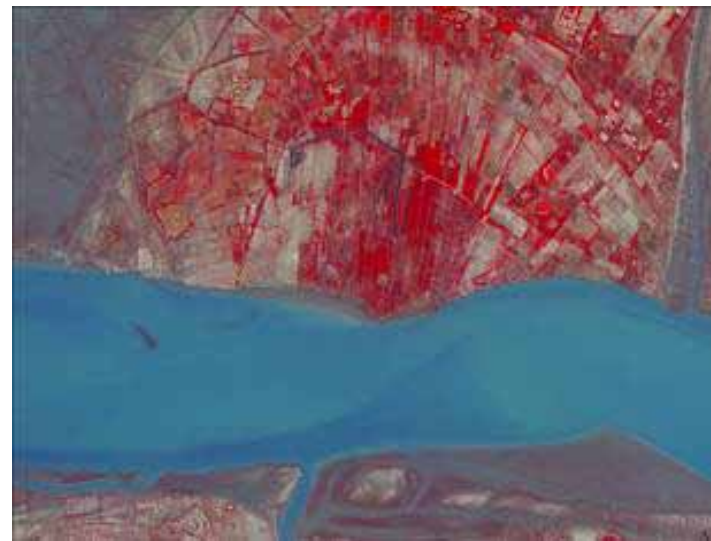
Figure 7: Pre and post flood image – *Mesquite* in low lying areas

The flood intensity was reduced when it reached the study area, not much negative impact was observed (Fig. 6). However, the land cover changes observed during the temporal change analysis are mentioned in Fig. 5 and Table 2. The analysis of the thematic maps reveals an overall increase in the extent of the density classes of '*Mesquite/Tamarix* spp./Reeds' (Table 2). The increase appears to be due to the positive impact of flood on this class especially on *Tamarix* spp. *Mesquite* spp., which is an exotic and perennial weed was present in the river bed and adjoining areas along with *Tamarix* spp. In low depression areas, where the flood water remained stagnant, *Mesquite* has been damaged.

These vegetative blocks have been taken away by flood waters in some of the areas. The dense patch of *Mesquite* spp. near Saleh Dandal village that appears as a maroonish red tone in the pre-flood satellite image has been dried and appears as blackish red tone in the post flood image. Although *Mesquite* spp. has been damaged in some low lying areas, but the overall contribution of the damaged class is minute compared to the healthier impact of floods on riparian vegetation.

2010, an increase in land cover classes of bushes and grasses has been observed. This is mainly due to the seasonal variation/post monsoon impacts. It was analysed by comparing pre (26th March, 2010) and post (28th September, 2010) flood satellite images and the land cover maps that recent floods have resulted in land erosion in some of the areas of Kharo Chann. The land cutting due to water pressure was high near Atharki, Saleh Dandal, Jamnagar and Chor Goju villages. Approximately, an area of 38 ha has been lost around these villages during the flood period. The areas near Atharki and Saleh Dandal villages have been facing land erosion since year 2000 but the floods of 2010 washed away some of the agricultural fields and houses as shown in Fig. 7.
