Energy Infrastructure Damage Analysis for Hurricane Rita

Dorothy A. Reed, M.ASCE¹; Mark D. Powell²; and Julie M. Westerman³

Abstract: In 2005, Hurricane Rita caused significant damage to the energy infrastructure in the Gulf of Mexico region. In the context of this investigation, the “energy infrastructure” refers to the offshore oil platforms, refineries, and gasoline supply stations in the region, often referred to as the “petroleum infrastructure,” the natural gas supply lines, and the delivery of electric power. In this paper, we examine the structural damage to the networks as defined by restoration, resilience, and fragility with a focus on the analysis of the electric power delivery disruptions. Our concern is not on the evaluation of risk, but rather to provide those who assess hurricane risk with relevant structural damage prediction models. We provide correlations of hurricane wind speed data with outages. We conclude that high winds alone can create significant damage to the energy infrastructure system.

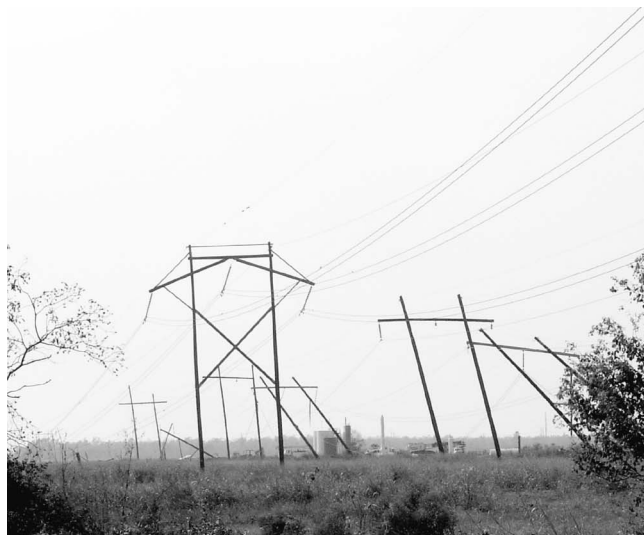
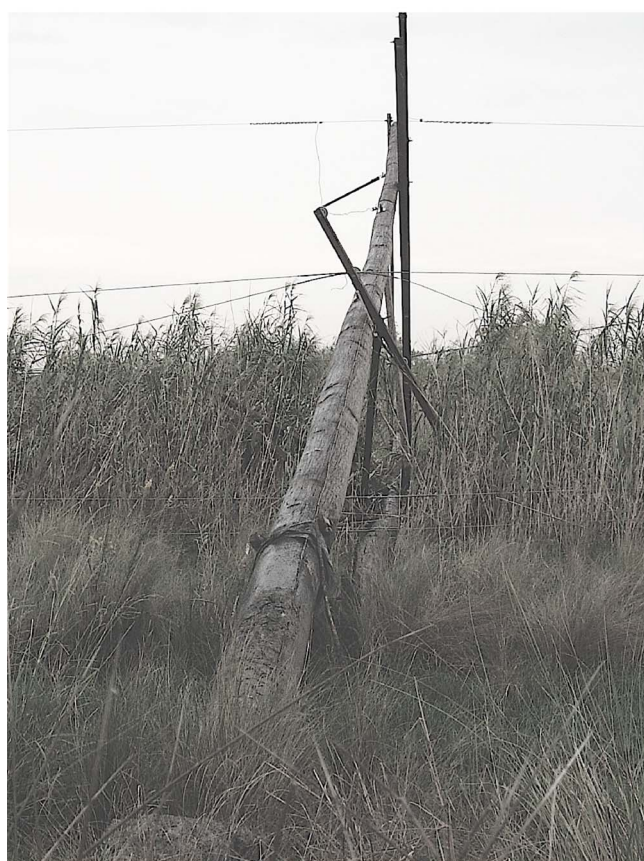
Fig. 4. (a) Row of tower failures along the line; (b) wooden tower failure at the base

Wooden towers did not fare any better than the steel structures. Fig. 4(a) shows a group of towers in an open region near a major highway in which damage occurs along the line rather than normal to the line. The base failure of a wooden transmission tower off of Highway 73 near State Route 124 in Texas is shown in Fig. 4(b). Its location is (approximate) 29°32′N and 94°24′W.

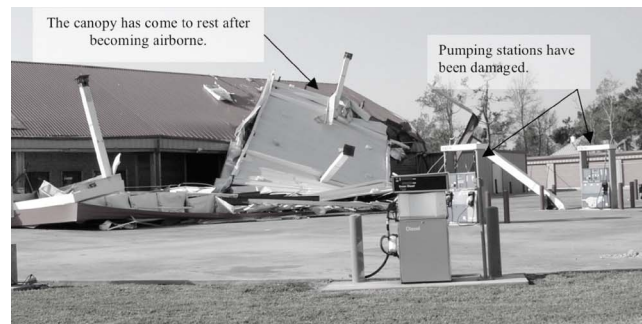
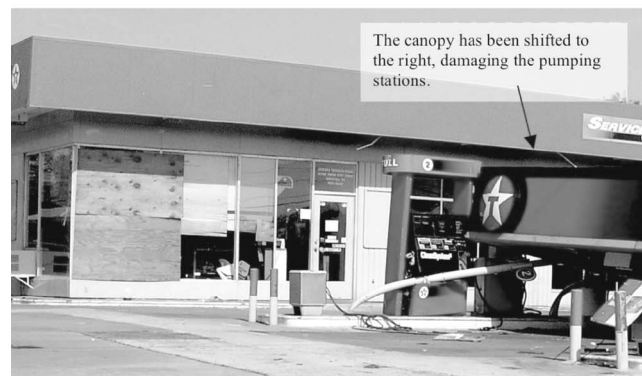
Fig. 5. (a) Damage to a gasoline station. Ripped from the base of its column attachments, the canopy has been destroyed and the pumping stations have suffered significant damage. (b) Damage to a canopy and pumping station. (c) An airborne canopy traveled across the street before landing.

Surface damage also occurred to gasoline supply stations. These types of failures are widespread and disrupt the supply chain. Figs. 5(a–c) illustrate the type of common failures that occurred throughout sections of Louisiana and Texas affected by the hurricane. In Fig. 5(a), a canopy has become airborne and then come to rest on a convenience store. The pumping stations also suffered significant damage as the sidings have been ripped off possibly due to high winds. In Fig. 5(b), a canopy has been damaged although its attachment at the base is secure. The pumping stations have consequently been damaged in the process. Finally in Fig. 5(c), a canopy that broke at the support base evidently became airborne and came to rest across the street from the station. Their widespread failure creates disruptions in the supply of gasoline. It is also noted that the pumping stations require a power supply to operate.
