2011 to 2012 Queensland floods and cyclone events: Lessons learnt for bridge transport infrastructure*

RW Pritchard[†]

Queensland Department of Transport & Main Roads, Brisbane, Queensland

REFERENCE: Pritchard, R. W. 2013, "2011 to 2012 Queensland floods and cyclone events: Lessons learnt for bridge transport infrastructure", *Australian Journal of Structural Engineering*, Vol. 14, No. 2, pp. 167-176, <http://dx.doi.org/10.7158/S13-009.2013.14.2>.

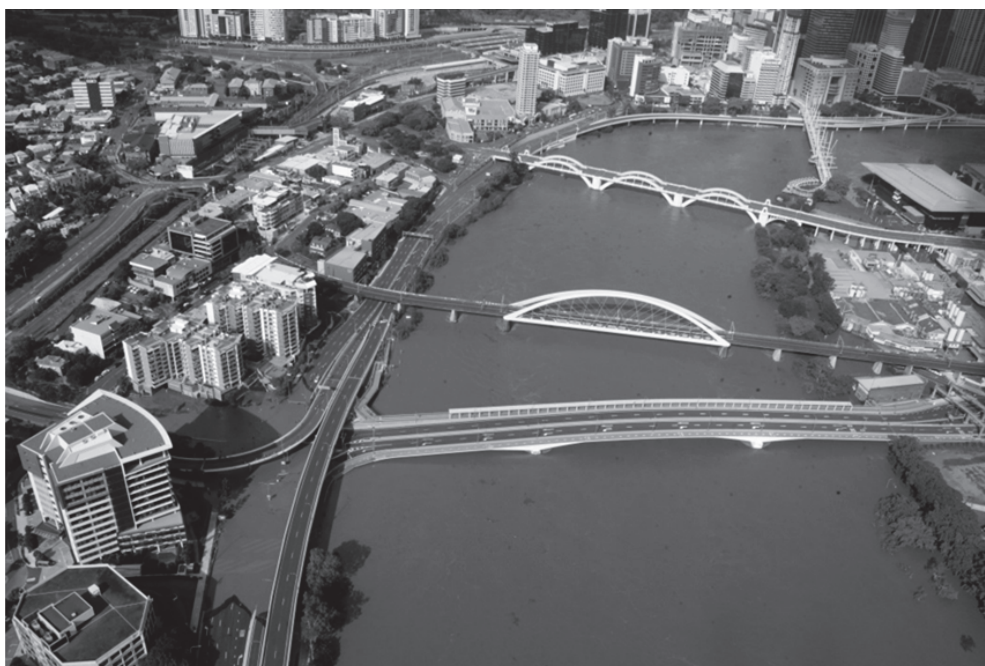
Prior to 2011, Brisbane last experienced major flooding in 1974. The extent of the 2011 flooding in Brisbane CBD is shown in figure 1. The South Brisbane end of the Go Between Bridge and William Jolly Bridge were flooded and overtopping of the Riverside Expressway (shown in figure 1) resulted in major transport connectivity issues in the CBD and negatively impacted on the emergency flood response.

Figure 1: Brisbane River in flood in Milton Reach of Brisbane River.

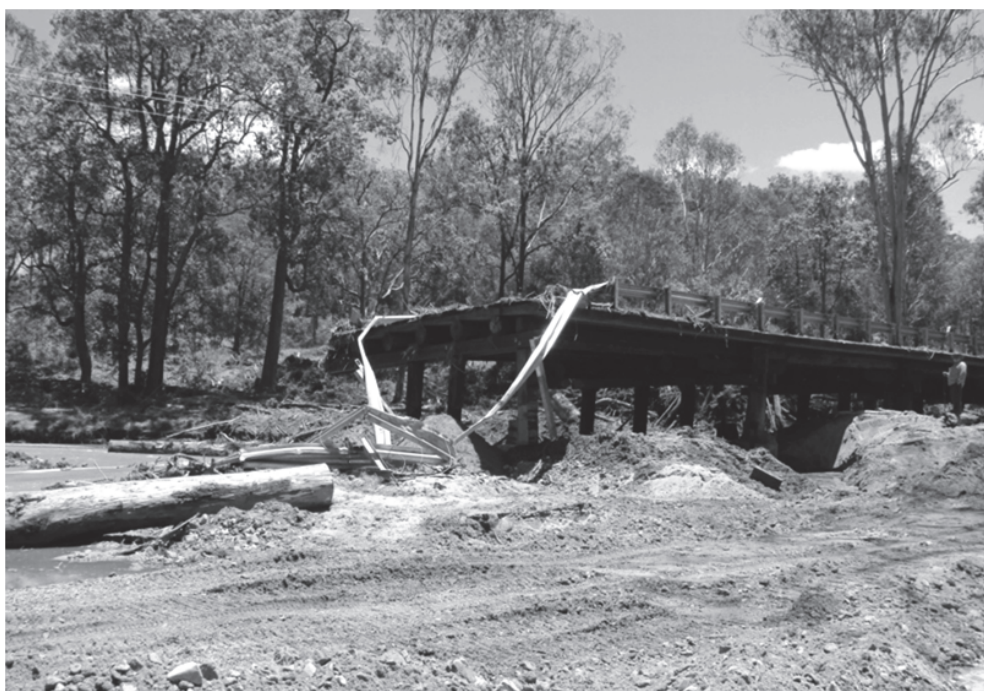
Two timber bridges required replacement due to flood damage. The severe damage to one timber bridge is shown in figure 2. The types of damage to these two timber bridges included:

- the bridge being lifted and moved sideways by the flood water
- adjacent segments of spliced piles were no longer connected together
- broken timber piles
- the loss of road approach.

Figure 2: Timber bridge damaged by floodwaters.

These damages demonstrated the intensity of the flood event.

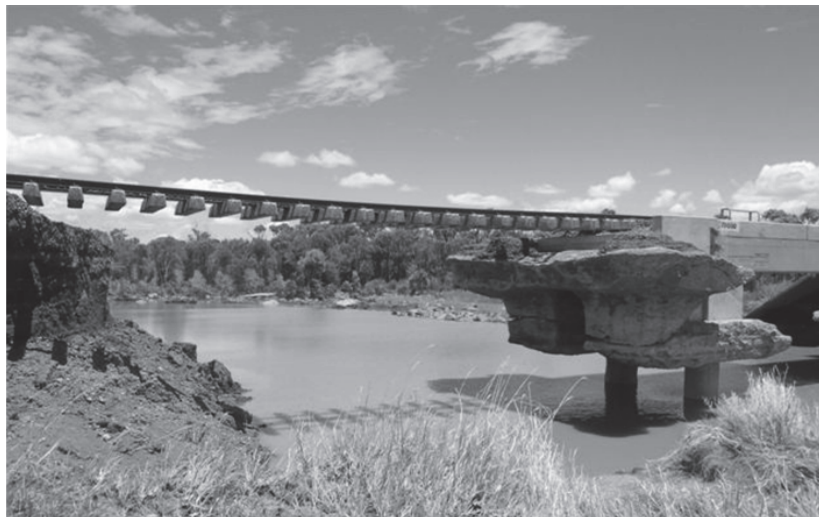
The scouring of approaches to bridges and removal of spill-through abutment at bridges was wide spread across all bridges throughout Queensland (figures 3 and 4). Notable observations on the flood damage include:

- traditional abutment protection is currently not suitable for high velocity situations
- abutment scour and loss of road approach caused major connectivity issues and impacted on emergency response in some areas
- relieving slabs at bridge abutments were rendered unfunctional and had to be replaced.

Figure 3: Scour of bridge approach and spill-through abutment.

It is essential in future to install a more resilient abutment protection system in high velocity

situations. Scour depth needs to be better understood by designers. Many papers have been written on this subject but little guidance is provided for bridge designers, especially in design criteria. AS 5100 provides no guidance on the topic.

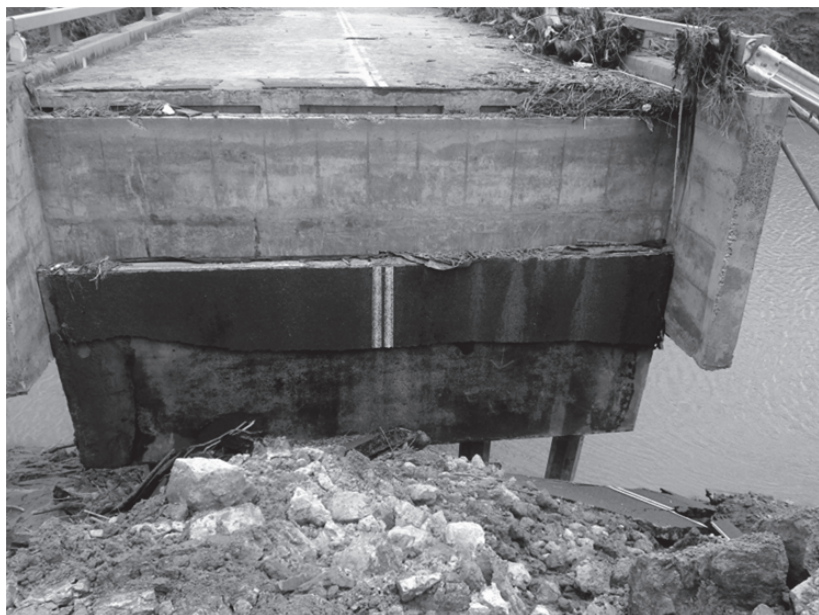
Figure 4: Scoured road approach at bridge abutment.

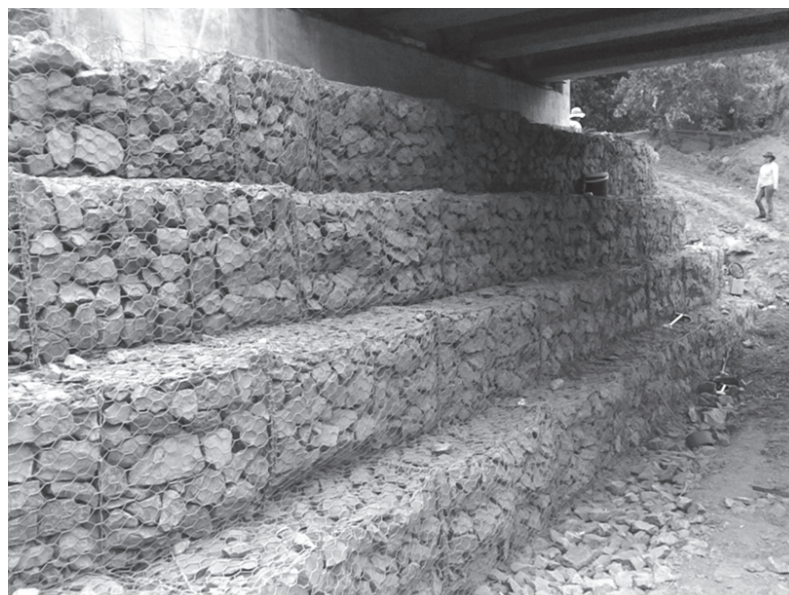
Stone pitched spill-through abutments are not serviceable for high velocity flow (greater than 4 m/s). If a road approach embankment is overtopped, scour will occur on the downstream face unless this face is protected against scour.

Figure 5: Heavy-duty gabion spill-through abutment protection.

Heavy-duty gabions (refer to figure 5) provide a means of achieving a high performance abutment scour protection.

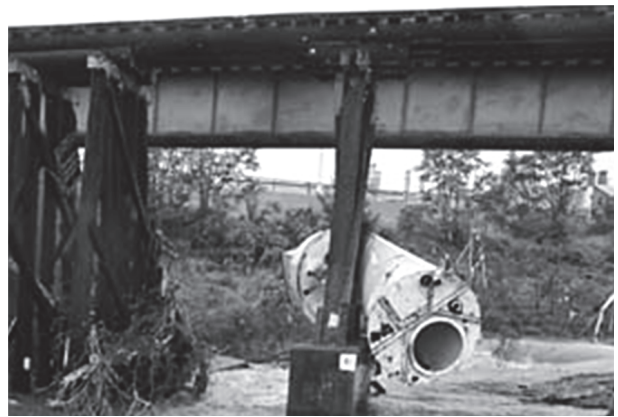
- pressure vessels and grain silos (figure 8)
- cars and four wheel drive vehicles as both a flood impact load and buoyancy load (figure 7)
- two axle delivery trucks as both a flood impact load and buoyancy load in trapped under the bridge superstructure
- traditional debris mats
- pleasure crafts in the Hinchinbrook Channel.

Figure 8: Urban debris; pressure vessel/grain silo against a bridge pier.

It is concluded the Brisbane 2011 flood event was an urban flood event that differed significantly from the design assumptions of the current AS 5100:2004 Bridge Design Code. The current flood loads in AS 5100:2004 Bridge Design Code loads are too small compared to some urban debris loads that occurred during the reported flood events. It is suggested the code should be updated to reflect these design loads.

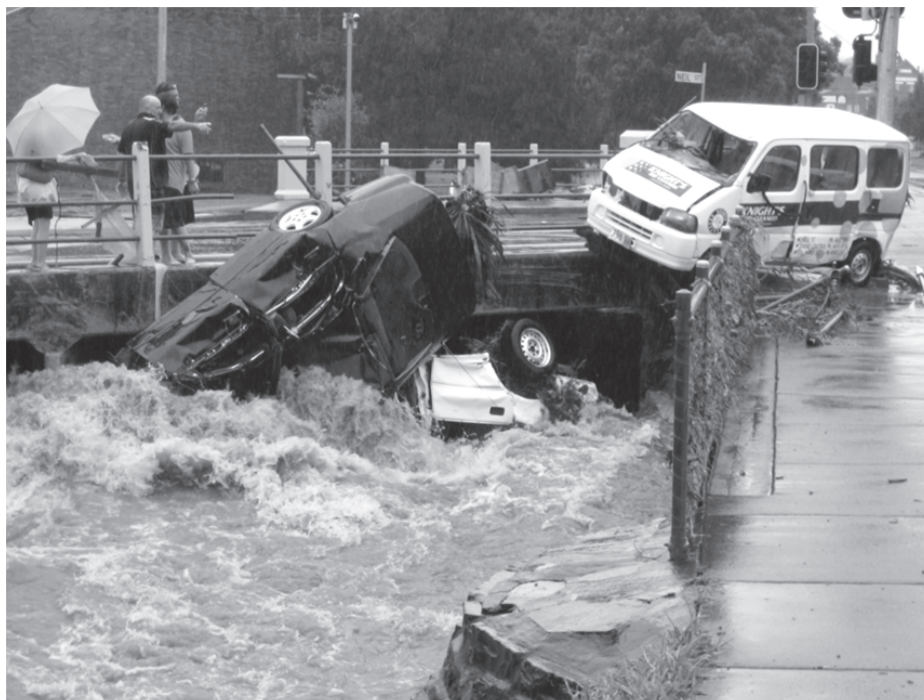
The graphic news photos of Toowoomba highlighted these issues. The hydraulic jumps created in streams were in part caused by the damming of waterways. This was due to small bridge spans being blocked by cars and delivery vehicles (figure 7) that had been washed into the river from surrounding urban areas. The afflux caused by stream blockages may also result in an inundation of water to adjacent houses and/or businesses. Detailed investigation needs to be undertaken to provide justification for each design and further guidance needs to be provided by bridge design codes. It is understood that future editions of *Australian Rainfall and Runoff* will provide guidance on how to address blockages including those with potential catastrophic consequences.

- pontoons carrying the *Drift Restaurant*.
- shipping containers both as an impact load and a buoyancy load if trapped under a bridge superstructure.
- cars and four wheel drive vehicles as both a flood impact load and buoyancy load if trapped under bridge superstructure (figure 7).

Figure 7: Urban debris (Toowoomba); cars and four-wheel drives.
