BITNG LAB UPDATE

Carl Demolder

Date 6/07/2021

Strain sensor

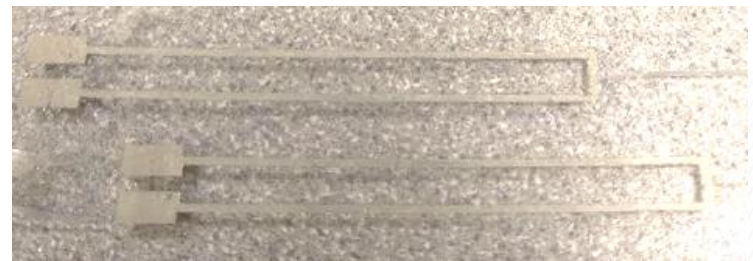
Strain Sensor

- Straight line AgNW

- Works effectively
- Manufacturing yield is about 50%
- Width = 0.5 mm
