### Evaluation of barrier lake breach floodS: insights from recent case studies in China

By Zuyu Cheny, Qiang Zhang, Shujing Chen, Lin Wang, Xingbo Zhou, 2019, WIERs

Welcome to DB-IWHR. This set of data supports the paper:

Article: Evaluation of barrier lake breach floods: insights from recent case studies in China

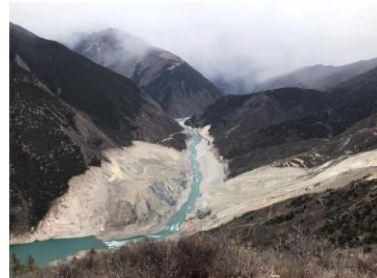
Breach of the Baige barrier lake on November 12, 2018 on Jusha River, China. Photo by Shuangfeng Jia.
