## RESIDENTIAL INSPECTION REPORT

1234 Main Street  
Port Elgin, ON N0H 2C0

Buyer Name  
05/18/2024 9:00AM

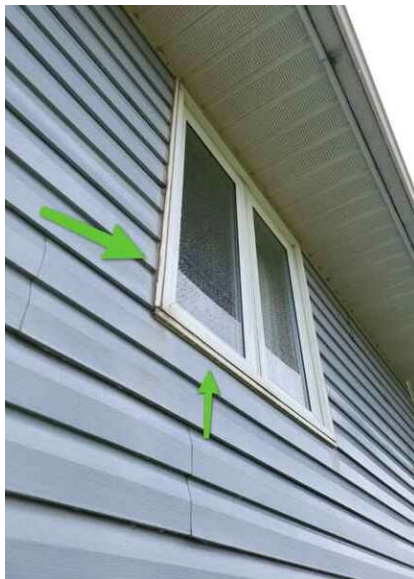
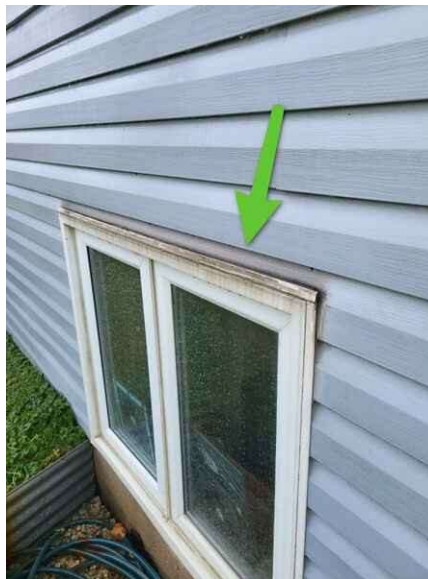
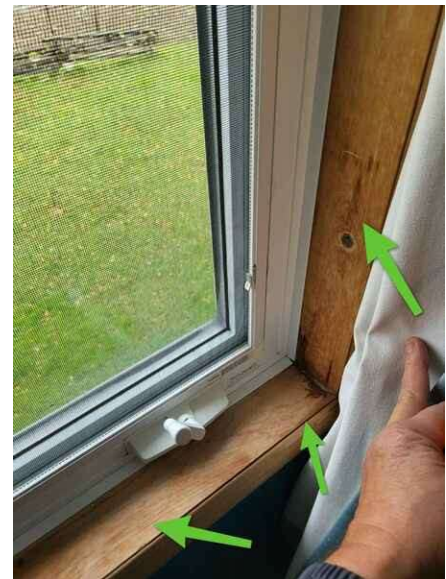
### Siding, Flashing & Trim: Additional Caulking

Additional caulking was applied to west windows suggesting past issues with water or wind on this side of the house. A look at interior window sill suggests there may have been a past issue with water intrusion on this side of the house. Moisture detection did not pick up significant moisture readings.

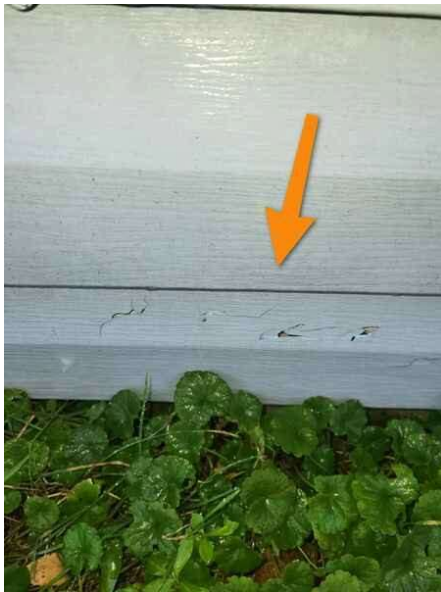
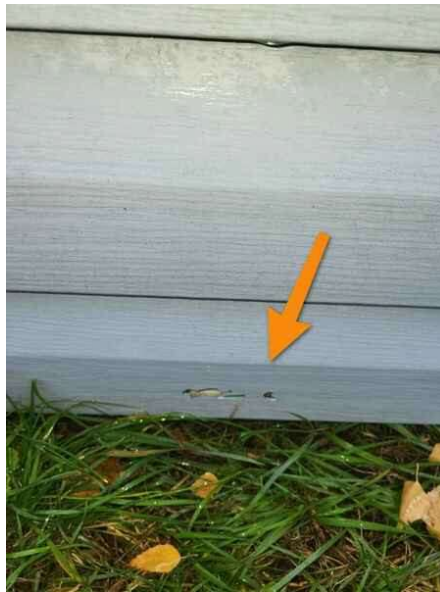
Some minor damage to siding was observed on west side and east side of building. I recommend repair.

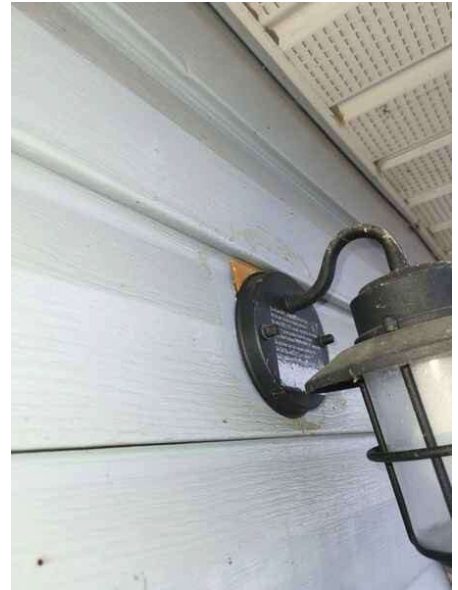
Outdoor light observed with wood behind light to aid in vertical level. This opens an area for water intrusion. Recommend a qualified professional to further evaluate in order to provide opportunity to appropriately caulk this outdoor fixture.

Outdoor fixture with temporary level.

Contact a qualified professional.

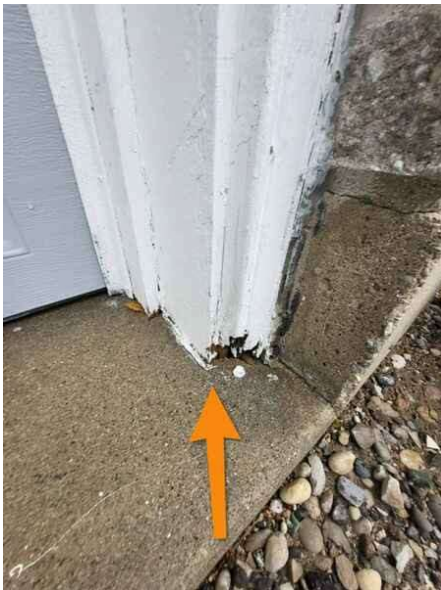
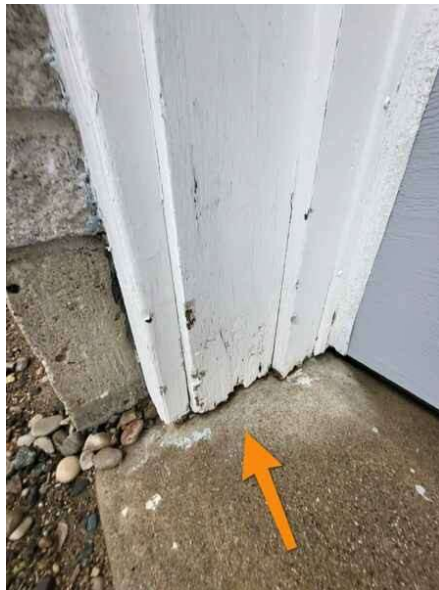
### 2.3.1 Exterior Doors

The garage door trim was inspected and signs of rotted wood was observed on both sides at the bottom of the door. Wood that touches concrete or soil rots much quicker than wood that is protected by a barrier. Recommend further evaluation and repair by a carpentry contractor.

Contact a qualified carpenter.

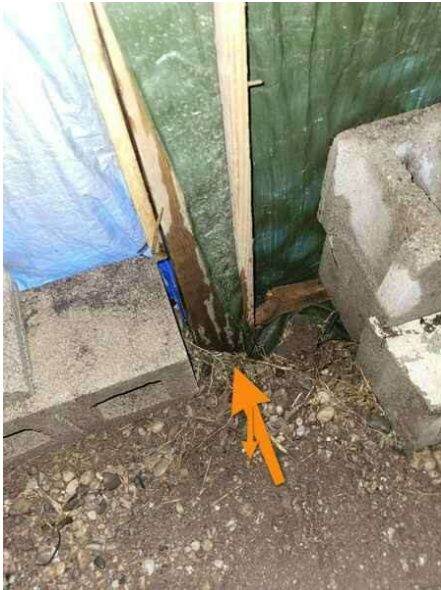
Deck was observed to have general poor construction practice used. Observed improper Ledger Board fastening that could weaken stability of the deck structure. Also, it was observed that improper beam and beam supports were used resulting in the weight of the deck structure being placed on carriage bolts which is a safety hazard. Deck weight needs to rest on top of the column support post. It was also observed that deck column posts were in contact with soil which promotes premature rotting. Wood distance from soil should be maintain at least 6 inches. Also, incorrect size of joists hangers used for size of joists used. Recommend qualified deck contractor evaluate.

Column in contact with soil.

Contact a qualified deck contractor.

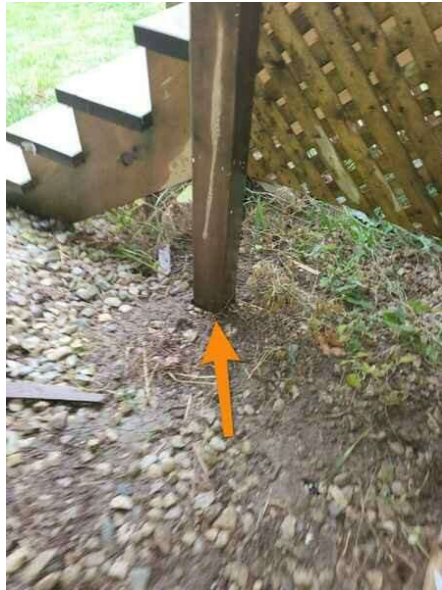
Bottom column areas are where wood rot may occur more quickly if in contact with concrete or soil. There should be at least 6 inches between wood and soil to help alleviate wood rot due to soil contact.

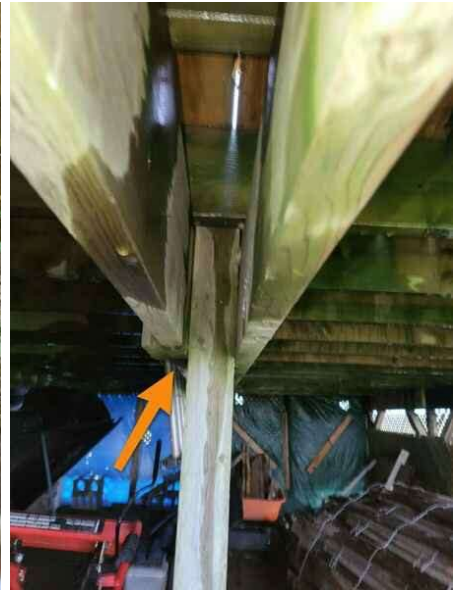
Deck beam and column assembly incorrectly constructed.

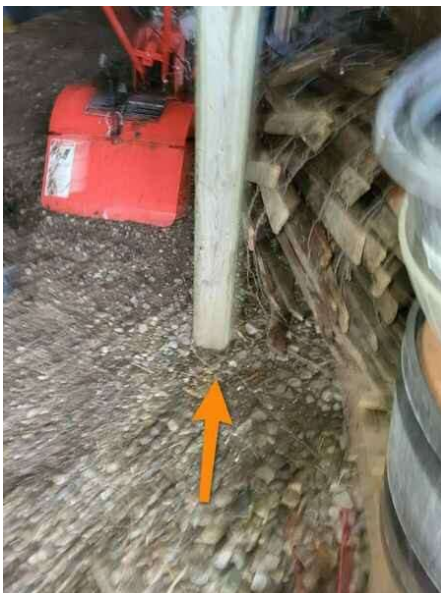
Column in contact with soil.

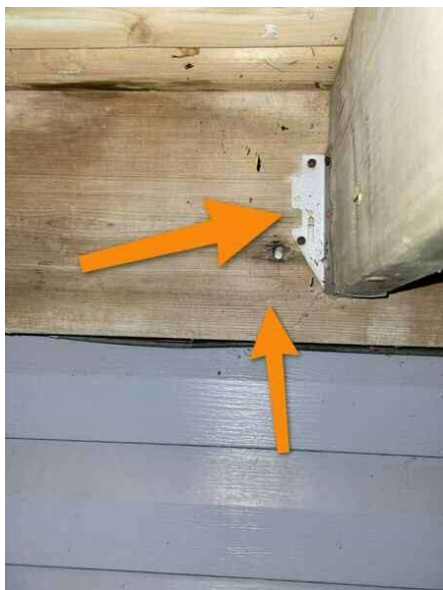
Joist hangers not correct size for size of joists used. One bolt is observed in ledger board

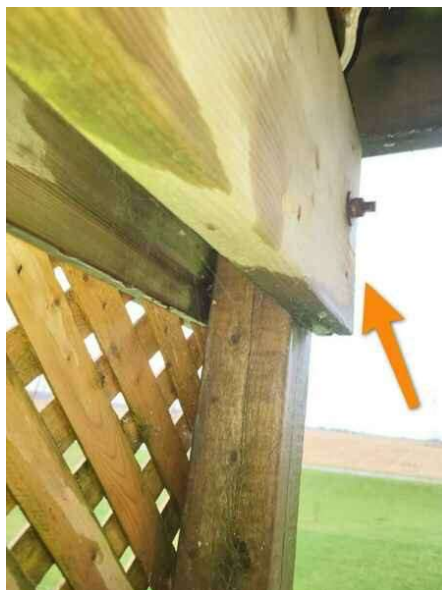
Weight of deck being placed on bolts. This is a safety hazard.

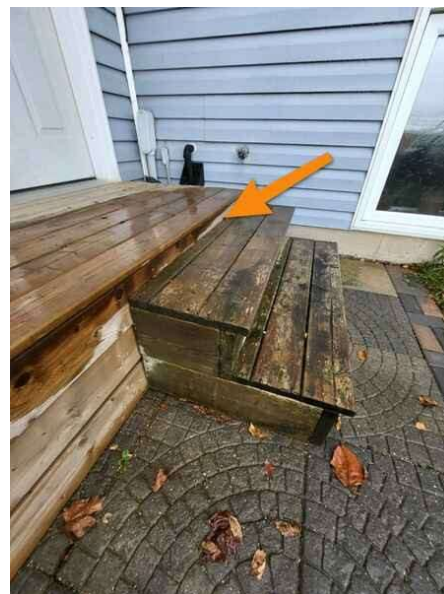
## 2.4.2 Decks, Balconies, Porches & Steps

It was observed that the back step has a short step of only a few inches when stepping down to enter the backyard. Step riser height should be maintained between 4 7/8 inches to approximately 8 1/4 inches with a maximum variation between each step of 3/8 of an inch. This is a tripping hazard. Recommend repairing to ensure safety.

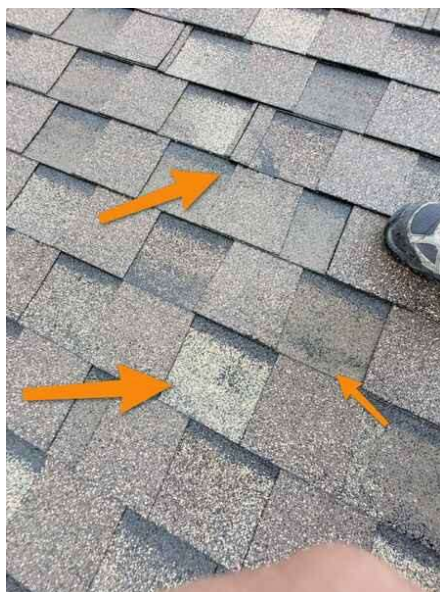
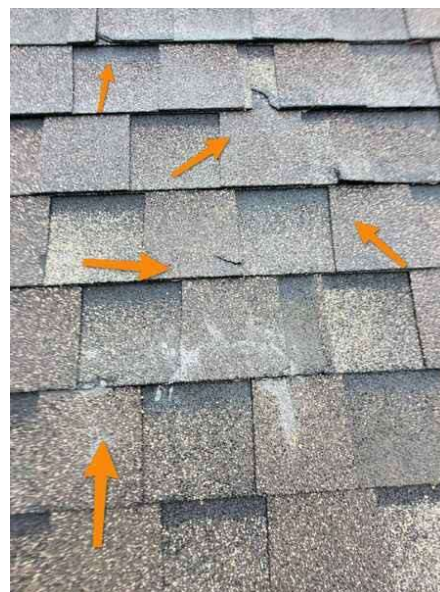
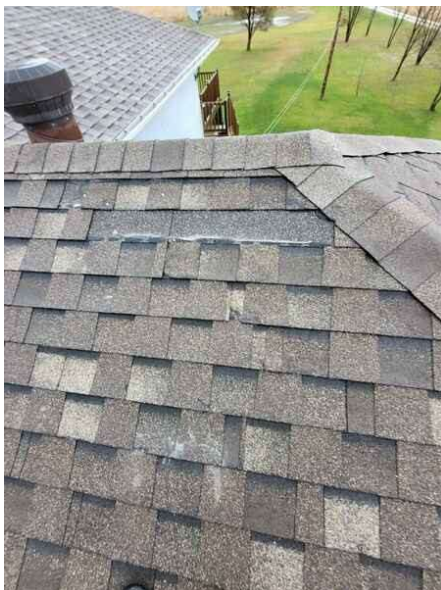
### MINOR SHINGLE DAMAGE

Some minor damage and granular wear were observed to shingles in a few areas. West side of roof showed wind damage and granular wear. Also, some damage was observed to shingles above main entrance way to home. Recommend shingle repair.

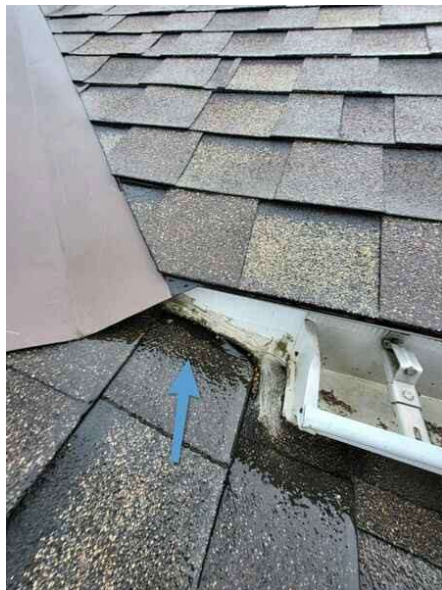
### 3.1.2 Coverings

Some areas such as flashings and nail heads that previously had roof caulking applied is now becoming separated. Recommend recaulking these areas.

Contact a qualified handyman.

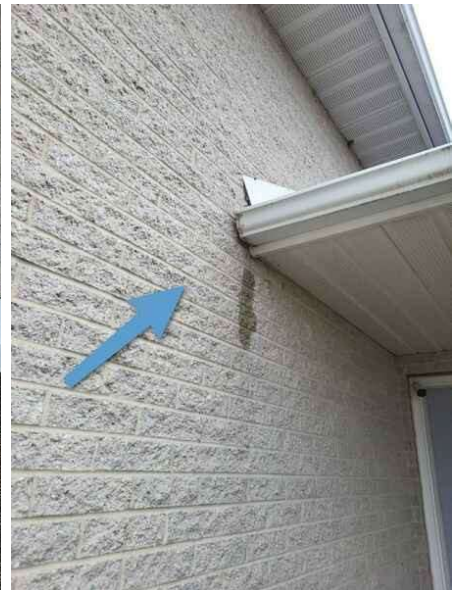
Over Front Entrance

A couple areas were observed where kickout flashing would be beneficial. Kick out flashing helps divert water away from the side of the house ensuring it is all captured in the gutter. Recommend considering kickout flashing.

Here you can see water leaking down side of brick. Kickout flashing would help direct all water from roof flashing into the eaves-trough.

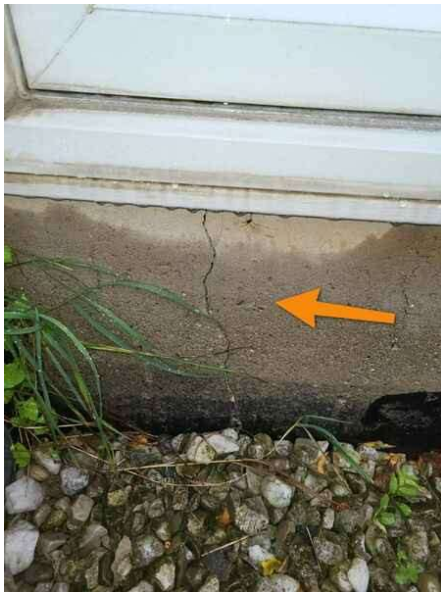
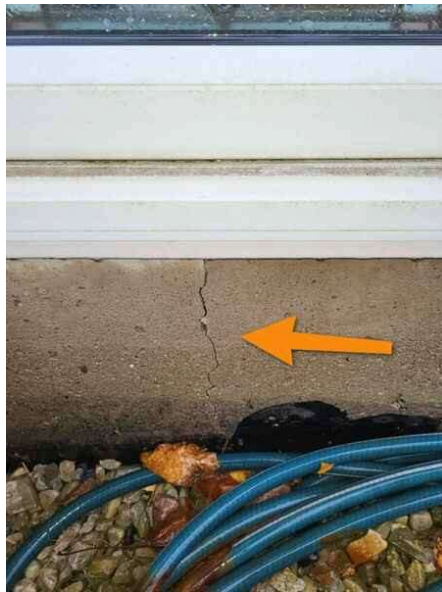
### 4.1.1 Foundation

Minor cracking was noted at the foundation west wall window wells. This is common as concrete ages and shrinkage surface cracks are normal. Recommend monitoring for more serious shifting/displacement or leaking.

Recommend monitoring.

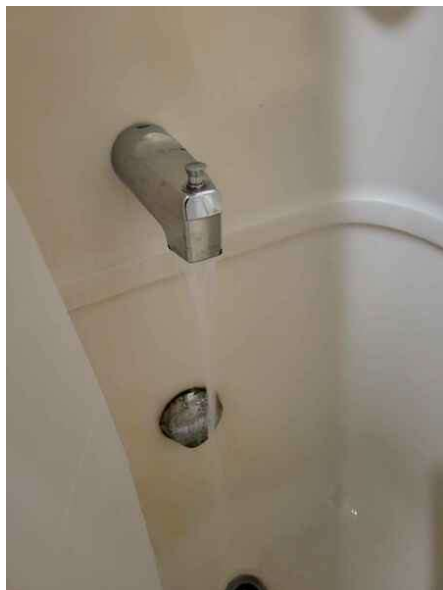
### 7.3.2 Water Supply, Distribution Systems & Fixtures

Water supply pressure was weak in upstairs main bathroom when multiple uses were applied. Recommend further evaluation by a plumbing contractor.

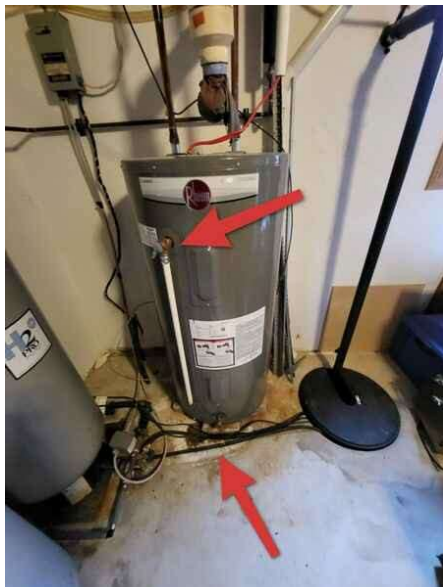
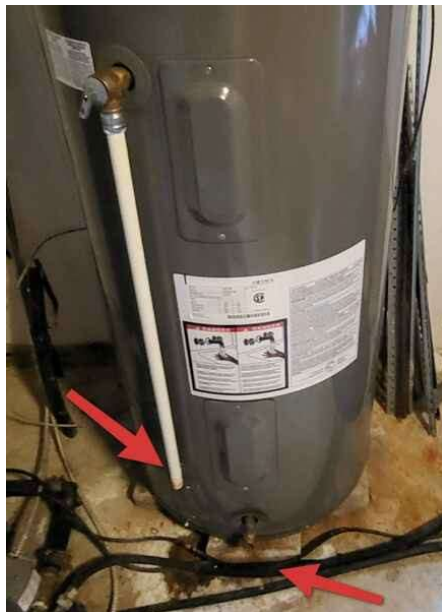
#### 7.4.1 Hot Water Systems, Controls, Flues & Vents

Water stains/rust were observed beneath water heater, particularly the Temperature Pressure Relief Valve. Water was observed on the inside pipe and stains below the pipe. indicating a recent leak in the valve. TPRV is a safety feature to ensure access temperature and pressure is relieved from the tank safely. This is a safety hazard. Recommend further evaluation and repair by a qualified plumber.

Contact a qualified plumbing contractor.

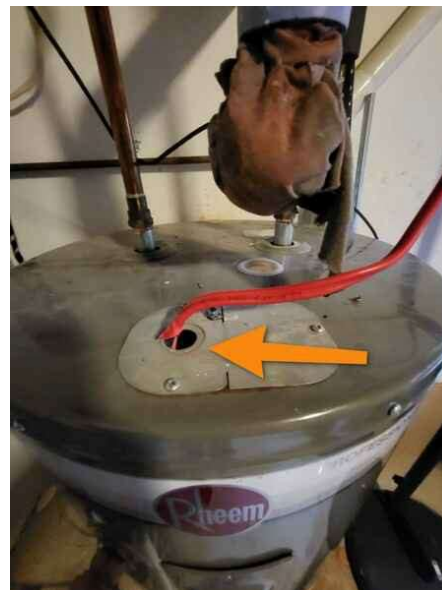
## 7.4.2 Hot Water Systems, Controls, Flues &amp; Vents

The electrical connection to the hot water tank did not have a saddle connector for the 12/2 wire feed to the tank. This is a safety hazard. Recommend correction by an electrical contractor or qualified professional.

Contact a qualified electrical contractor.

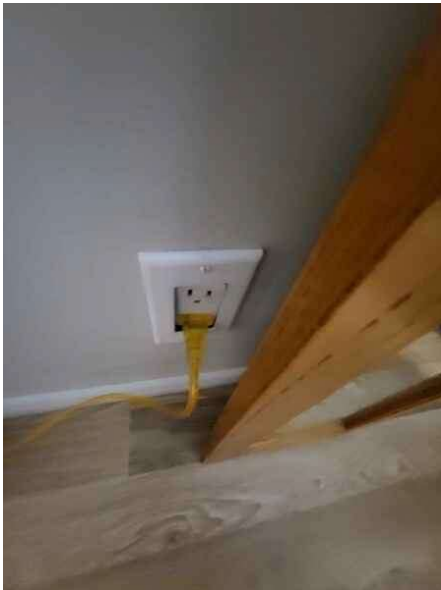
One receptacle was observed to not be seated correctly in the downstairs bedroom area. A receptacle underneath the upstairs kitchen was not have a cover plate or box to protect against moisture in this area. A receptacle in the downstairs bedroom nearest the driveway was very difficult accept and retrieve a plug from. The dryer receptacle is located above the ceiling tile directly beside the dryer vent hose above the lint trap. Recommend Electrical Contractor to further evaluate.

Bedroom receptacle.

Contact a qualified electrical contractor.

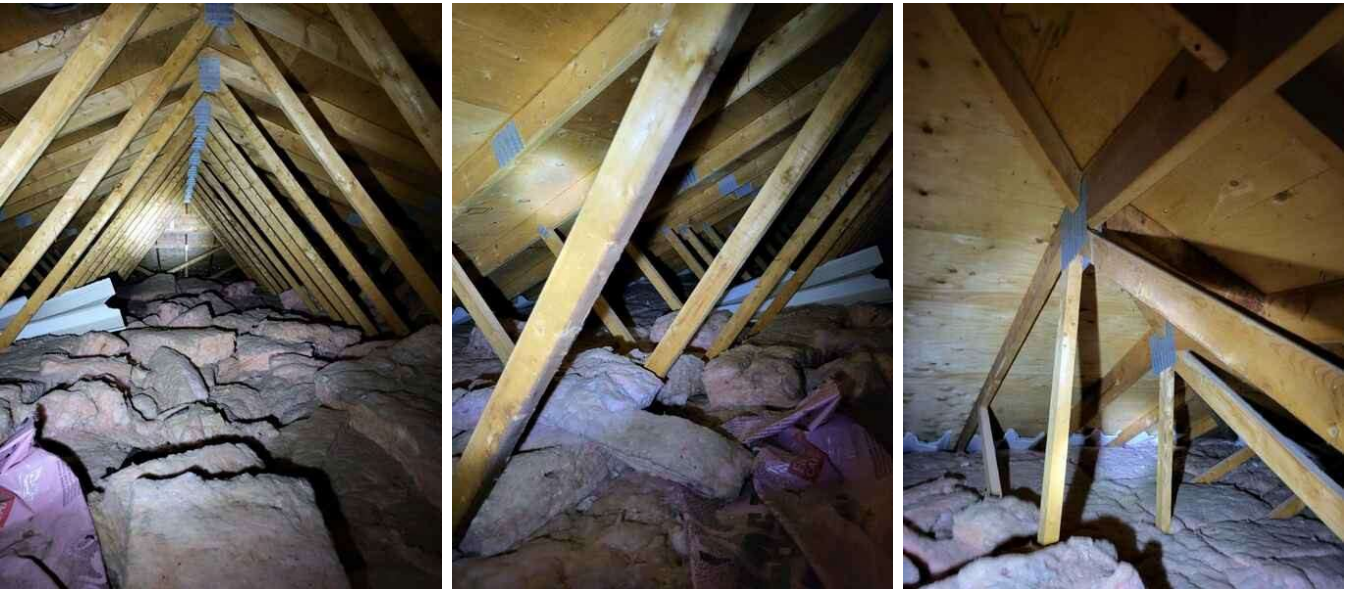
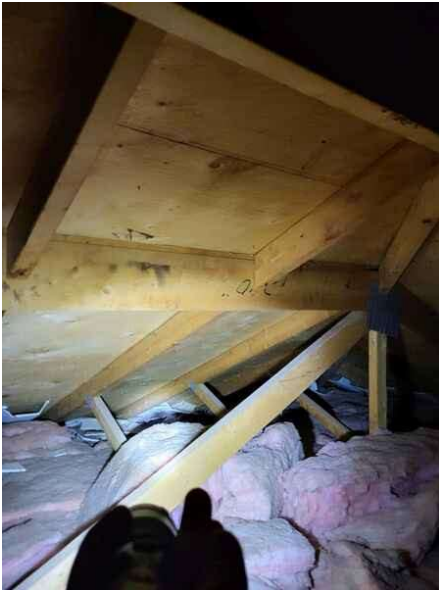
Some batt insulation in the attic was observed to be misplaced or improperly installed. Some of the batts of insulation were observed to be piled randomly in the middle of the attic with lesser amounts toward outer wall. Recommend insulation contractor to evaluate.

Recommendation  
Contact a qualified insulation contractor.

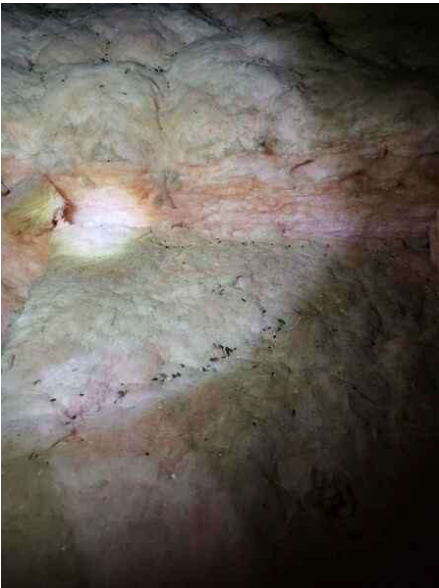
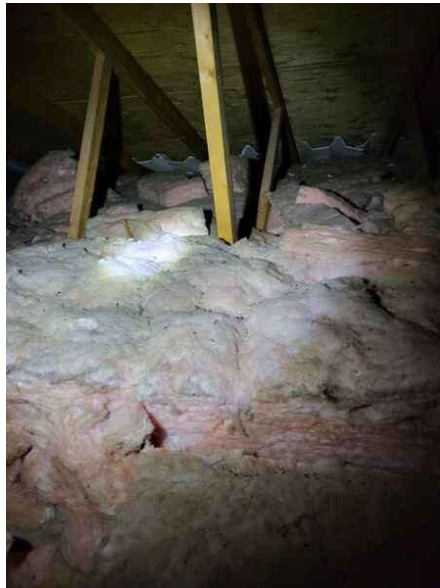
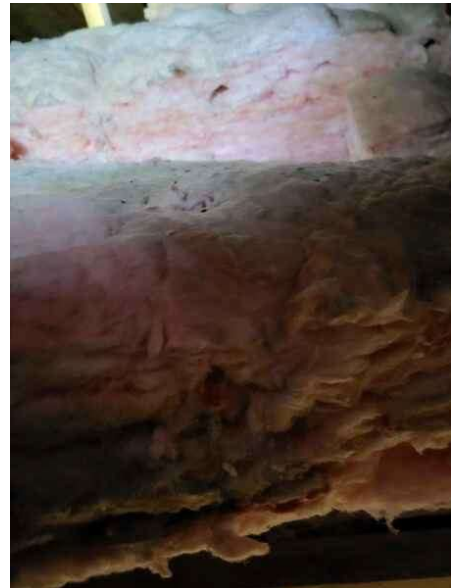
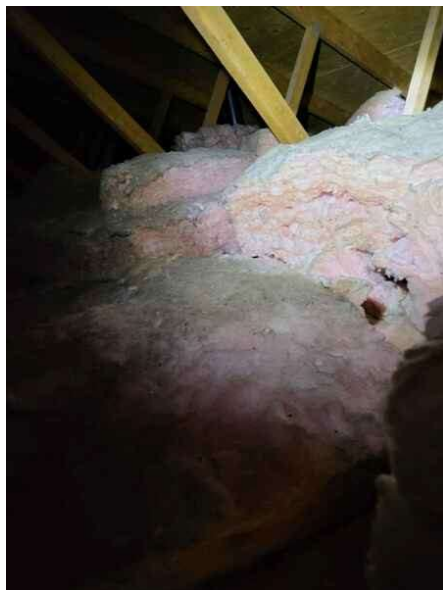
#### 10.1.2 Attic Insulation

Mice droppings were observed on top of the insulation near the attic hatch. Recommend pest control evaluation.

Contact a qualified pest control specialist.

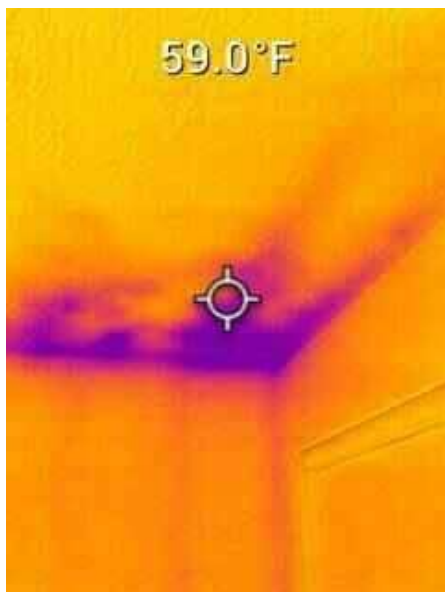
West Ceiling

Thermal scans of interior showed signs of thermal variation in some areas of up to 5 degrees F in a variety of ceiling areas along the west side of the building. When checked with moisture meter, only minor signs of moisture variation were observed. Strong wind was coming from the west at time of inspection suggesting some moist air intrusion could be taking place along that side of the building. Recommend further evaluation by an insulation contractor.

Contact a qualified insulation contractor.
