Team 7: Measuregraph Inspectors

Final Report

TE 533 Spring 2024

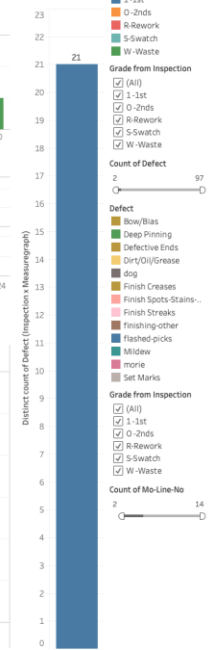
A-5: S-Swatch

Avg Days spent b/w Insp and Measuregraph

Top Repeated Defects

Line Defect Freq

No of Defects

When a user selects any one of these filters by clicking on the color in the graph, the entire dashboard will adjust to reflect only data from that particular grade. Filtered snapshots of the dashboards for Waste, 1sts, 2nds, and Swatch are attached in Appendix A. In the upper right-hand corner, line defect frequency shows the line numbers with the highest count of defects from each
