# Experimental investigation of wood decking assemblies exposed to firebrand showers

Samuel L. Manzello<sup>a,\*</sup>, Sayaka Suzuki<sup>b</sup>

<sup>a</sup> Fire Research Division, National Institute of Standards and Technology (NIST), Gaithersburg, MD, USA

<sup>b</sup> Large Fire Laboratory, National Research Institute of Fire and Disaster (NRI), Chofu, Tokyo, Japan

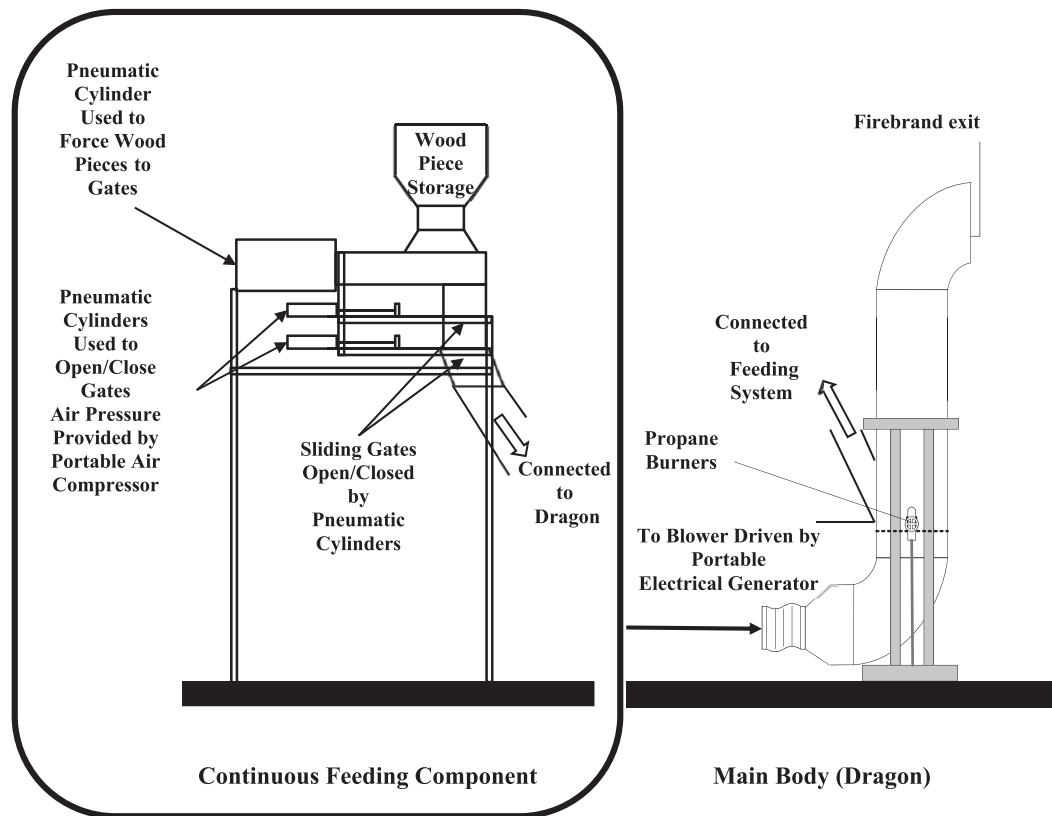
Fig. 1. Schematic of full-scale continuous feed firebrand generator. This version of the device is designed to generate firebrand showers using Douglas-fir wood pieces.

The experiments made use of a full-scale Continuous Feed Firebrand Generator [9]. This version of the device is modified from the NIST Dragon and consists of two parts, the main body (essentially the same as

prior investigations; Dragon component), and continuous feeding component (see Fig. 1). A blower, to provide airflow, was connected to the main body, with more details of the blower described below [9]. To produce firebrands required a feeding system to meter in specific amounts of wood pieces. The feeding system consisted of a pneumatic cylinder coupled to a cylindrical container where the unburned wood pieces were stored. Details of the feeding system are presented elsewhere [9]. For all experiments, Douglas-fir wood pieces machined to dimensions of 7.9 mm (H) by 7.9 mm (W) by 12.7 mm (L) were used to produce firebrands. The same-size wood pieces have been shown to be commensurate with sizes measured from full-scale burning trees, as well size distributions obtained from actual WUI fires [9].

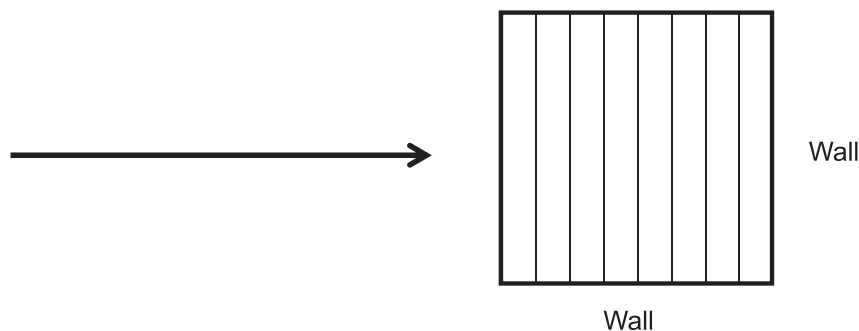
Fig. 2. Orientation of deck boards with respect to the direction of the firebrand-laden flow. Note that this drawing is for illustration purposes and is not intended to reflect the total number of deck boards used per experiment or the actual dimensions of the decking assembly itself [9].

The spacing of the decks boards was 5 mm [9,11]. The boards were installed using a wood supporting frame (boards were 38 mm thick by 140 mm height) with members spaced 406 mm on center. Fig. 2 displays the orientation of the decking boards for all experiments.

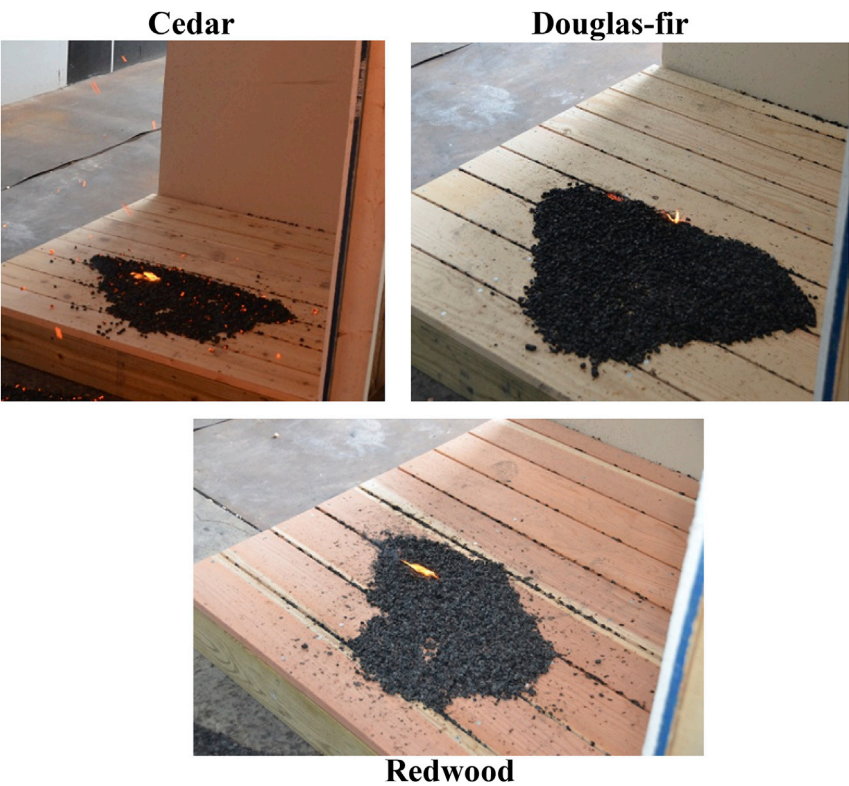
Fig. 3. Flaming ignition of Cedar, Douglas-fir, and Redwood decking assemblies at 6 m/s [9].

It was not possible to determine the time for the exact onset of smoldering ignition. This was because the board gaps were eventually covered with firebrands (Fig. 3). However, intense smoke generation, an indication of smoldering ignition, was observed. Therefore, the time to reach flaming ignition was determined for each wood type. The time was defined as the time *sustained* flaming was observed on the deck surface less the time the first firebrand landed on the deck surface. The time to reach flaming ignition was the longest, on average, for the Douglas-fir decking assemblies. Firebrand generation was continued until sustained flaming ignition was observed. Table 1 provides a summary of all results.

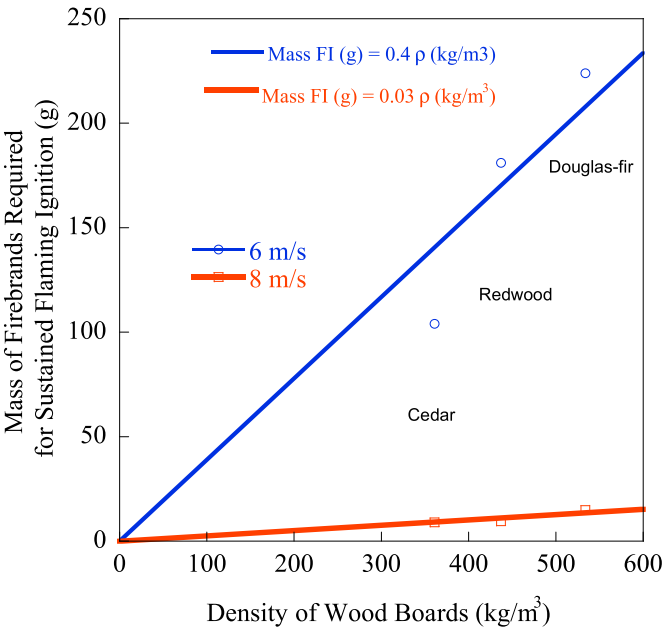
Fig. 4. Firebrand mass required for sustained flaming ignition as a function of wind speed. The 6 m/s data is taken from Ref. [9]. The average moisture content (MC) of all three wood decking types was 12% (dry basis) for data at 8 m/s; the average MC was 11% for all three wood types at 6 m/s [9]. Correlations are proposed for mass required for sustained flaming ignition of deck boards.

As discussed earlier, the total number/mass flux of firebrands generated from the full-scale Continuous Feed Firebrand Generator was determined. However, all the generated firebrands that depart the exit duct of the main component (Dragon) did not land on the surface of the deck. The total number of firebrands arriving on the surface of the deck was determined from image analysis of video records to estimate the number and thus mass required for ignition. The results of these analyses are shown in Fig. 4.

calculated as well for 8 m/s, and is shown in Fig. 4. Based on the calculation, approximately 7 g–25 g of firebrands were required to cause flaming ignition on deck boards under a wind speed of 8 m/s. Results were also compared with the data with 6 m/s; see Table 1 [9]. Less than 10% of the mass of firebrands were required to cause flaming ignition of decking assemblies under a wind speed of 8 m/s than 6 m/s. The highest wood density resulted in the largest mass required for flaming ignition, as was observed for wind speeds of 6 m/s as well.

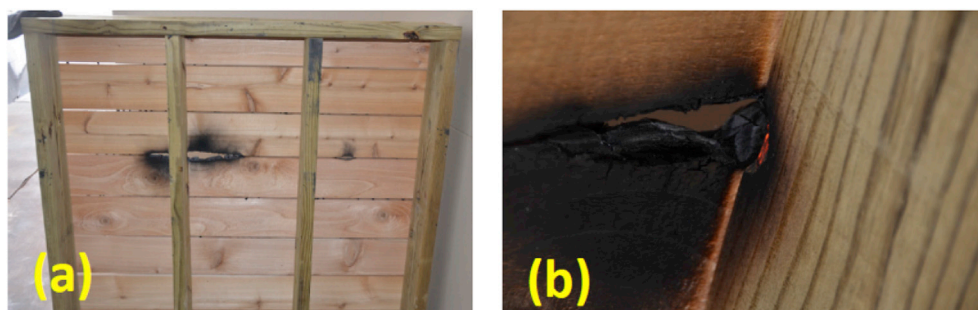
Fig. 5. (a) Picture of the underside of the decking assembly (Cedar); overall view. (b) Detail of the underside of the decking assembly (Cedar). The ignition process spread to the wood supporting members [9].

Finally, the ignition of deck boards also began to produce smoldering ignition in the supporting members under the decking assembly. Fig. 5 shows the underside of the Cedar decking assembly (overall view and detail of one of the sections). Even long after the experiments were completed, sustained smoldering ignition was occurring in the supporting members. This provides direct confirmation of what has been observed in post-fire studies. Specifically, burning decking assemblies are extinguished by the fire service and these assemblies have been observed to re-ignite once again requiring additional suppression, or without suppression, resulting in the loss of the home in the WUI [4].

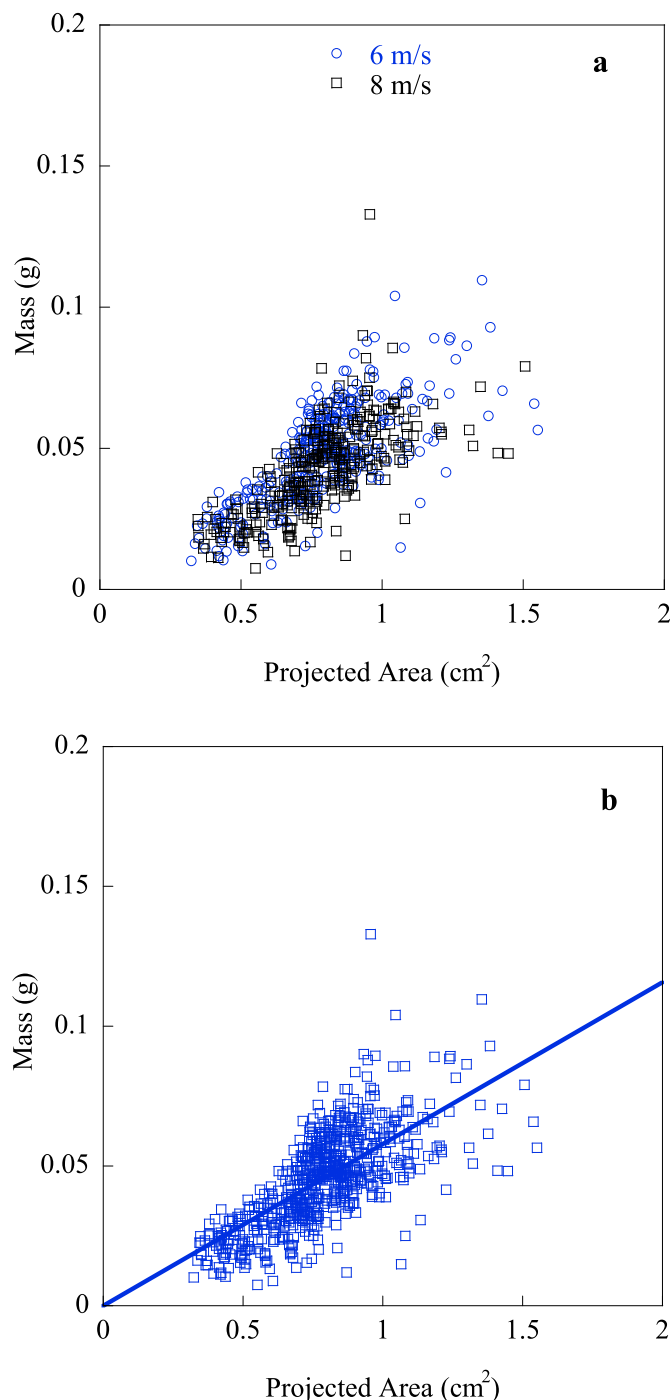
Fig. 6. a. Mass of firebrands as a function of projected area that were directed at the decking assemblies for wind speeds of 6 m/s and 8 m/s. b. The data were similar under 6 m/s and 8 m/s, and a curve fit was applied.

The mass of firebrands as a function of projected area was determined for the firebrand showers directed at the decking assemblies and is shown in Fig. 6a. As the mass versus the projected area of the generated firebrands were similar for 6 m/s and 8 m/s, all the data were plotted together, with a simple curve fit applied (Fig. 6b). Overall, it was observed that less firebrands accumulated on the surface of decking assemblies under a wind speed of 8 m/s than 6 m/s. Firebrands were observed to accumulate around the corner of deck/reentrant corner assemblies (see Figs. 7–9; 8 m/s results), while firebrands accumulated around the front under a wind speed of 6 m/s, and this resulted in flaming ignition of the decking boards. Ignitions occurred near the corner in 5 out of 6 experiments while in one case firebrands caused ignition near the front of the decking assembly. Figs. 7–9 shows the severity of ignition on the assemblies. The supporting joists, as well as deck boards, were also ignited. Firebrands that accumulated between the gaps caused ignitions. Fig. 10 displays a schematic to better grasp the differences in the accumulated firebrand location zones for the different wind speeds. Note that accumulation zones are not intended to represent actual areas, but to simply show locations where firebrands accumulated for the different wind speeds.

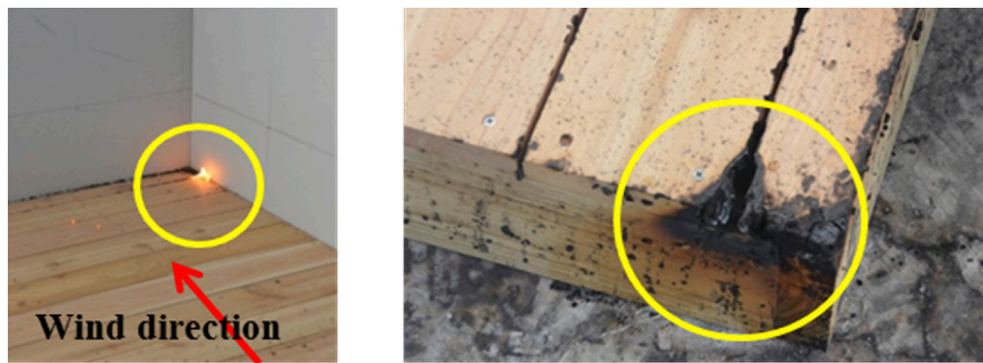
Fig. 7. Cedar decking assembly ignition by firebrand showers at 8 m/s. Note that the circles denote the same ignition locations.

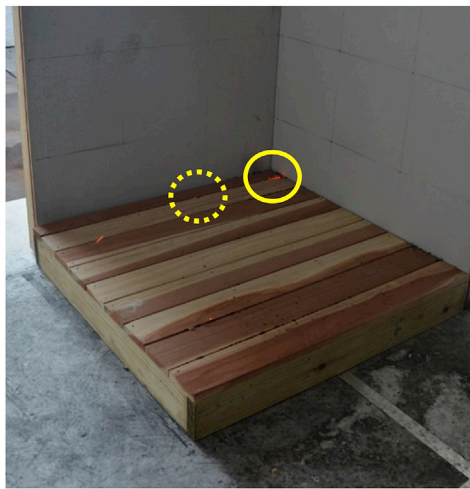
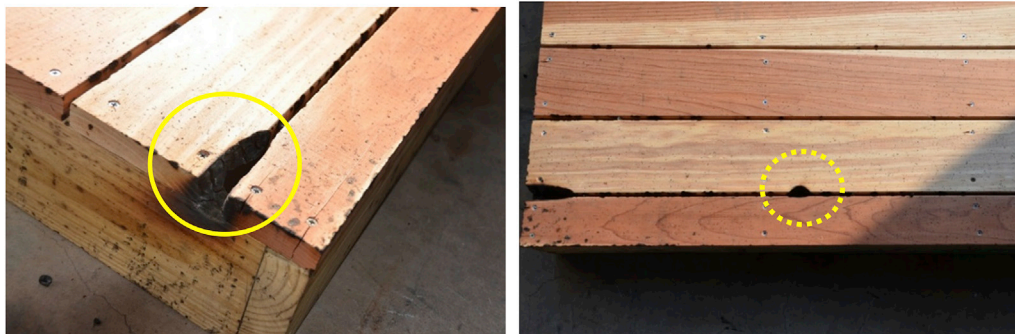
Fig. 8. Redwood decking assembly ignition by firebrand showers at 8 m/s. Note that the circles denote the same ignition locations.

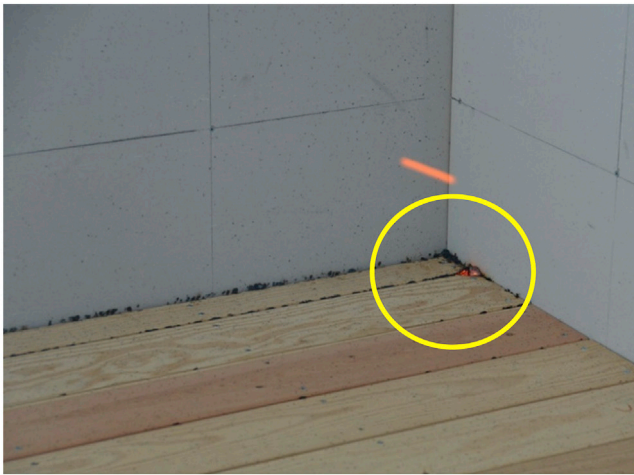
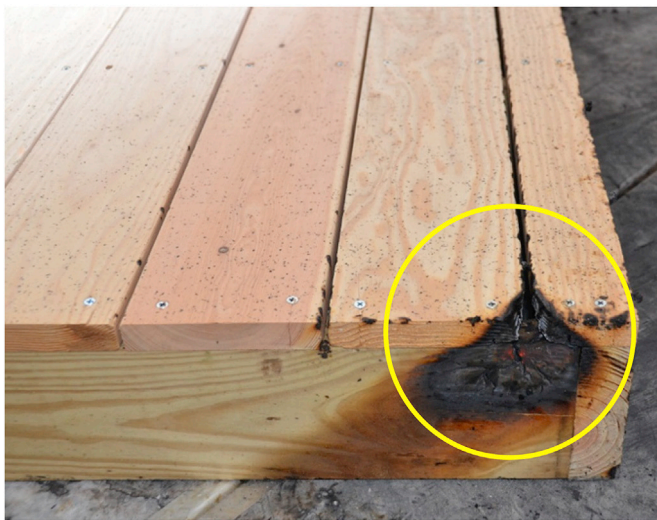
Fig. 9. Douglas-fir decking assembly ignition by firebrand showers at 8 m/s. Note that the circles denote the same ignition locations.

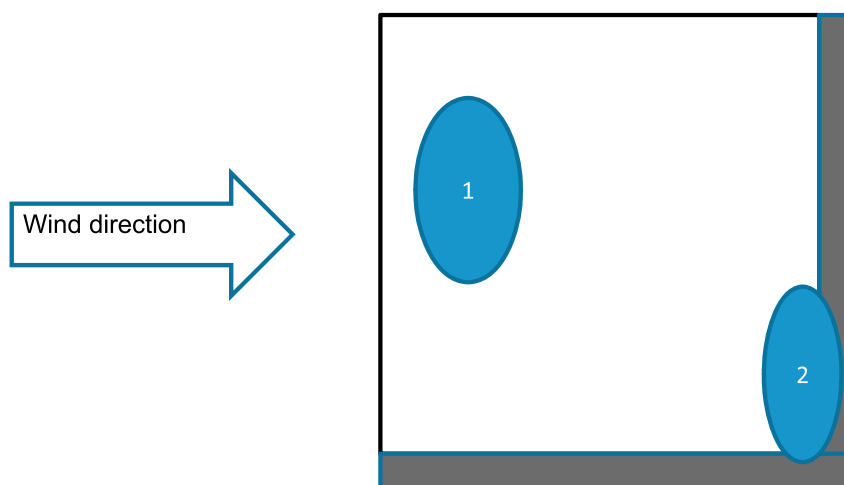
**Fig. 10.** Differences in the accumulated firebrand location zones for 6 m/s and 8 m/s wind speeds. The most firebrand accumulation was observed in Area 1 (6 m/s), as compared to when the wind speed was increased, Area 2 (8 m/s). Note that accumulation zones are not intended to represent actual areas, but to simply show locations where firebrands accumulated.

Another interesting observation was that as the wind speed was increased, fewer firebrands accumulated on the decking assembly surface. This result was qualitatively similar to prior work where firebrand accumulation patterns were measured in front of walls under various wind speeds [14]. In that work, it was observed that fewer firebrands accumulated as the wind speed was increased from 4 m/s to 10 m/s. In each of these studies, the same continuous-feed firebrand generator was used and was fed with the same wood pieces to generate similar firebrand size and mass distributions. This was done intentionally to enable a direct comparison. While firebrand accumulation patterns are dependent on several parameters in actual WUI fires, future studies should consider exposing assemblies to disparate firebrand size/mass distributions as

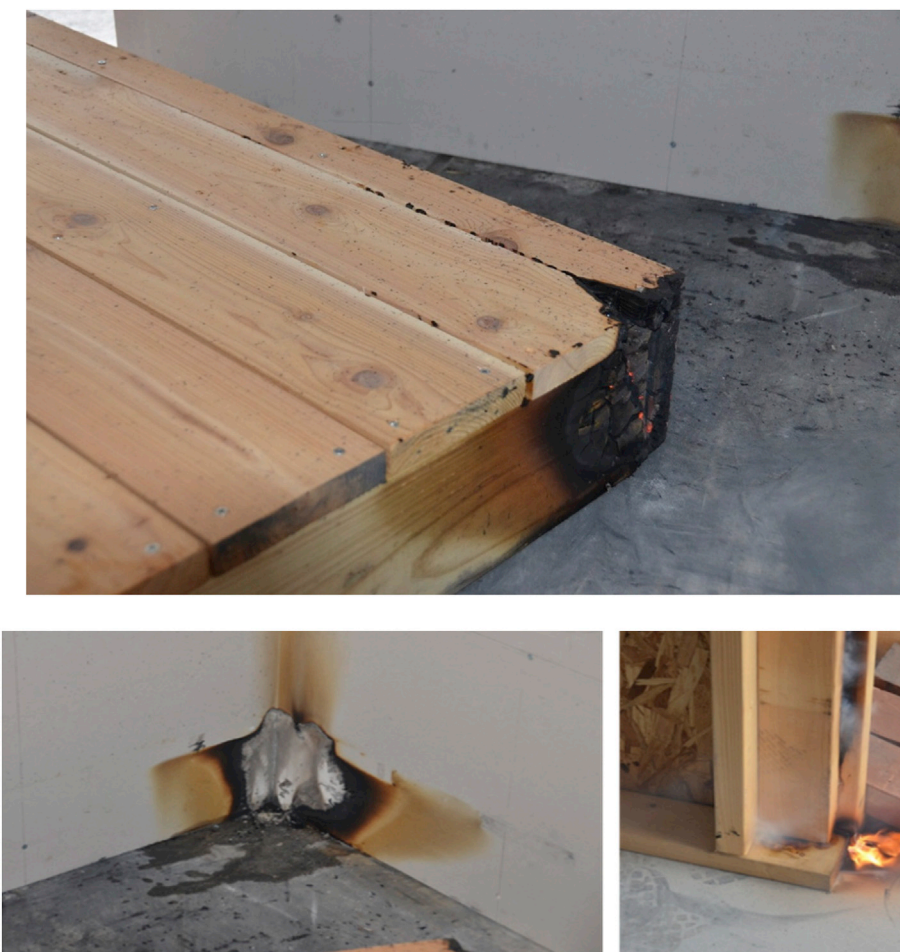
**Fig. 11.** Once ignition occurred, the cedar decking assembly was allowed to combust until flame spread was observed through the re-entrant corner. In this experiment, the wall was lined with gypsum board.

configuration, lined with one layer of gypsum board, was used for the first experiment. After the decking assembly was ignited by firebrand showers, combustion on the deck boards was allowed to continue. Fire spread through the assembly was observed even though the wall was protected by gypsum boards all the way down to the ground (see Fig. 11). Future experiments will quantify this heat flux.

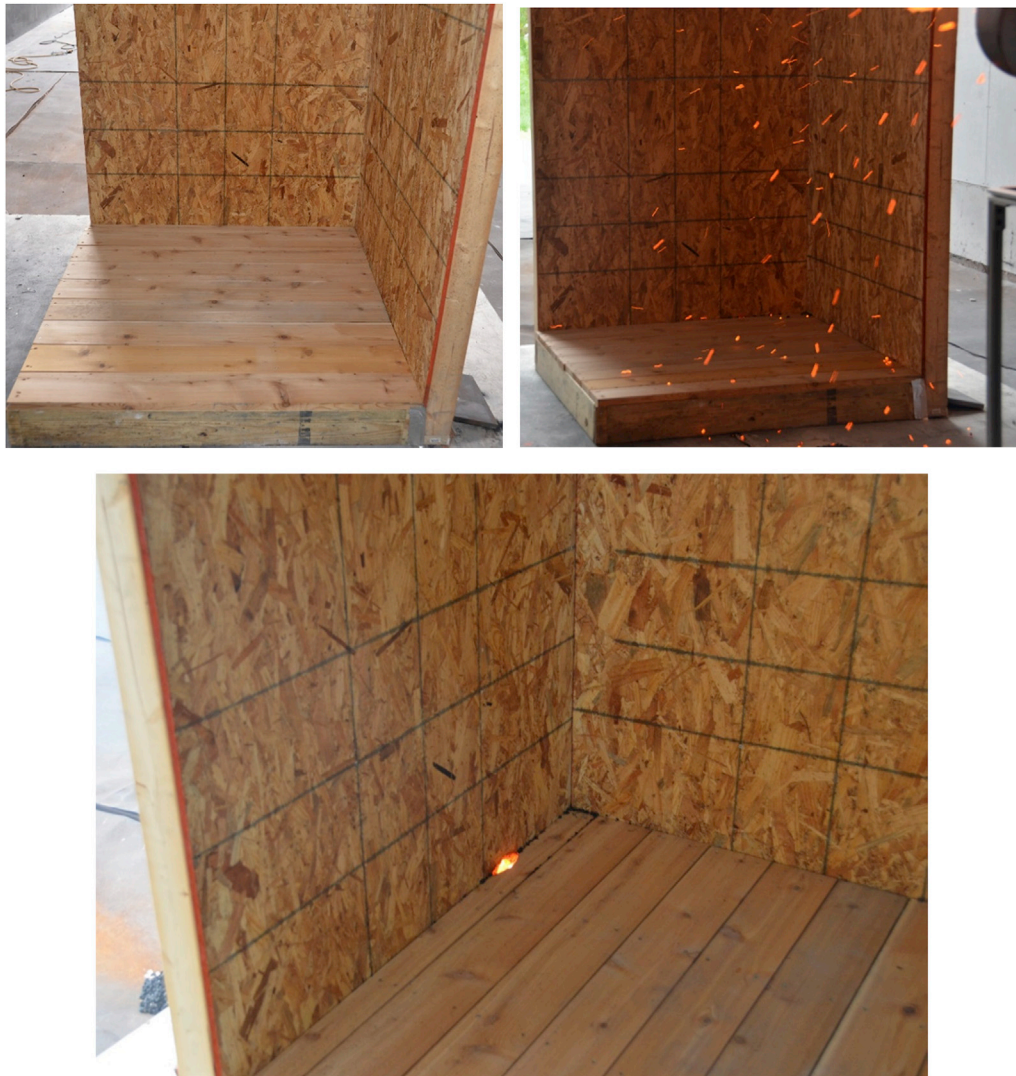
Fig. 12. Once ignition occurred, the cedar decking assembly was allowed to combust until flame spread was observed through the re-entrant corner. In this experiment, the wall was not lined with gypsum board (bare OSB).

A second experiment was conducted to show the influence of bare unprotected oriented strand board (OSB) placed adjacent to a cedar decking assembly (see Fig. 12). The firebrands ignited the decking assembly as well as the OSB. The purpose of this experiment was to simply show a situation where a decking assembly is located next to unprotected wall assembly.

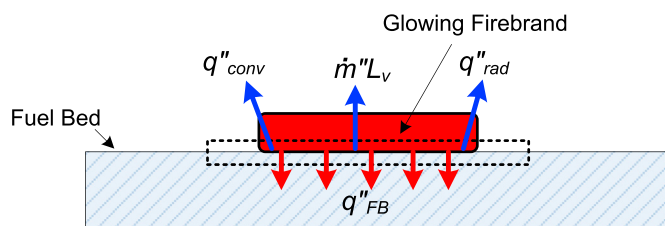
Fig. 13. Heat and mass transfer processes that take place at the deck board in contact with a glowing firebrand.

It was observed that less than 10% of mass of firebrands were required to cause flaming ignition of decking assemblies under a wind speed of 8 m/s, as compared to 6 m/s. This result is postulated to be due to higher firebrand surface temperatures as the wind speed was increased, since the sizes of generated firebrands were similar at 6 m/s and 8 m/s (see Fig. 6a,b). It is important to consider the heat and mass transfer processes that take place at the gap between the deck boards in contact with glowing firebrands. The deposited firebrands heat up the surface, resulting in the production of pyrolysates. Flammable air/fuel mixtures are formed above the gaps between the deck boards. Continued heat supplied from the firebrands contributes to exothermic gas-phase reaction, leading to ignition. The heat and mass transfer process that occur for a firebrand in contact with wood decking boards are shown in Fig. 13. The net heat flux  $q''_{net}$  to the deck board from the accumulated firebrands is given as:

$$q''_{net} = q''_{FB} - (q''_{conv} + q''_{rad} + \dot{m}'' L_v) \quad (2)$$

where  $q''_{FB}$ , the heat flux from the firebrands,  $q''_{conv}$ , the convective heat flux,  $q''_{rad}$ , the radiative heat flux,  $\dot{m}''$ , the mass loss rate per unit area, and  $L_v$ , the heat of gasification of a given wood decking board.

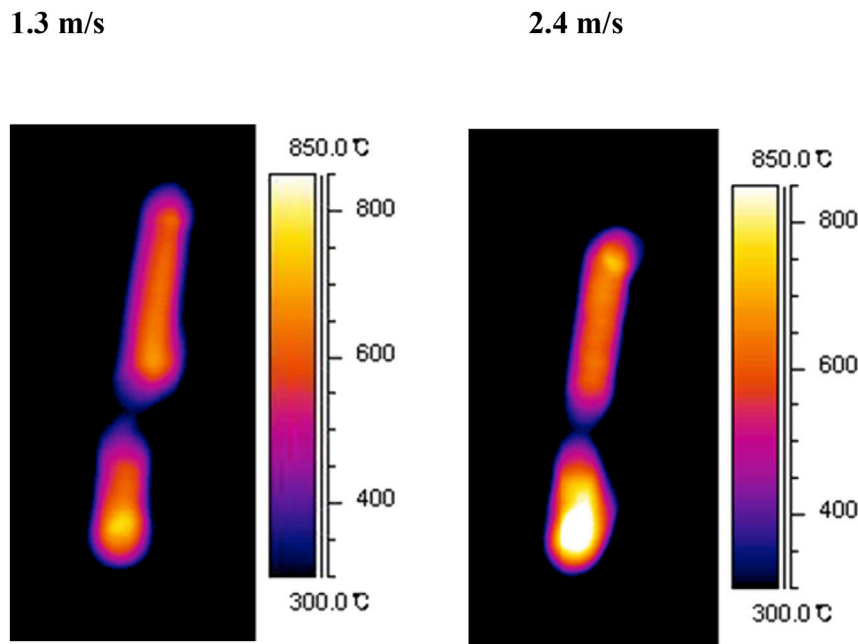
Fig. 14. IR images of the glowing firebrand exposed to two different air flows [16].

Manzello et al. [16] quantitatively showed that glowing firebrand surface temperature increased as the wind speed was increased (see Fig. 14 taken from Ref. [16]). In that work, the surface temperature of charred area on the glowing firebrand was simultaneously measured using both the thermocouple and the infrared camera in a quiescent environment [16]. The glowing, charred, area close to the thermocouple bead was imaged using the infrared camera and the emissivity was then adjusted until the temperature readings on the infrared camera converged to those registered by the thermocouple measurements. Temperatures measured by the infrared camera approached those measured by the thermocouple as the emissivity set on the camera was reduced from 0.7 to 0.6. Based on these experimental results, the emissivity of the glowing firebrands was set to 0.6 [16]. As may be seen, the firebrand temperatures are quite sensitive to airflow. Therefore, larger firebrand temperatures were expected as the wind speed was increased from 6 m/s to 8 m/s.
