## Mercedes Benz C 250 Sedán 2013 (204.047) L4-1.8L Turbo (271.860)

### AR46.40-P-0400EW Revisar y reemplazar el guardapolvo de goma

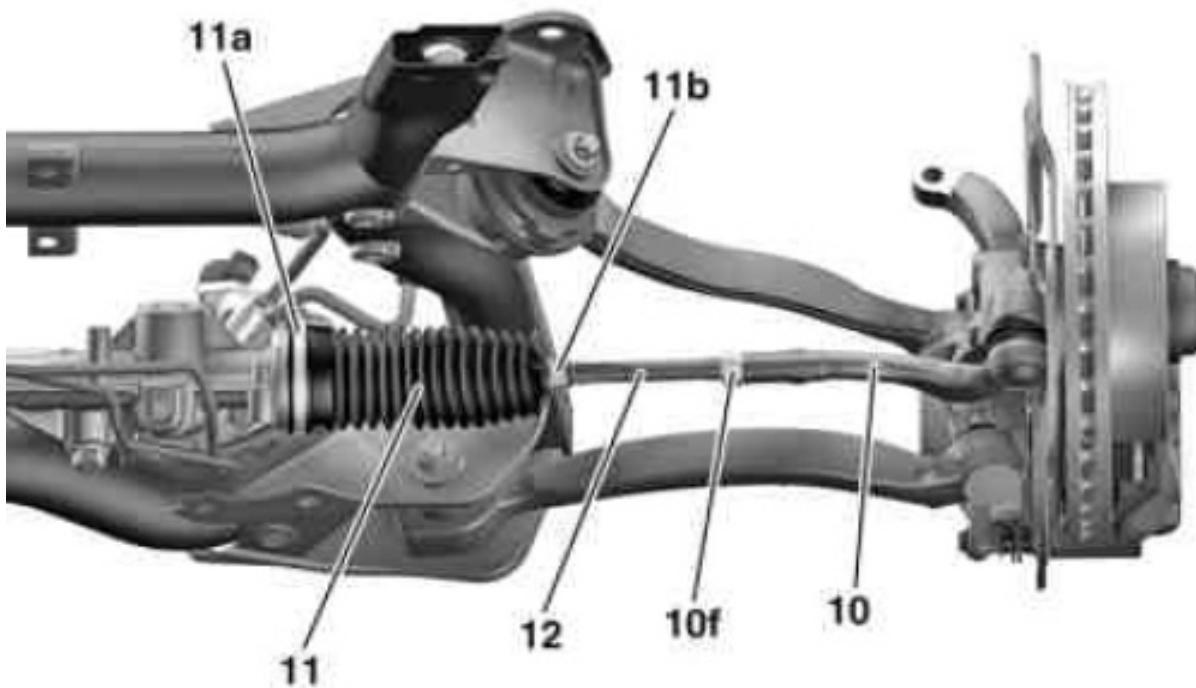
MODELO 207 con dirección asistida eléctrica **Se muestra en el modelo 212 con dirección hidráulica** 10 Barra de acoplamiento 10f Contratuerca 11 Fuelle 11a Abrazadera interior 11b Abrazadera exterior 12 Barra de dirección interior

Stretch boots (11) by turning the steering to the left and right and while doing so checking for damage (cracks, holes, chafe marks and intrusions); install a new boots (11) if necessary.	
3	Check water drain valve in steering gear	Model 166, 218, Model 207, 212 with electric power steering	AR46.20-P-0005EW

5	Unscrew lock nut (10f)		
6	Detach inner clamp (11a) and outer clamp (11b) from boot (11)

<b>Installation:</b> Model 207, 212, 218: Note positioning of inner clamp (11a) and the outer clamp (11b).	AR46.40-P-7200-01EW
7	Pull off bellows (11)

<b>Installation:</b> Model 207, 212, 218: Note positioning of boot (11).	AR46.40-P-0400-02CW
