On the use of temperature for online condition monitoring of geared systems – A review

T. Touret ^{a,b,c}, C. Changenet ^{b,*}, F. Ville ^{a,*}, M. Lalmi ^c, S. Becquerelle ^c

ABSTRACT

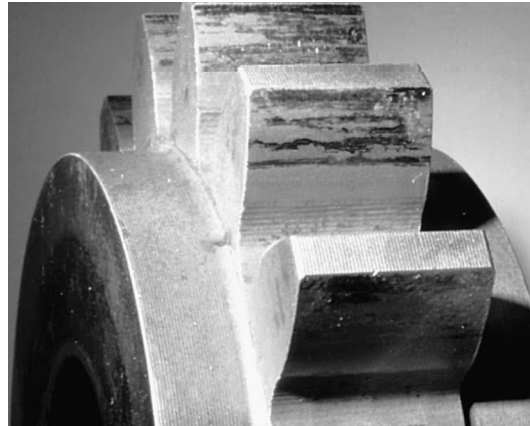
Fig. 3. Micropitting on a FZG gear [16].

Figs. 3 and 4 show two different surface defects that can occur on gear or rolling element bearing (REB). A surface defect can be localized, such as the spalling shown in Fig. 4 or distributed (e.g. micropitting on Fig. 3).

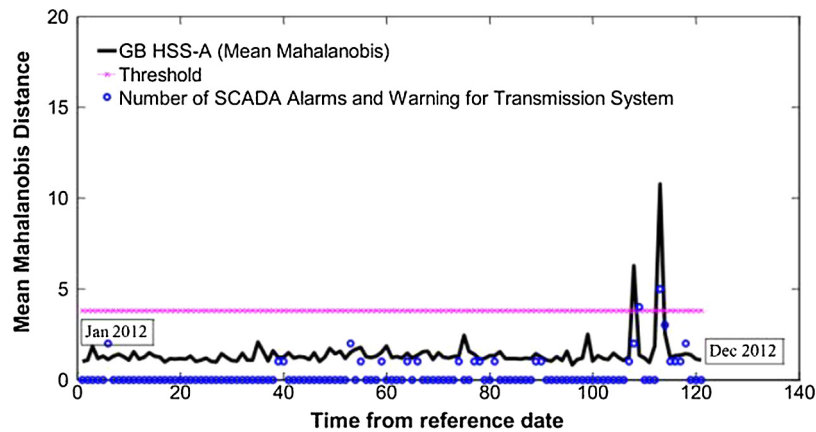
Fig. 5. One year average MD calculated with temperature [23].

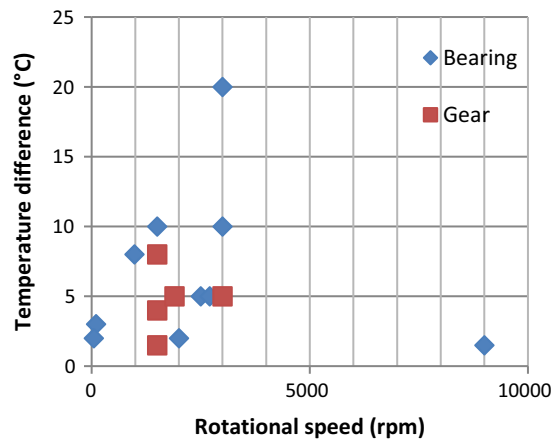
**Fig. 11.** Plot of the temperature increase due to fault versus rotational speed of the mechanical element.

- Fig. 11 shows that no clear correlation has been found between the rotational speed and final temperature increase of a faulted gear unit (the fault may be located on gear or bearing).

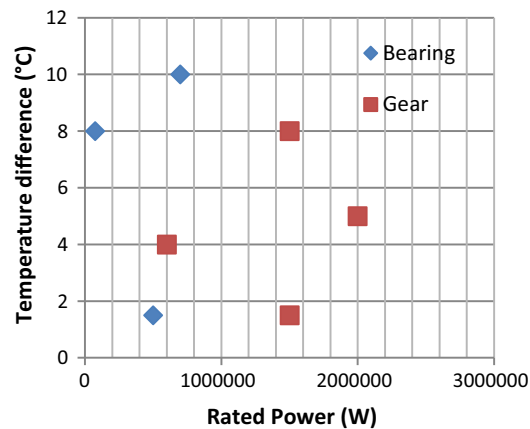
**Fig. 12.** Plot of the temperature increase due to fault versus rated power of the system.

- The rated power is neither a significant parameter for temperature increase as shown in Fig. 12. However, it seems that more transmitted power is required to perform temperature health monitoring on a gear rather than a bearing.
