Wind and Waves Conditions off the Coast of Libya during April 2015

Richard Limeburner
Senior Oceanographer Emeritus
Physical Oceanography Department
Woods Hole Oceanographic Institution
Woods Hole, MA USA
May 2, 2016

This report documents the wind and surface wave conditions observed during April 12 and April 18, 2015 in the Mediterranean Sea approximately 120 km north of Libya when two fishing boats overloaded with migrants from Libya capsized. It is believed more than 1200 migrants died in these two tragic accidents alone despite the presence of rescue boats near each capsized boat. The objective of this report is to determine if the wind and wave conditions at the time of the accidents contributed to the difficulty of the at-sea rescue operations and subsequent deaths of so many of the migrants.

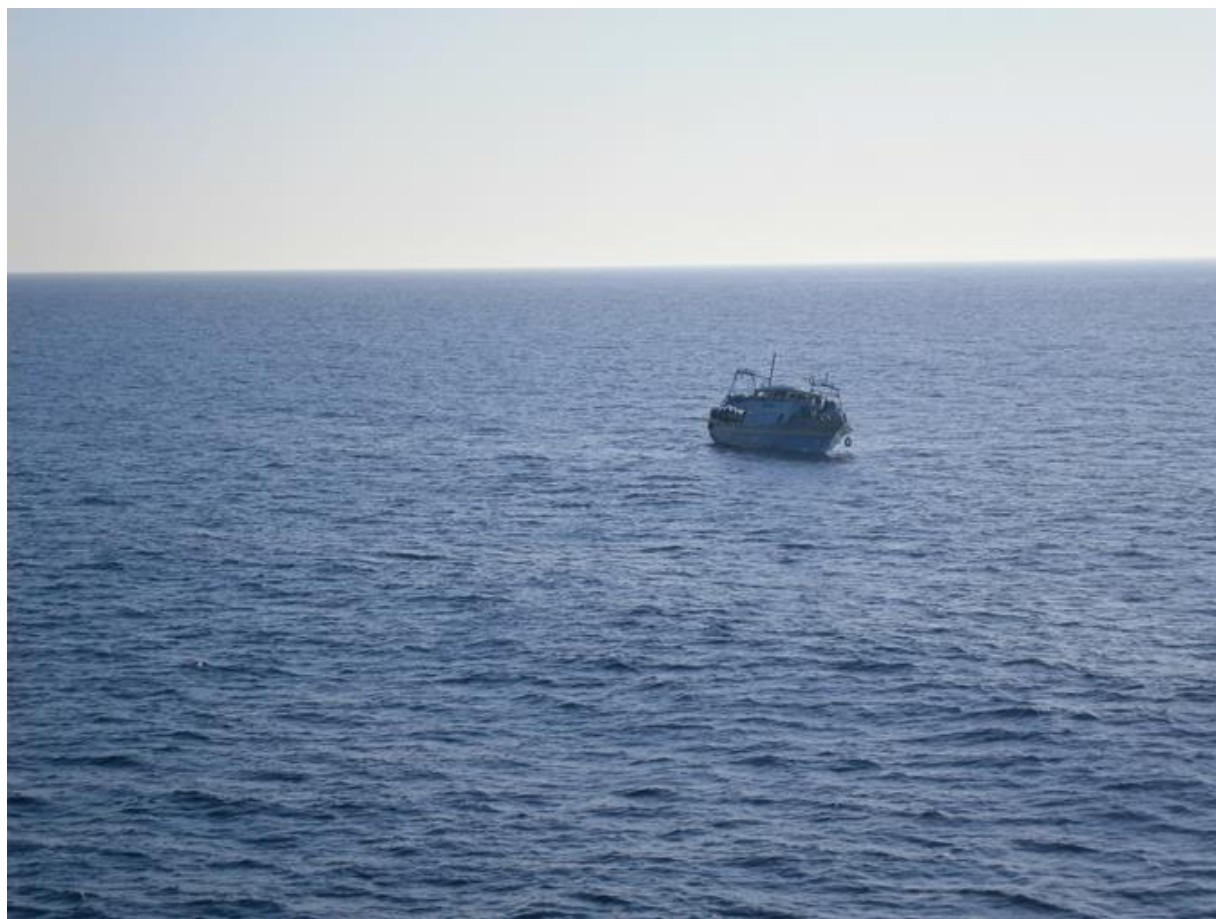
A photograph on 12.04.2016 at 1611 UTC (1811 CEST) of the overloaded migrant boat just minutes prior to the capsizing is shown in Figure 4. This photo was provided to the press by Opielok, the company managing the OOC *Jaguar*, the vessel that observed the capsizing from a distance of only a few 100 m. An oil platform, ENSCO 5004, at the Bouri oil fields was located less than 1 km from the location of the capsizing.

Figure 4. The unstable migrant vessel 12.04.2015 at 1811 CEST just prior to capsizing.

The Figure 4 photo shows the overloaded migrants' boat clearly leaning to the port side in the distance. I estimate the wind in this photo to be weak, probably less than 10 kt and the local wind driven waves were < 20 cm high. A low frequency swell is observed in the Figure 4 photo and is estimated to have a wave length of 2 boat lengths, ~ 100 m, and the wave period would be 7.7 seconds from linear wave theory. The swell height is probably less than 30 cm. Clearly the wind and wave conditions just prior to the capsizing were weak and would not hinder other vessels from rendering assistance.

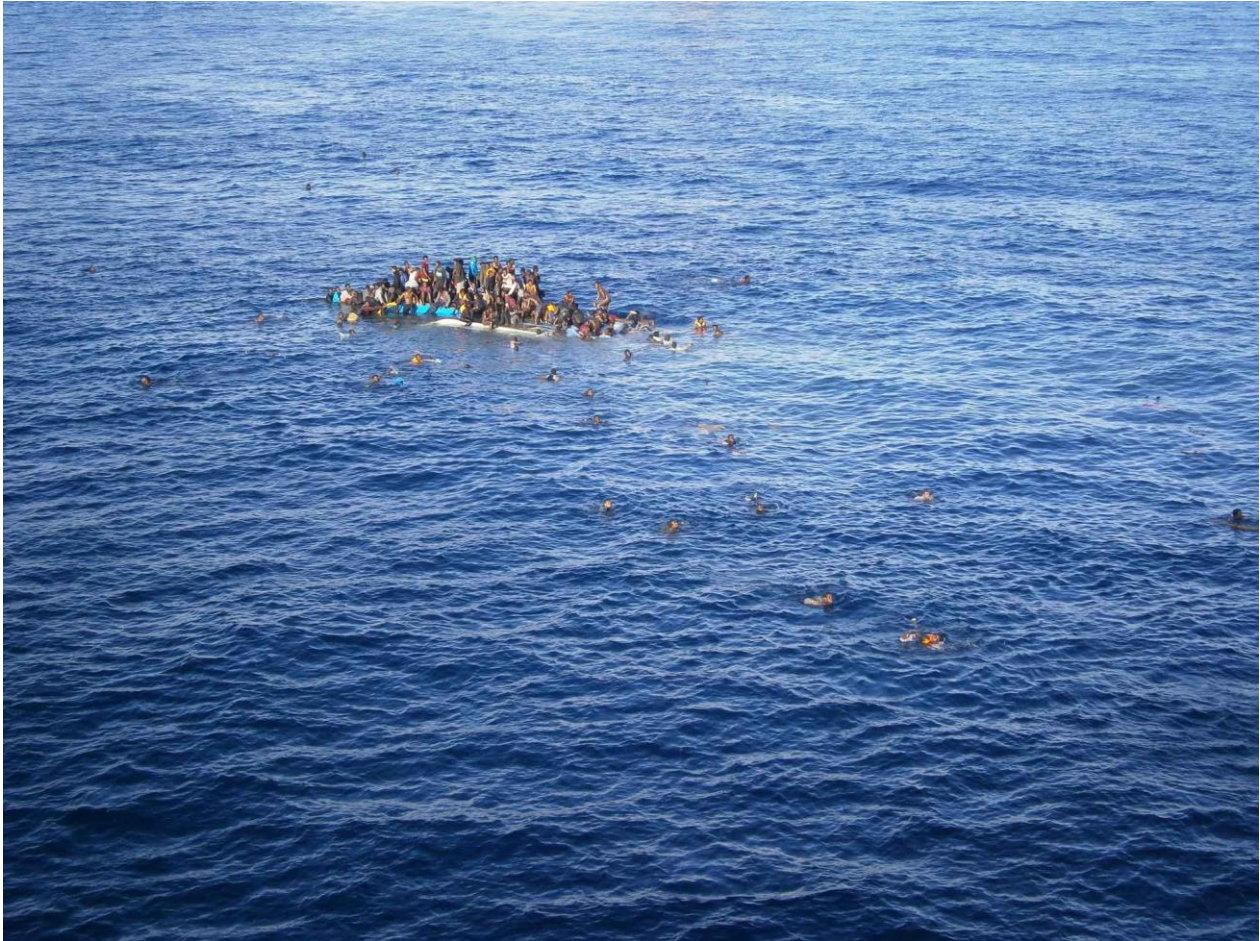
Figure 5 shows the vessel after the capsizing. The winds and waves were still weak and about 80 migrants can be seen standing/sitting on the overturned vessel and another 20 are in the water drowning or swimming toward the vessel where the photo was taken.

Figure 5. Capsized migrant boat 12.04.2016 at 1754 CEST.

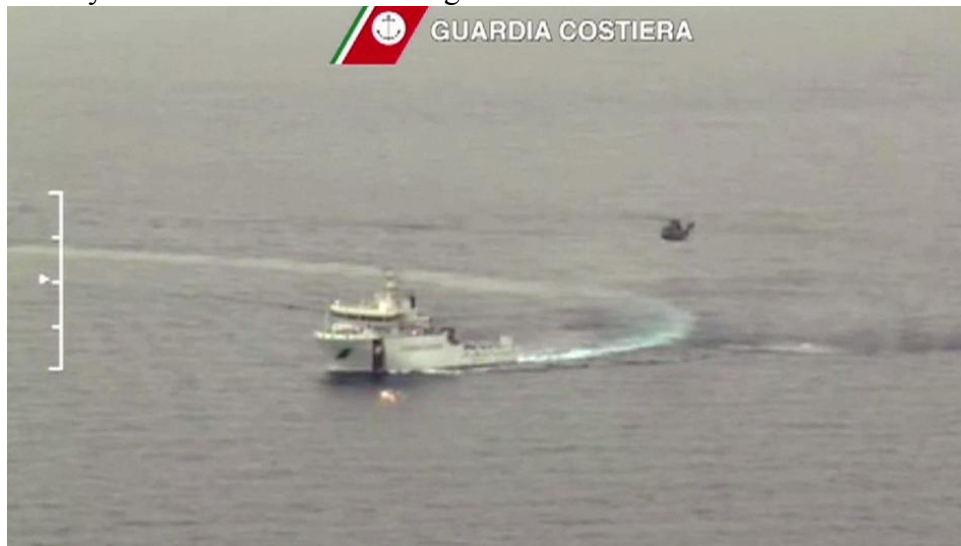
Figure 9. An Italian coast guard vessel and helicopter during ongoing search and rescue operations in the Mediterranean Sea south of Lampedusa Island, Sunday April 19, 2015.

The sea surface in Figure 9 is relatively flat indicating light and variable winds and small surface waves less than 20 cm. Currents at the sea surface at the time of the capsizing are shown in Figure 10. The data and image for the surface current were provided by Mercator Ocean, a French nonprofit producer of ocean forecasts and analysis.
