**Interim Report on
Archaeological Excavations at
Bottoms - Holcombe Moor
April to October 2014**

Neil Coldrick
Holcombe Moor Heritage Group

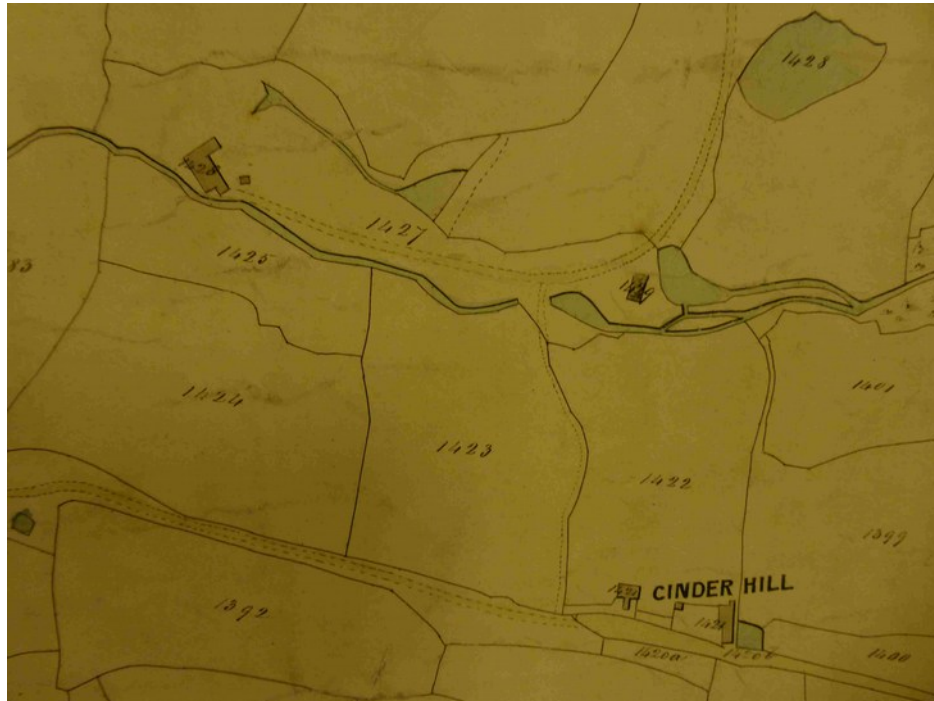
Illustration 2: Tithe map of 1842 showing Bottoms by the pond bay

Bottoms Mill was first recorded around 1782. In 1794 it is referred to as an engine house owned along with Cinder Hill Farm and other buildings by Laurence Brandwood. The building is shown on the Tithe Map of 1842, shown below, and also appears on the 1850 OS map.

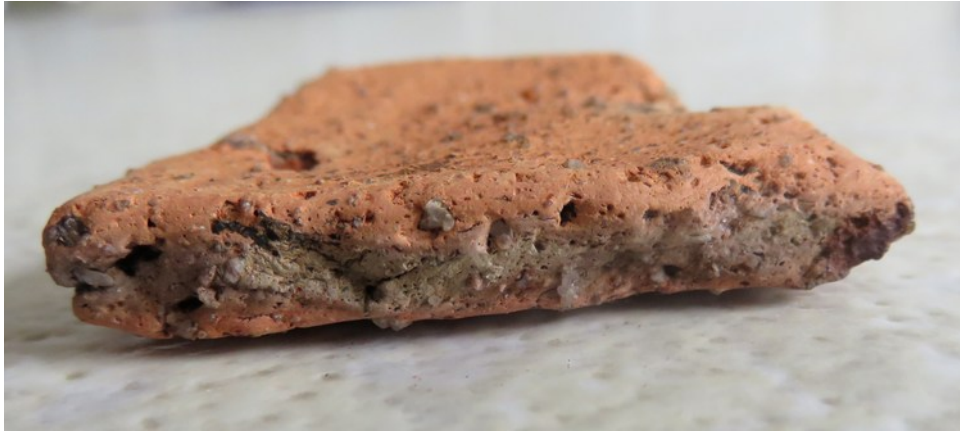
Illustration 3: A sherd of 12th century Pennine Gritty Ware

There was also four sherds of Pennine Gritty Ware medieval pottery found. Three sherds were from the same pot and were of a reddish yellow colour internally and light red externally with a

pale brown fabric. Quartz inclusions up to 2mm in size were evident throughout the fabric and also protruding through the surface. The other sherd was a cream colour, with a grey fabric and the same quartz inclusions.

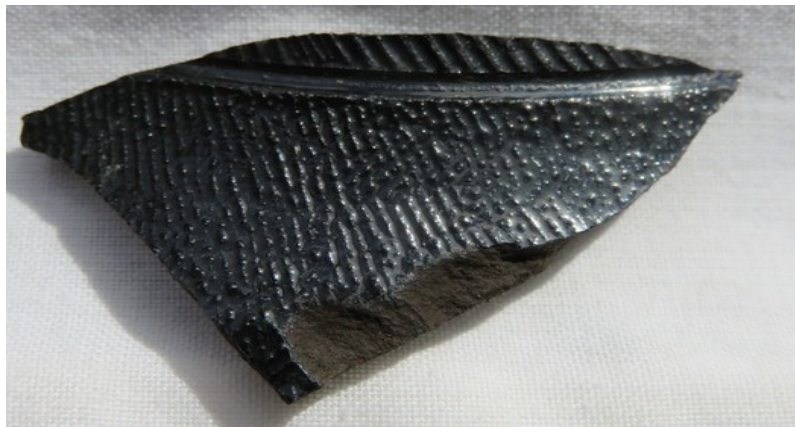
Illustration 4: A sherd of Egyptian Blackware

Another sherd of interest was a piece of Egyptian Blackware. Egyptian blackware is actually a fine stoneware produced in Staffordshire from the early 18th century.

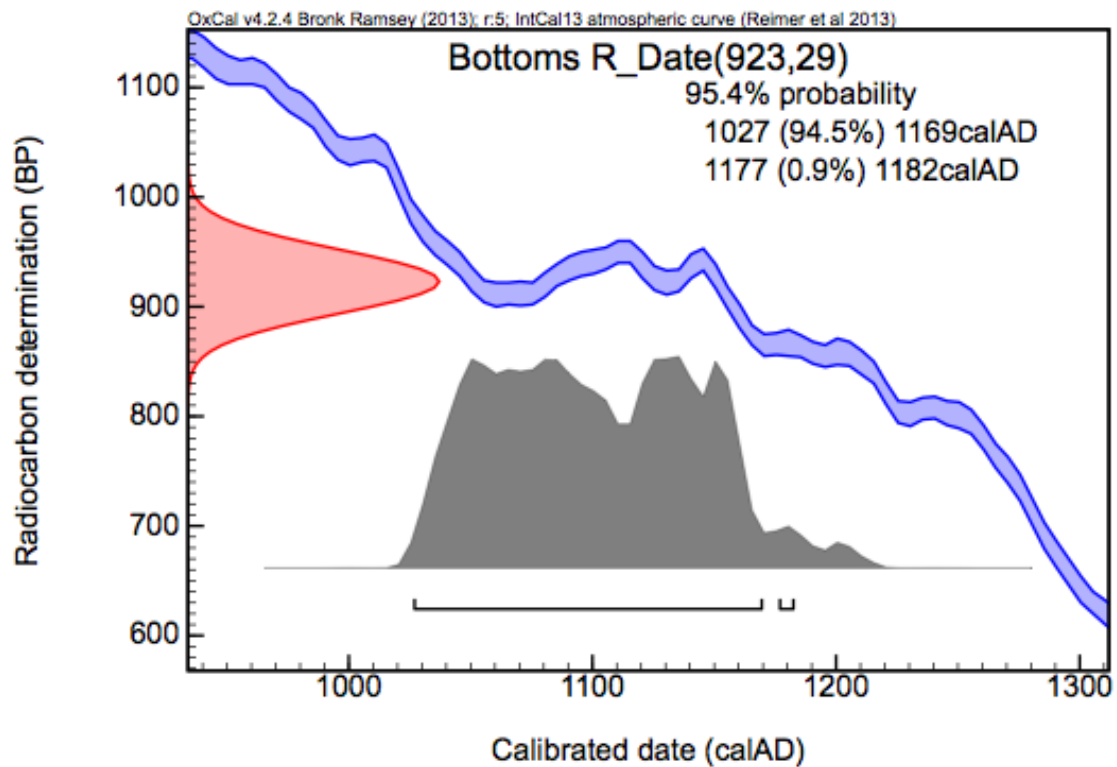
The Radiocarbon age BP for the sample was 923 ± 29 , which gave a calibrated age range of 1027 to 1182calAD with a 95.4% probability.

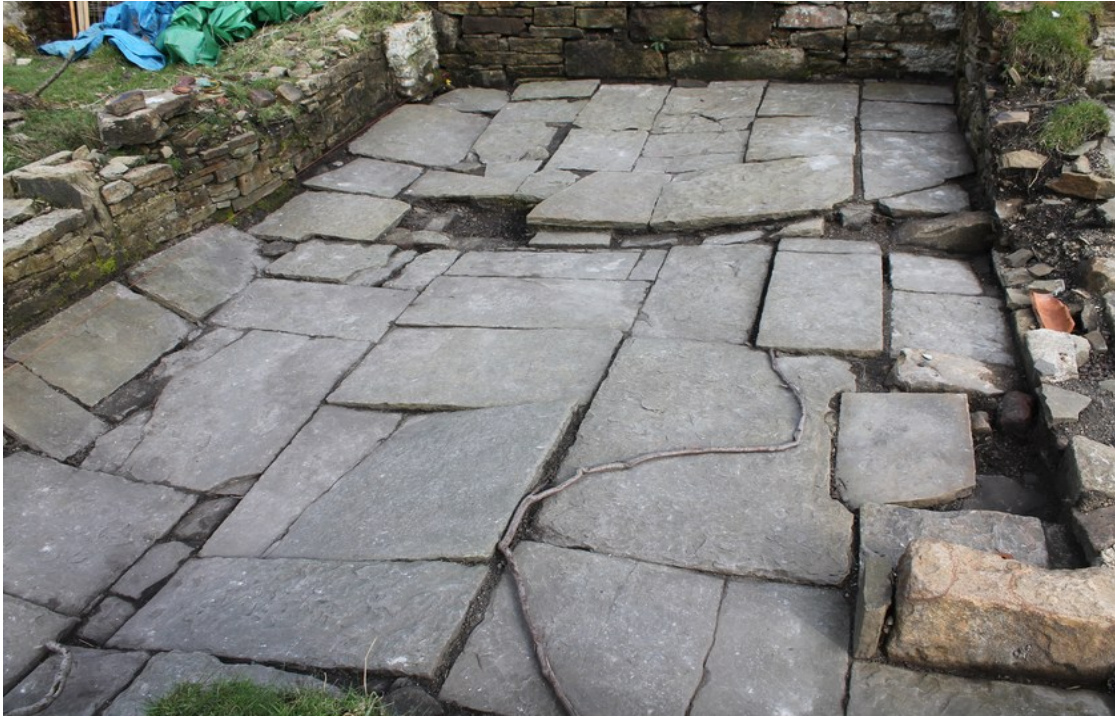
fig 1 - Photo showing the collapsed floor in the central bay

In 2013 the central bay of the building had been cleared and the eastern bay of the building had been partially cleared of demolition rubble revealing the flagstone floor in both bays. This year we set about clearing the rest of the eastern bay and doing all the planning of the two bays. What became apparent was the difference in the style of the flagstones between the two bays. The eastern bay had very fine, small flagstones (036) roughly 75cm by 50cm although many were slightly smaller or larger. They were closely fitted together, reasonably level and gave the impression of a domestic area. In comparison the flagstone floor in the central bay comprised of large, thick industrial type flags (037), roughly 75cm by 1m. These flags were very uneven, (fig. 1), in particular towards the western wall (033) where it appeared that the floor had collapsed and had sunk possibly due to an unexcavated feature underneath. Alongside the eastern wall (032) of the central bay, situated in the flagstone floor we found three stone blocks that would have been vertical and were possibly used to support a stone bench or slab. These were spaced approximately 1m apart with the northern most stone just slightly more than 2m south of the northern wall (034). One particular item of note on the central bay floor was a series of marks cut into one of the flagstones, possibly made by a chisel when cutting out a piece of sheet metal. This was situated 3.5m south of the north wall (034) and 2.2m from the western wall (033).

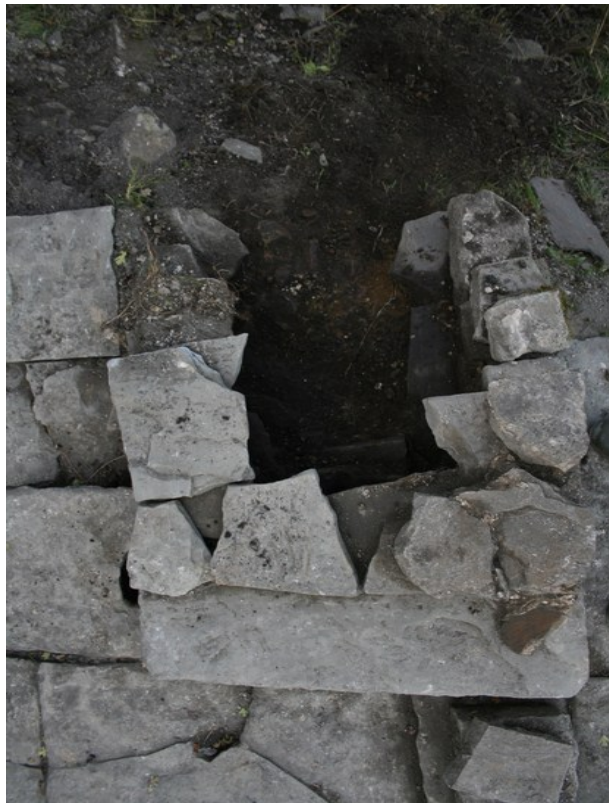
fig 2 - Photo showing the stone structure to the east of the partition wall

Approximately 2.5m south of the northern wall in the eastern bay appeared a partition wall running east/west across the building with a doorway 70cm from the western wall. Directly to the east of the doorway was a stone feature 1.2m by 80cm (fig. 2). The flagstone floor in this area was badly damaged due to the demolition collapse onto it and its proximity to the stream edge of the site.

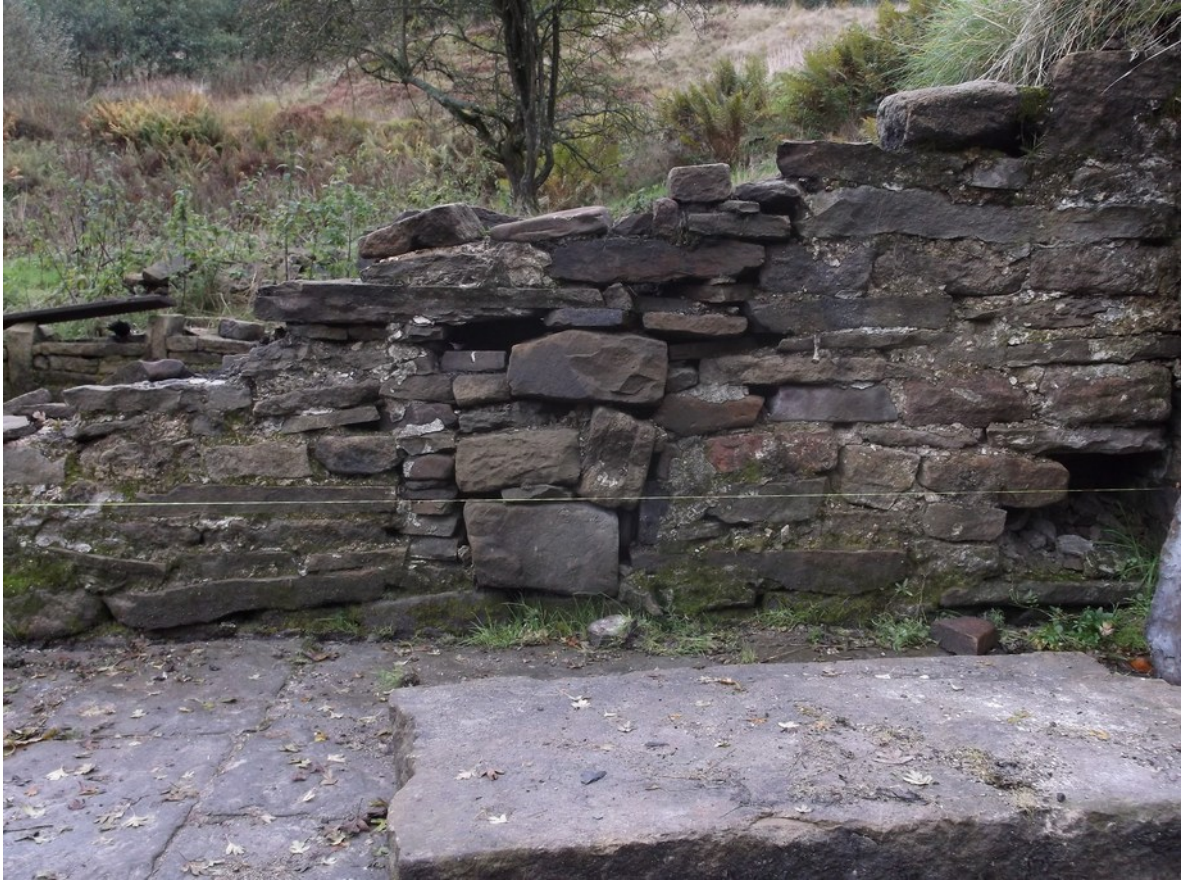
fig 3 - Photo showing the possible blocked hole in the western wall of the eastern bay

The western wall of the eastern bay (032) comprises of a mix of building materials, sandstone, gritstone, flagstone and handmade bricks. There are no fine dressed stones and the stone is of a fairly rough appearance. However the stonework to the north of the partition wall appears to be of a more regular appearance, being constructed with more regular sized stone than the rest of the wall. There was evidence in the rubble fill (009) removed from the area of lime washed mortar / render so it is fairly safe to assume the walls were in fact rendered. The wall varies in width from 55cm at the northern end down to 45cm at the southern end. This wall butts up to the northern wall (035) with no evidence of any keying. There is evidence of a blocked up hole in the wall 1m south from the northern wall (035). This measures 50cm x 50cm and starts one course up from the flagged floor. (fig. 3)

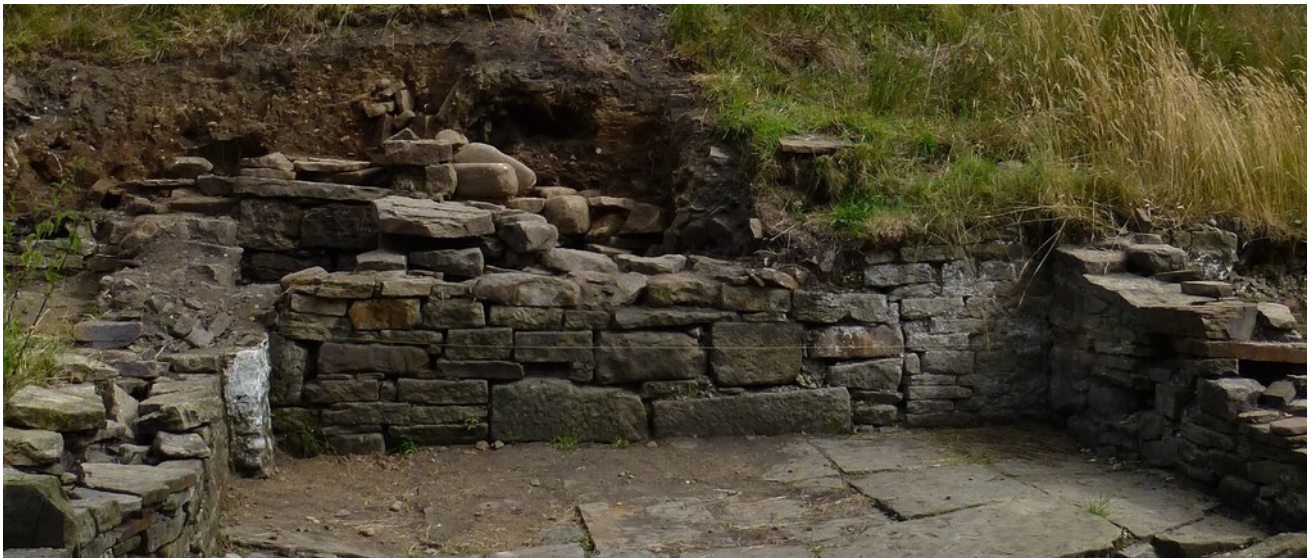
fig 4 - Northern wall of the central bay showing phasing

The northern wall (034) of the central bay shows signs of multiple phases of use (fig. 4). The first phase comprises of the very large blocks of stone positioned at the bottom of the wall at flag stone surface. These are roughly 90cm along the face, further dimensions are unavailable due to their position in the wall. The second phase is the larger blocks of stone built on top and around the first phase. These blocks are smaller than the first phase and are roughly 30cm x 10cm. Finally the finer construction to the east of the section was added on at a later date. These are slightly smaller blocks roughly 25cm x 8cm. This final phase extends between 60cm and 80cm west of the western wall of the east bay (032). There is a straight joint between the final and the second phase up to the sixth course where the final phase overlaps the second. The final phase is mortared using a friable buff mortar and has then had a lime wash render applied. This is very fragmentary. The standing height is between 80cm at the western end of the bay and 1.2m at the eastern end where it meets the western wall of the east bay (032).

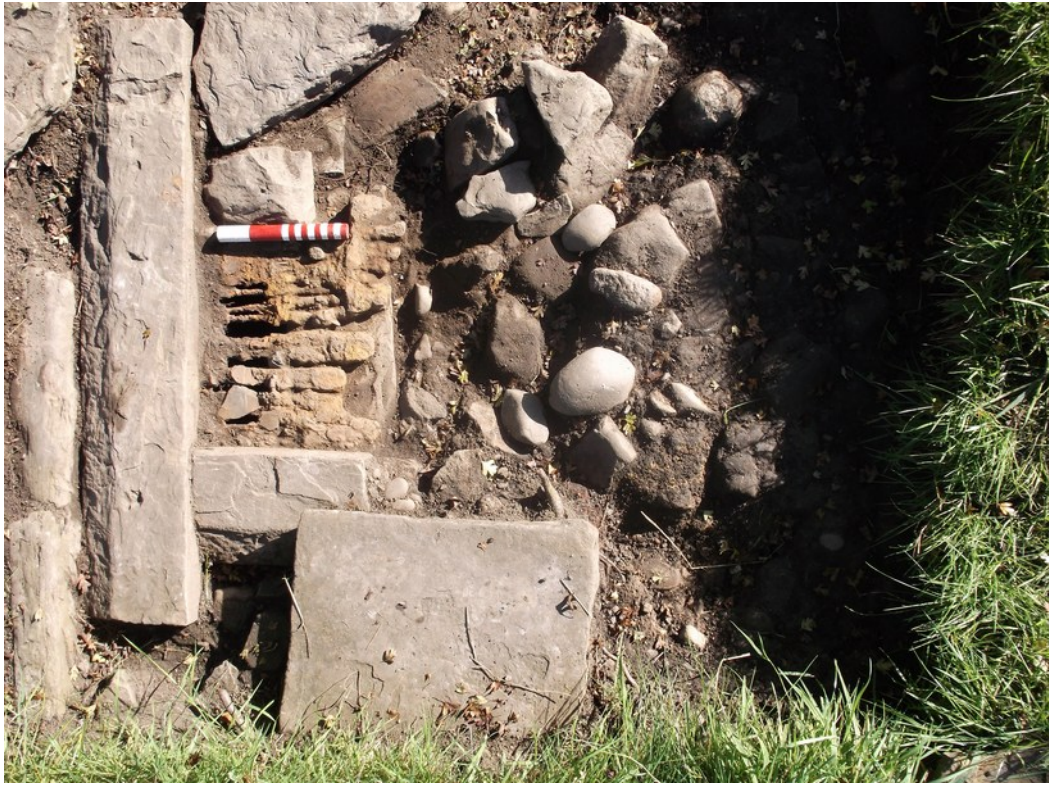
fig 5 - showing the grid for the east west drain

The east/west drain (031) extends 8m in a roughly east/west direction from the exposed section in the stream bank to the east, to the front of the paved surface (011) in front of the west wall of the central bay (033). At the terminus of the drain is an iron grid roughly 35cm x 30cm, which is badly corroded to the extent that the grid appears 'bulky' with no drainage slots. The dimensions are similar to the north/south drain (025) and also has a width of 60cm. Internal dimensions are 20cm x 20cm. The side walls are constructed from river cobbles rather than flat stones. The cap stones are made up of two distinct styles. The cap stones from the eastern edge run 4m to the west and are mix of boulders and flatter stones. The style then changes to several tight fitting stones which are chamfered on one side and appear to be reused window sills or lintels. These stones are very similar in shape and size, measuring 49cm x 17cm in plan. Towards the grid the cap stones change again to rough flat stones. Two large flat stones which have been placed on their side, are positioned to the north and the west of the grid, chamfers pointing away from the grid. These appear to be of similar design to the ones used as cap stones in the middle of the drain. The area just south of the grid is made up of rough cobbles extending 1m from the western edge of the trench eastwards. (fig. 5)

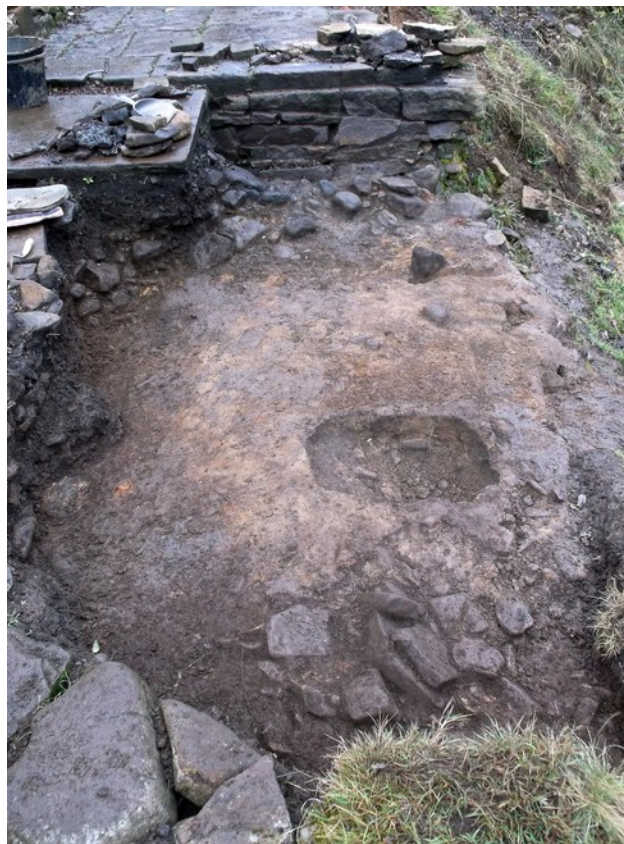
fig 6 - showing the medieval layer with the intrusion

Towards the eastern edge of the layer, 2.2m south of the foundation cut (028), was an oval negative feature (046) measuring 0.7m east/west x 0.45m north/south. When excavated the feature was 27cm deep at its deepest point and 4cm deep at the shallowest. The deepest point was to the east of the feature with the shallowest being the west. (fig. 6) The feature (046) is cut through (044) and into the natural (999).

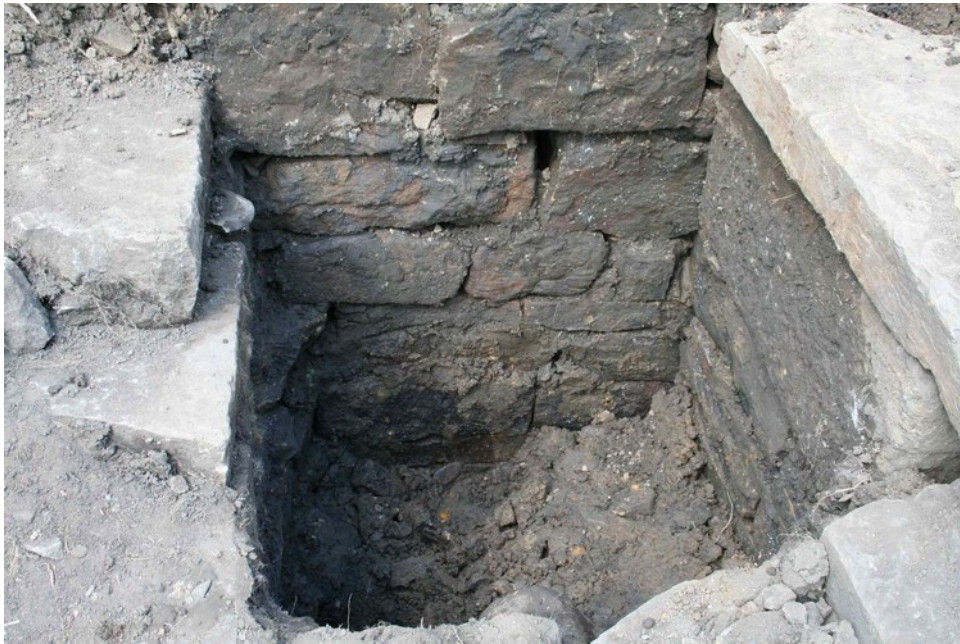
fig 7 - showing the stone structure built into the northern wall

to ascertain the width and construction. The area chosen was grid square 200/110, the north western corner of the central bay. Upon removal of the topsoil (026) we encountered a clay fill (021) which came down the bank and ended flush against the back of the wall. A collection of boulders and stone was noted in this layer and it was decided to extend the layer to investigate. Under this layer of clay we discovered a large 1m x 1m (internal dimensions) square "tank" (016) filled with river cobbles and boulders with a dark grey gritty silt mix. The "tank" was constructed with large stones, including one very large stone on the eastern side, which seemed to match the very large stones visible in the rear wall (034) (fig. 7). This fill went down 1m as excavated. To the rear of the "tank" appears to be another wall running east/west but this was confused due to a vast amount of rubble surrounding the area. Under the clay layer and on the stonework a 1797 Cartwheel Penny was discovered giving us an earliest date for the clay layer to have been put down over the structure. Further work will be carried out in this area next year to give us a better insight into the feature.

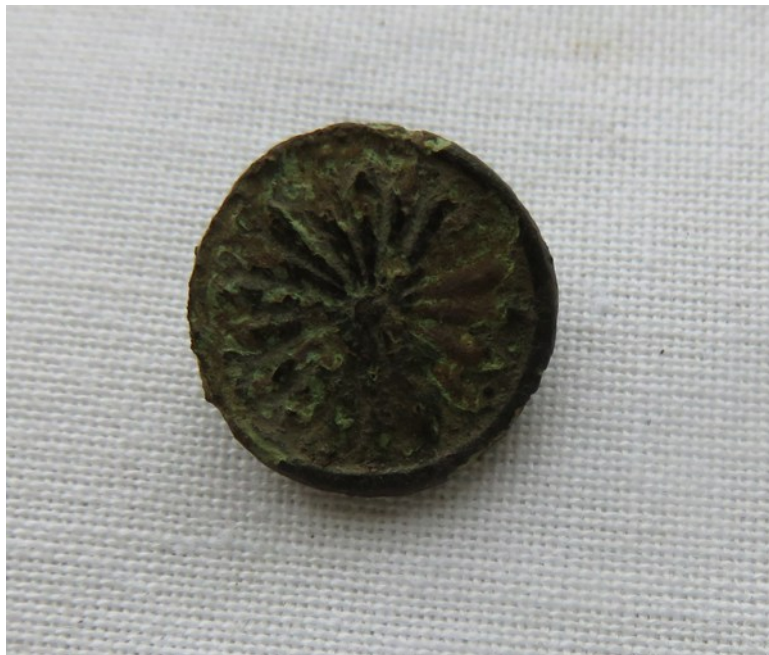
fig 8 – small decorated button 11mm diameter

Various pieces of metalwork were found in all areas of the excavation. These ranged from undiagnostic pieces of corroded metal to fine buttons. In total 3 buttons were found of varying designs and sizes. An example is shown in fig. 8. Various metal clips, iron washers, tools and lead window came were found in the demolition layers.
