Diagnostic Rev. 586220 – Extended Keyboard Dongle

Project number: 143

Revision: 1

# Diagnostic 586220 Harness - Keyboard Dongle Extended Rev. 1

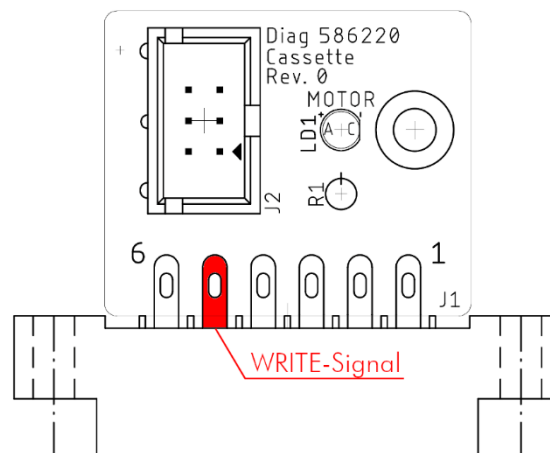
Figure 4: Locating the Write signal

This WRITE signal is generated via a voltage divider on the user Port Dongle, which is also fed back to the Cassette Port Dongle. It can be found on Pin 5 of the cassette edge connector (on every kind of test harness). An existing harness can be easily modified by soldering a 40cm Dupont cable to the indicated Pin (refer to Figure 4), which is then connected to J2 (one pin) of the extended Keyboard Dongle.

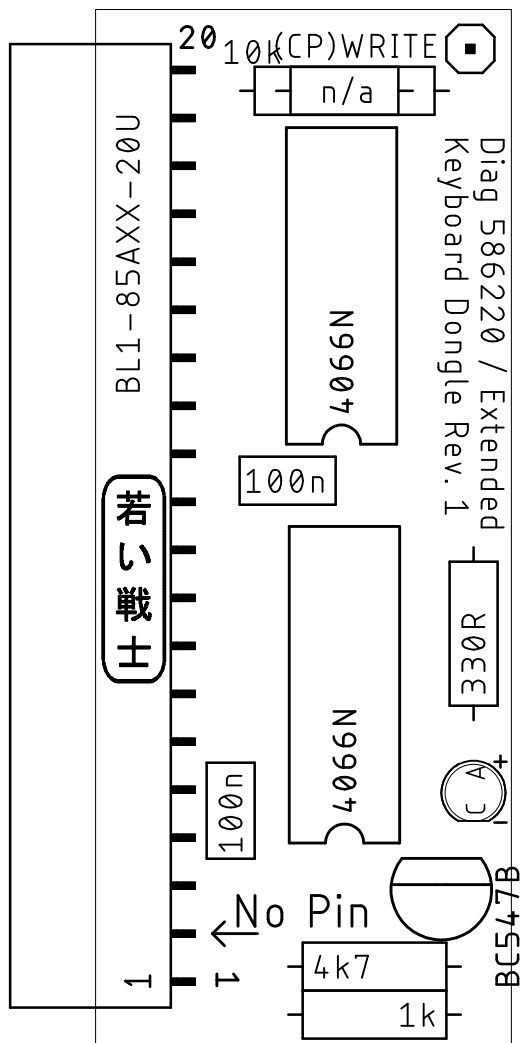
Sven Petersen 2020	Doc.-No.: 143-2-01-01	
	Cu: 35 $\mu$ m	Cu-Layers: 2
C64_Keyb-Test-ext		
11.03.2020 09:38		Rev.: 1
placement component side

R5 and R3 can be placed  
alternatively  
R5 is the left pads,  
R3 is the right pads.

In case this cable is not connected, the extended Keyboard Dongle shows a behavior, that depends on which resistor R3 or R5 is placed. In case R3 is placed, it works like a normal keyboard dongle. The analog switches are closed.

In case R5 is placed, the keyboard feedbacks are open in case J2 is not connected. The test would report keyboard "BAD" (not open, since 3 feedbacks are still present). This might be the preferred behavior, since it indicates that the test did not work properly due to a lack of WRITE signal on this dongle. The LED is switched off, too.
