Case Report

An Unusual Prepatellar Bursa Swelling: Patellar Button Dissociation and Migration

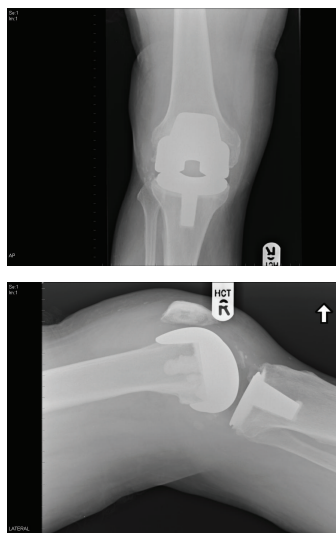
FIGURE 1: Initial operative AP and lateral radiographs of the right knee.

total knee arthroplasty 11 years previously (Figure 1) at another centre with no immediate postoperative complication reported, who presented with a prominent mobile mass over the right knee. The knee was otherwise functioning well with minimal discomfort and he had only noticed the mass for the previous 2 weeks when he felt it arise from inside the knee after a twisting motion whilst getting up. Medical history was significant for atrial fibrillation, obstructive cardiomyopathy with poor left ventricular function, previous myocardial infarction, hypertension, and a body mass index of 40. Despite these comorbidities he was able to mobilise himself indoors holding onto furniture and outside with a stick for approximately 200 yards.

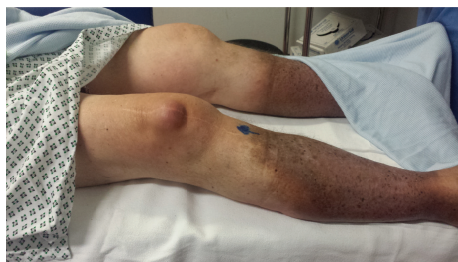
Examination demonstrated a well-healed midline scar and no effusion but a prominent swelling anterior to the patella. He had a range of motion from 5 to 100 degrees with minimal discomfort except at the end of flexion due to tightness over the patella caused by the mass with blanching of the skin (Figure 2). The swelling was mobile and smooth and after further investigation found to be the patellar button which was aseptically loose (Figure 3). Due to his significant medical comorbidities, the decision was made along with the patient, relatives, and anaesthetist that the button would be removed under local anaesthetic and a formal revision would

FIGURE 2: Clinical photo of the right knee showing a swelling anterior to the patella.

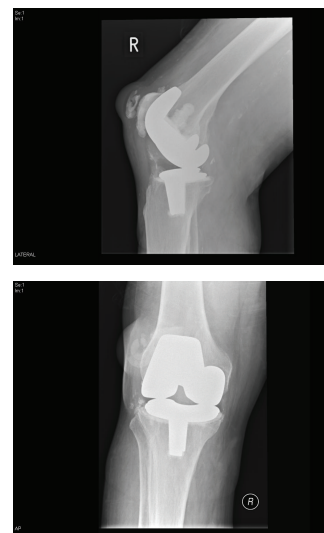
FIGURE 3: Postoperative AP and lateral radiographs of the right knee showing that the patellar button has migrated anteriorly to the patella.

Patellar button dissociation is an uncommon phenomenon, even more so when the implant migrates extra-articularly through the retinaculum and rests above the patella at the level of the prepatellar bursa [3, 4]. Reported patellar button dissociation has occurred at the level of the peg button interface and was suspected before implant retrieval on this occasion [2, 5]. The nature and path of the migration are also unusual, with the patellar button lying within the prepatellar space. Unfortunately the original operation note was not available for review, but at the time of retrieval, a defect was found in the lateral retinaculum rather than the medial side where a defect in a medial parapatellar approach repair could explain the path of the implant as described in another case

[6]. The patient described a varus deformity preoperatively and so a lateral parapatellar approach is unlikely. We hypothesised that an extensive lateral release may have provided the opening for the implant to migrate through the soft tissues.

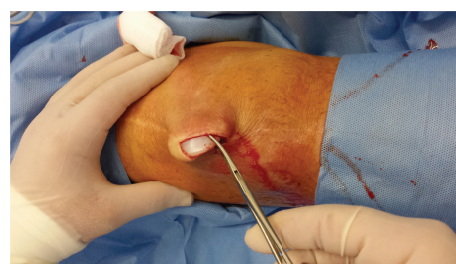
FIGURE 4: Intraoperative photo demonstrating the patellar button superficial to the patella.

not be undertaken at this point (Figure 4). Postoperatively he made an uneventful recovery and was back to his pre-morbid mobility at the 6-month review.

Inspection of the implant found that the single peg was intact and no fracture at the stem-button interface was seen. The cement mantle was shown to have a good imprint of the prepared patella surface indicating good preparation and pressurisation at the time of implantation.
