DTC	RrACSW, FACE	Rear Room Temperature Sensor Circuit
-----	--------------	--------------------------------------

CIRCUIT DESCRIPTION

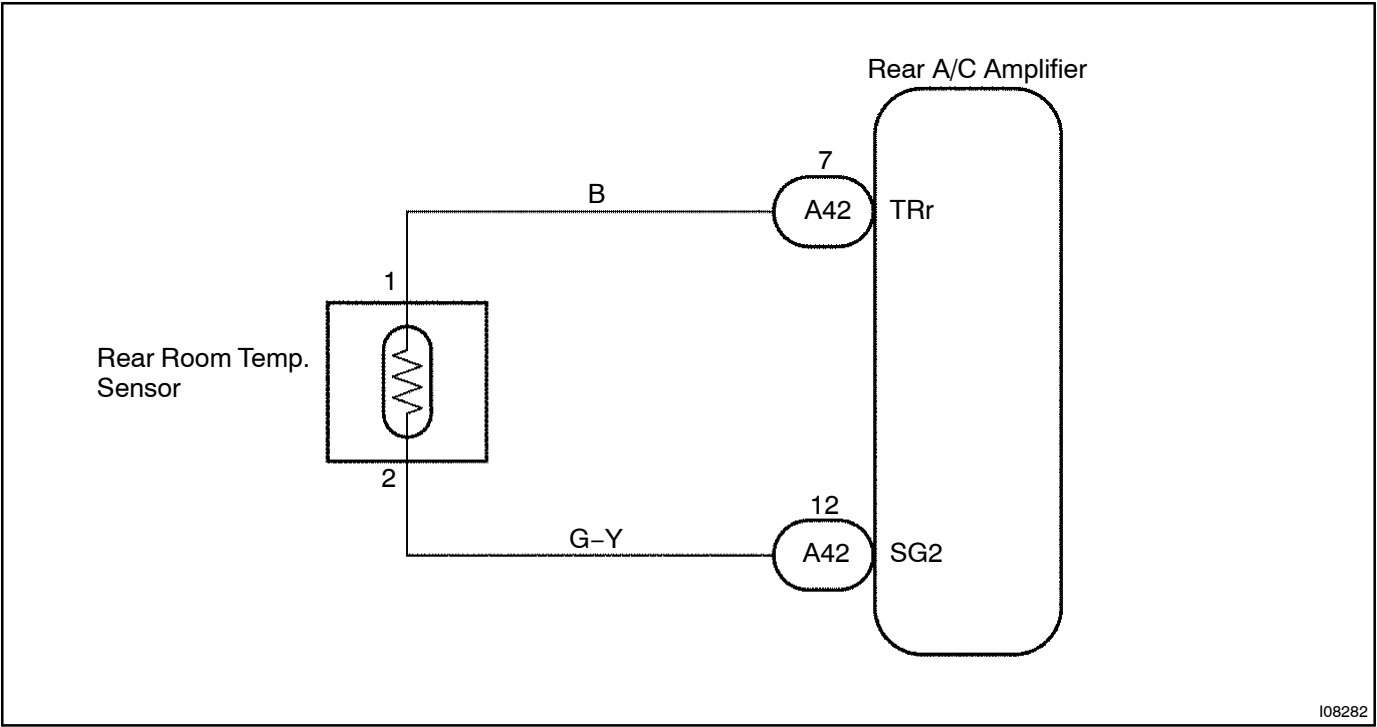
WIRING DIAGRAM

This sensor detects the temperature inside the cabin and sends the appropriate signals to the A/C amplifier.

Blinking light	Detection Item	Trouble Area
RrACSW FACE	Open or short in rear room temperature sensor circuit.	<ul style="list-style-type: none"><li>• Rear room temperature sensor.</li><li>• Harness or connector between rear room temperature sensor and A/C amplifier.</li><li>• Rear A/C amplifier.</li></ul>

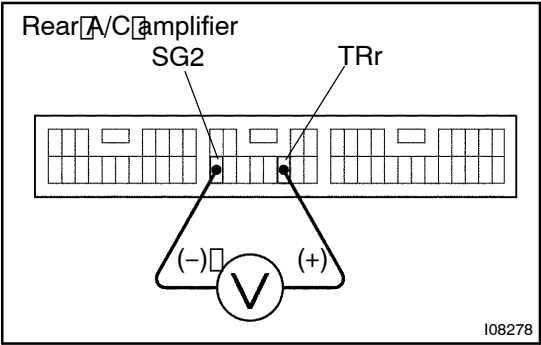
1	Check voltage between terminals TRr and SG2 of A/C amplifier connector.
---	---

- Turn ignition switch ON.
- Measure voltage between terminals TRr and SG2 of rear A/C amplifier connector at each temperature.

at 25°C (77°F) 1.8 - 2.2V

at 40°C (104°F) 1.2 - 1.6V

As the temperature increases, the voltage decreases.
