Installation Monitoring Report

Date: May 13, 2025

Project	NW 2050 Cypress Point	Job Number	24064	RGC Number	N/A
Address	7511, 7531, 7651 Minoru Boulevard Richmond, B.C.	Inspector	Matthew	Report Number	04
		Weather	Sun / 15°C	Time	4:00pm
Contractor	Flynn Canada Ltd.	Crew Size	8	Red Seal	3
				Apprentices	5

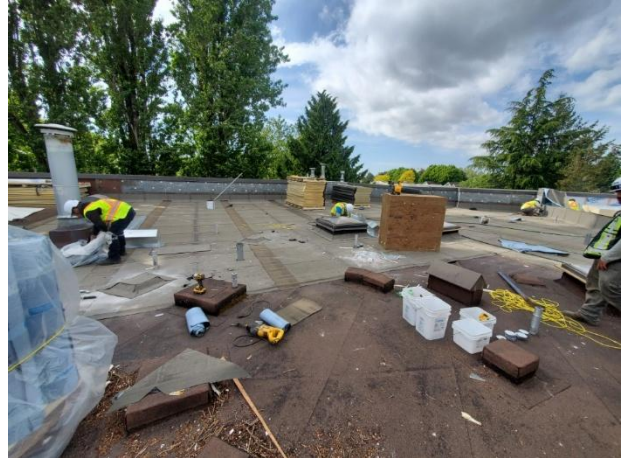
4.1 **Building B**

The crew moved the application of the 2n1 smart board to the South section of the main roof.

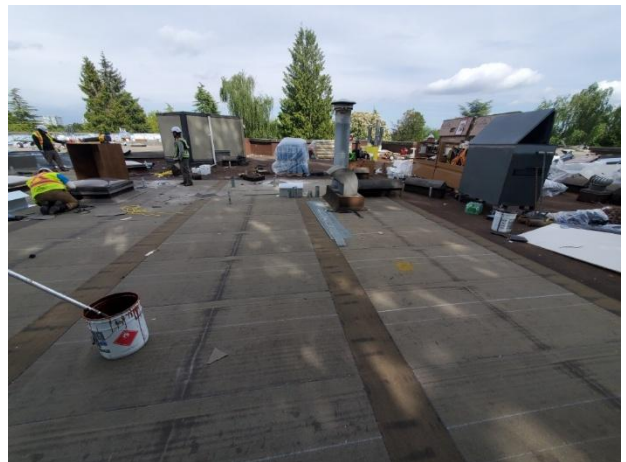
4.2 **Building B**

Overlay board is laid out in a uniform manner, secured with 2" barded seam plates / 2" #14 dek screws and end joints covered with a 12" lap joint detail. This is acceptable.

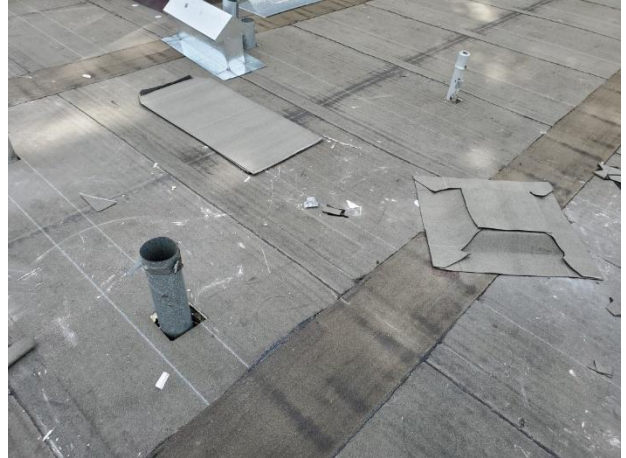
4.4 **Building B**

Protrusions and curb details are in progress of being roofed in with Sopraply Stick DUO base membrane and appropriated flashing.

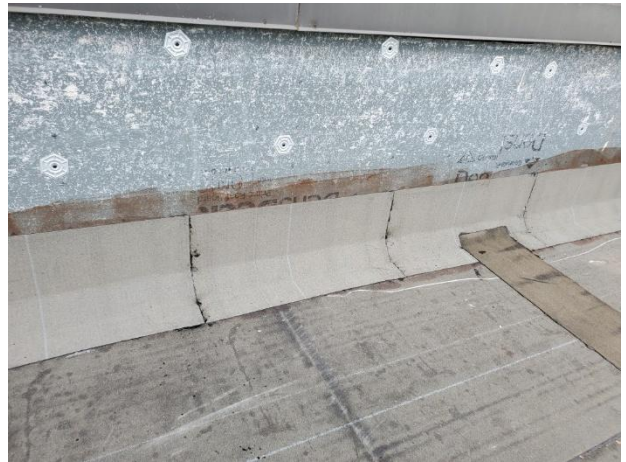
4.5 **Building B**

The independent base stripping is rolled in to acceptable primed surfaces and seams heat welded closed.

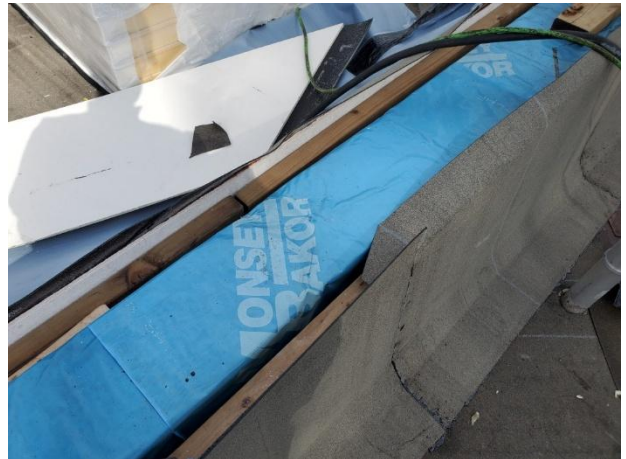
4.6 **Building B**

Build up on either side of the fire wall is acceptable.

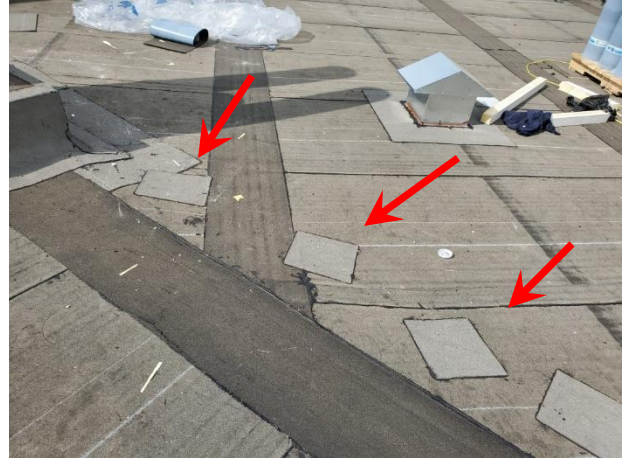
4.7 **Building B**

Additional screws and plates are being applied to remove any smartboard deflection. Base patches over top are acceptable.

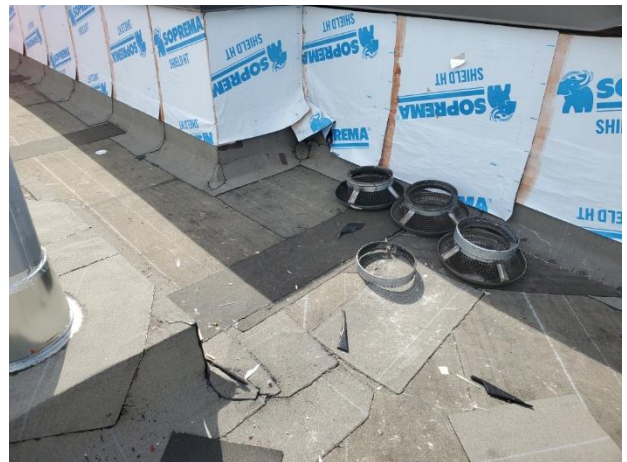
4.8 **Building B**

Gussets are in process of being applied to the corners of the base stripping as required.

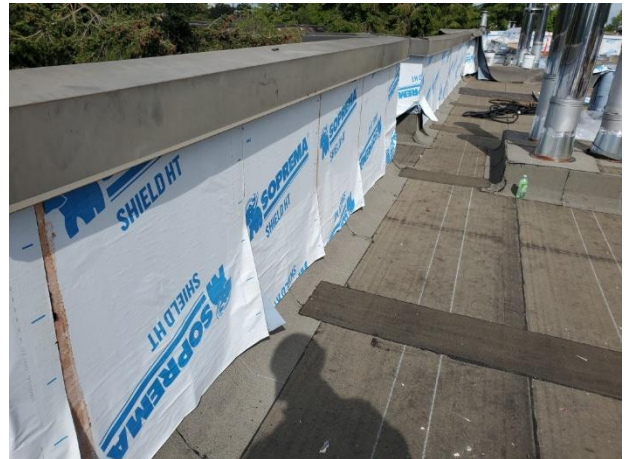
4.9 **Building B**

The HT SA membrane to the parapet walls is acceptable, crew have left the bottom section loose to allow cap membrane strip to be applied. This is acceptable.

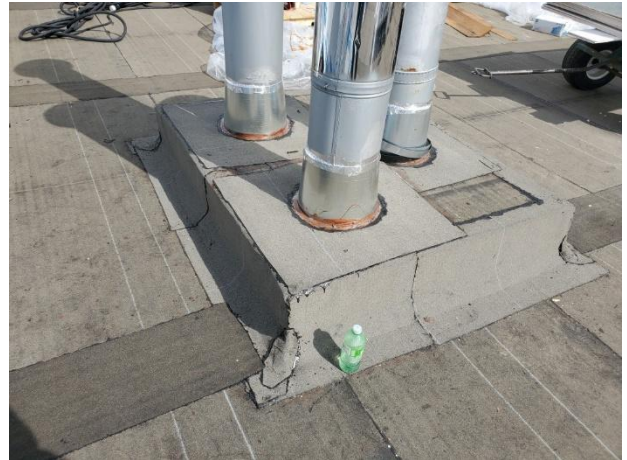
4.10 **Building B**

The membrane detailing to the multiple protrusion details is acceptable.

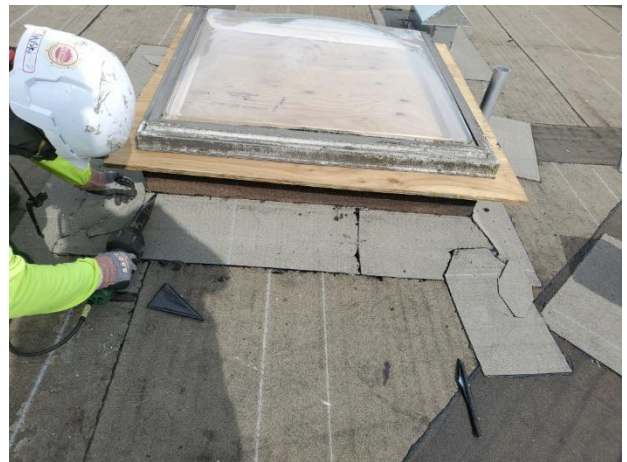
4.11 **Building B**

Temporary nighttime seals applied to the skylight curbs, the older roof membrane still to be removed from this detail.
