A.10 Haiti - 2010 - Earthquake

Case study:

The project targeted displaced disabled people in rural locations in the south of Haiti. The project used a participatory approach to build durable shelters. The project re-engineered a well known traditional technique known as *clissade* making it more durable, suitable for mass assembly and later upgrade by beneficiaries.

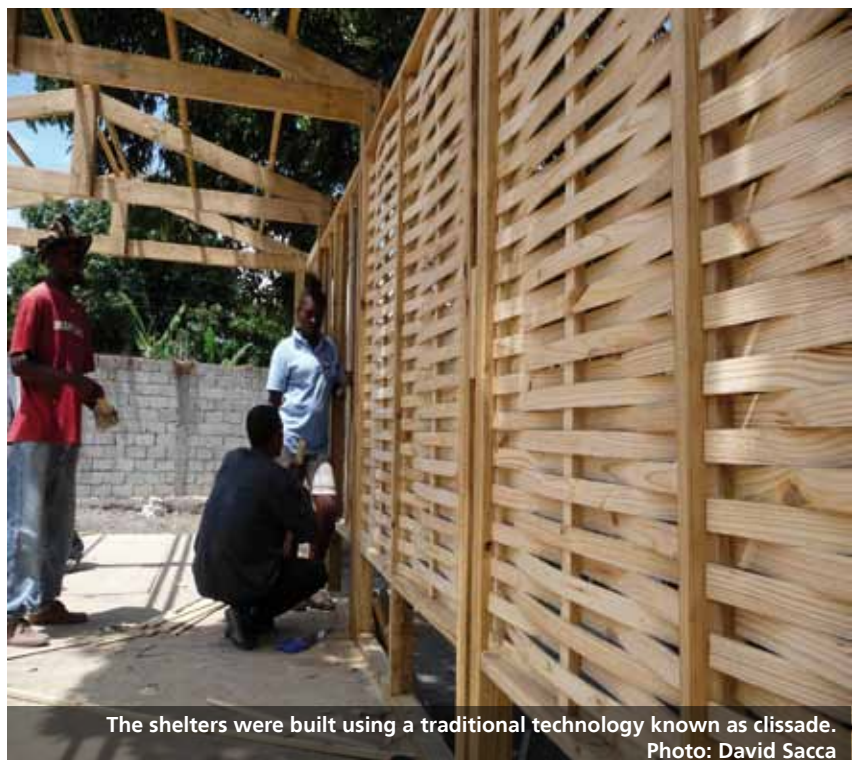
The shelters were built using a traditional technology known as *clissade*.
Photo: David Sacca

Before the earthquake, the majority of Haitian families who lived in rural areas lived in self-built houses. Many were built using *clissade*, a Haitian technique of weaving bars of palm wood to make walls. These walls were later covered by mud and cement. The roof was covered with corrugated zinc.

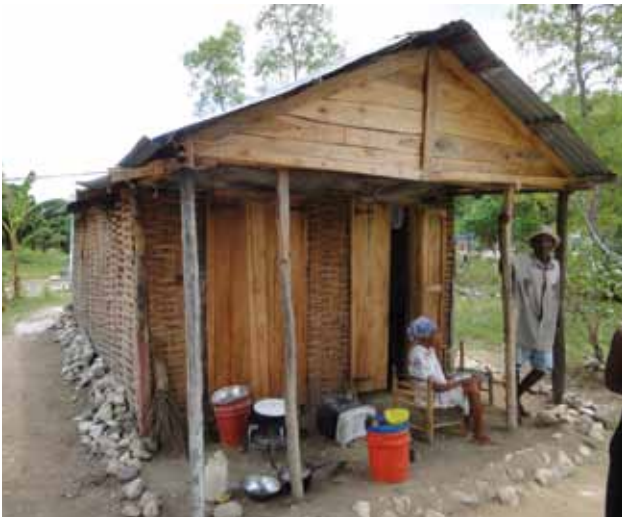
A traditional shelter that survived the earthquake.
Photo: Joseph Ashmore

In general, the *clissade* houses resisted the earthquake much better than the concrete houses. Where they were damaged in the earthquake, the injuries to the occupants were not as severe as those caused by collapsing concrete houses.

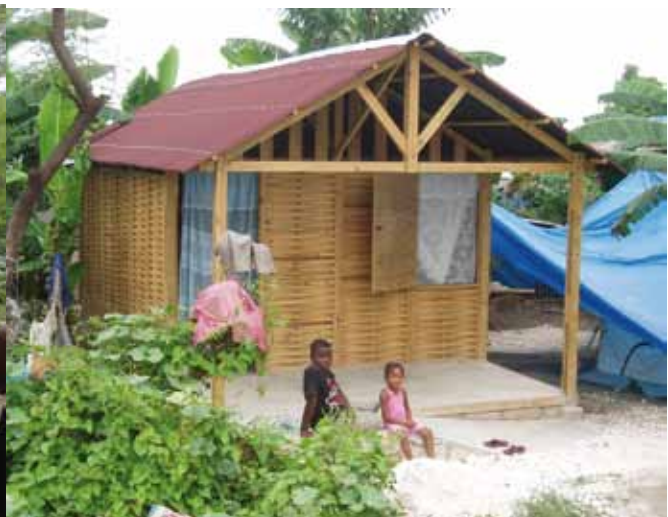
A completed shelter, based on vernacular styles.
Photo: David Sacca
