# **PIPE CRACK DETECTION IN CIVIL STRUCTURES**

A Thesis submitted to the faculty of  
San Francisco State University  
In partial fulfillment of  
the requirements for  
the Degree

Engineering: Structural/Earthquake Engineering

December 2022

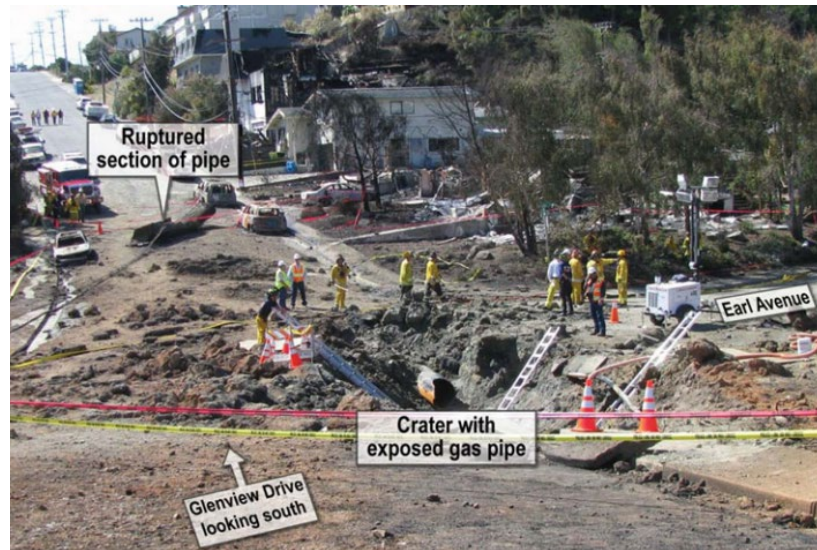
**Figure 1 - San Bruno pipe rupture [3].**

In the fall of 2010 a Pacific Gas & Electric Company's natural gas transmission pipeline ruptured in San Bruno California. This pipeline rupture unfortunately caused severe damage as it killed eight people, caused multiple injuries, and destroyed 38 homes . Figure 1 shows the damage [3]. The magnitude of severity of this prompted for the National Transportation Safety Board (NTSB) to come out to investigate to further determine the roots of this system failure. They took a 28-ft section of the ruptured pipe along with the exposed ends of the pipe still underground were sent to the NTSB Materials Laboratory in Washington, D.C., for examination [3].

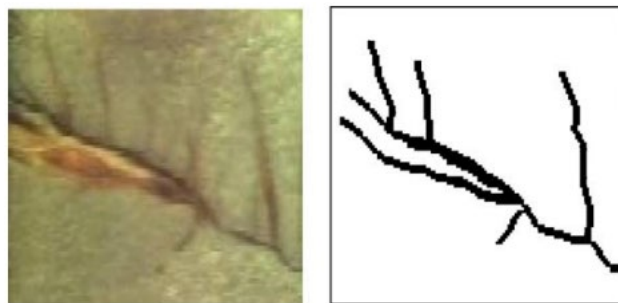
**Figure 8 - Original and Processed Images: Branch Cracks [8]**

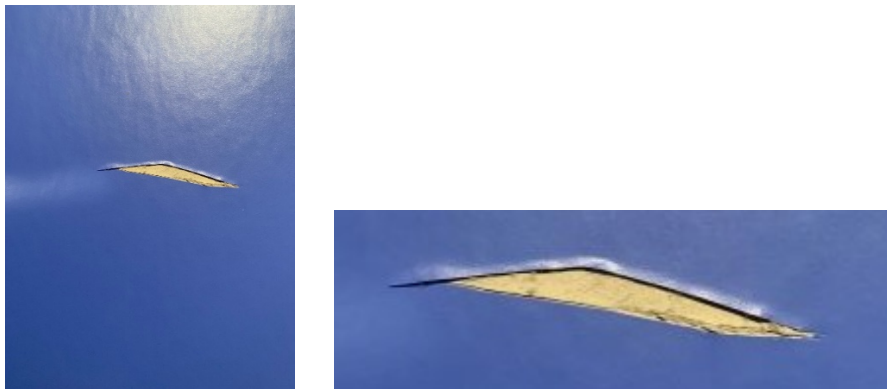
**Figure 19 – Binder image (a) original image, (b) cropped image**

Since the PVC pipe image was the first image that was evaluated and mixed results were obtained, a secondary object was used for observation and experimentation. The program needed to be verified for its effectiveness before proceeding on the data set of images. Therefore, a plastic binder was used with the idea an image of truly flat surface could be captured using the camera available. Any curvatures in the pipe when the image was being captured using the camera available for the experiment could have potentially been causing some of the error experienced in the PVC pipe images. A higher quality camera could have the ability to incorporate any curvature to images of pipe walls. The plastic binder image represented something closer to a concrete or wood shear wall in which a flat surface is being captured for observation.

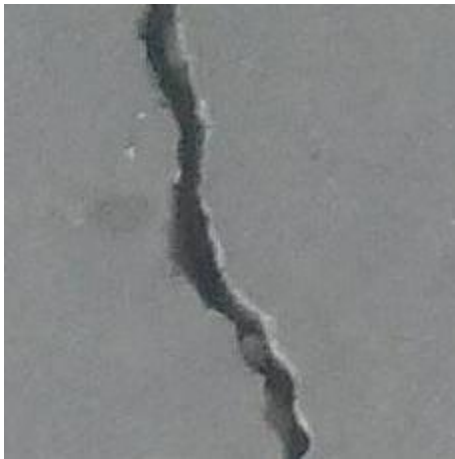
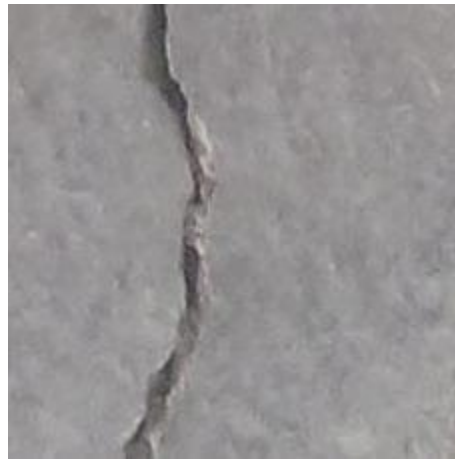
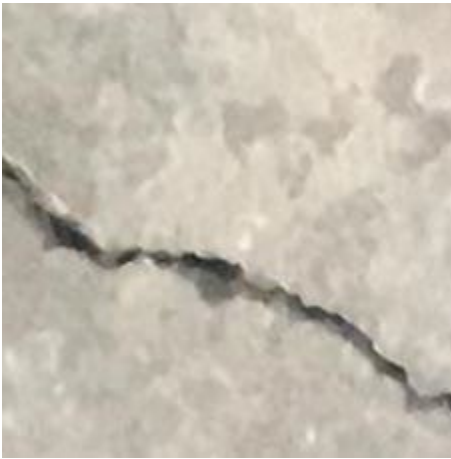
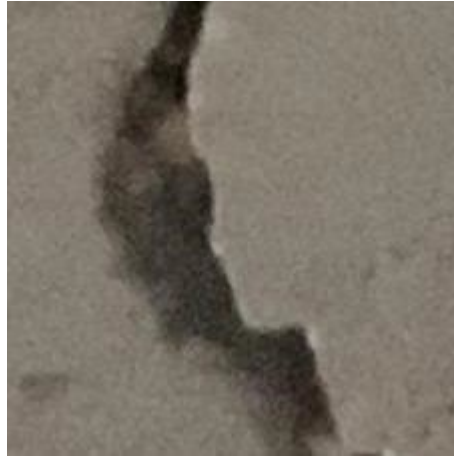
**Figure 22 - Data set of images used. (a) Image 00001, (b) Image 00026, (c) 00007, (d) Image 00068.**

The first image processed is labeled “00001” and the features, of this image has a crack running north-south within the image and with average crack size width relative to the rest of the data set. Unlike the controlled images, the crack size is unknown beforehand and could not be checked with a measuring device. This first image faced similar constraints with the thresholding value used within the non-max suppression portion of the program. If the threshold value was too small the crack would be identified however the edges of the crack would lose their definition, so they were no longer clearer marked. If the threshold value was increased the edges of the crack would be clearly identified. However due to the depth of the crack has a darker shade or darker pixels, when processed through this part of the program the area of the crack in which the pixels were at their darkest then when processed this area would be blurred. This meant that the program would not recognize it as part of the crack since it was far away from the edge.
