# **Final Grant Report**

## **Lower Spring Branch Creek and Suisun Hill Hollow Restoration Project**

### **Rush Ranch Open Space Preserve**

**Delta Water Quality and Ecosystem Restoration Program  
Grant Agreement P1596027**

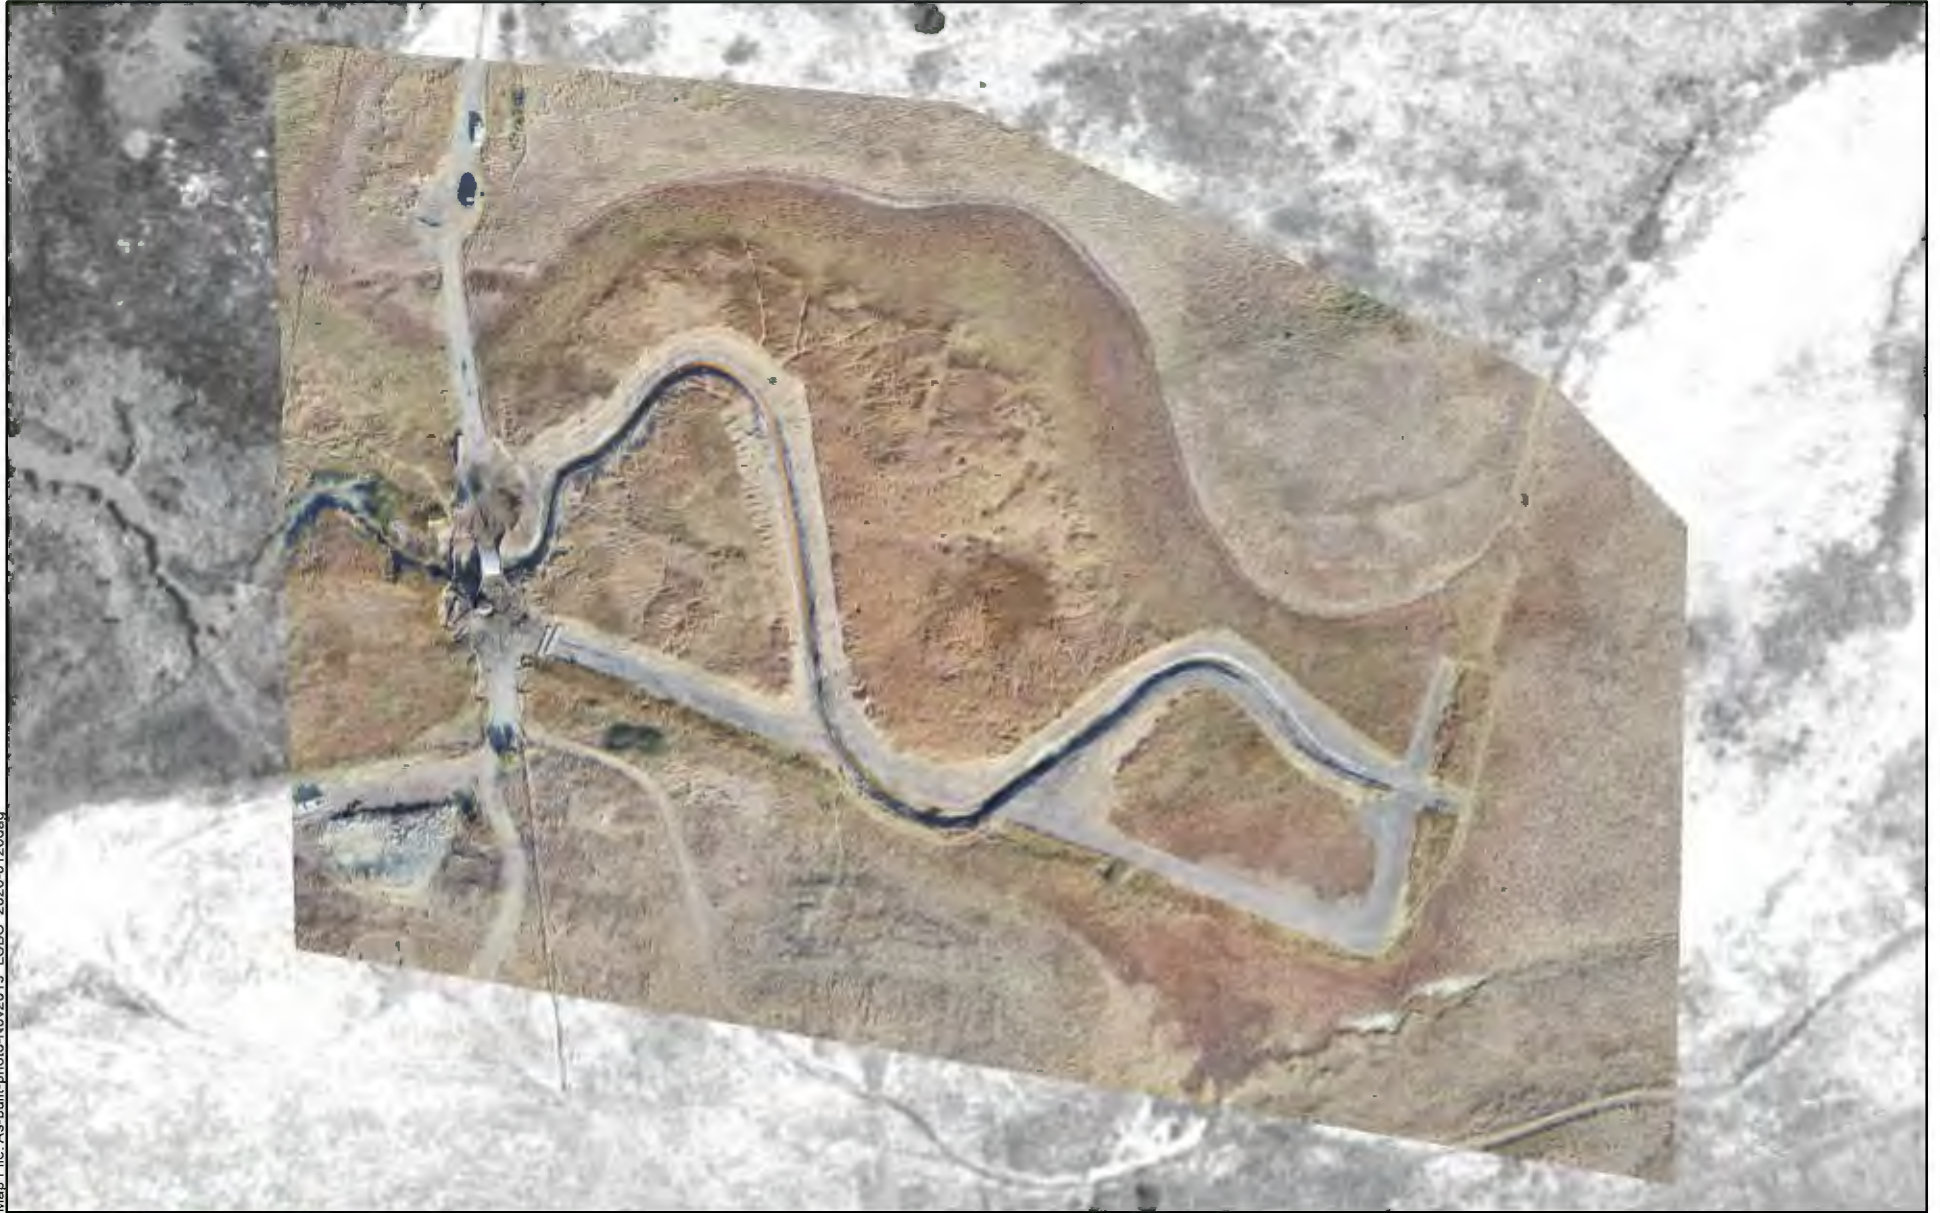
**Figure 7**  
**November 15, 2019 UAV Photograph - LSBC**

For LSBC, qualitative observations of the outcomes following completion of restoration suggest the design and its construction worked very well. Tides are flowing unconstrained through the new arch culvert and up the newly constructed channel and the higher high tides are inundating the marsh plain including the lowered L-berm area.

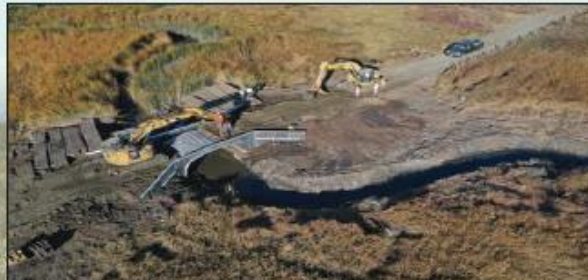
Aerial of Lower Spring Branch Creek during construction of new channel and arch culvert Photo Credit Moss Bishop

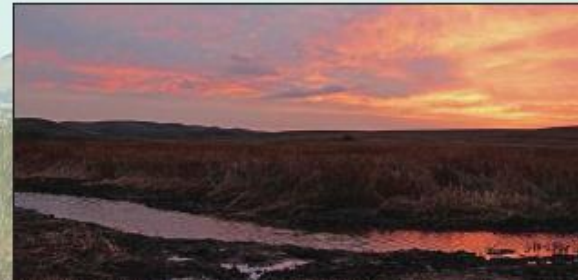
Early morning view of newly constructed tidal channel of Lower Spring Branch Creek Photo Credit Tom Mushelson
