SERVICE PROCEDURE

**G-07501-R2
AUGUST 2007**

**SUBJECT: SAFETY RECALL (U.S., EXPORT)
BATTERY CABLES on certain 9000 Models built
4/1/2002 thru 12/25/2006 with Caterpillar® Engines**

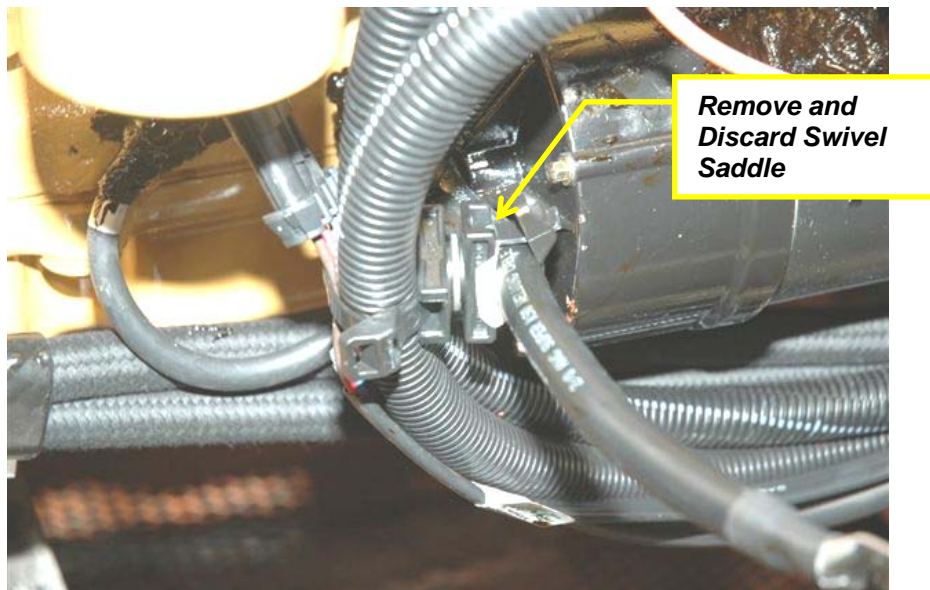
Figure 1

3. Remove swivel saddle clamp from between forward loop of positive cables, and frame ground cable.

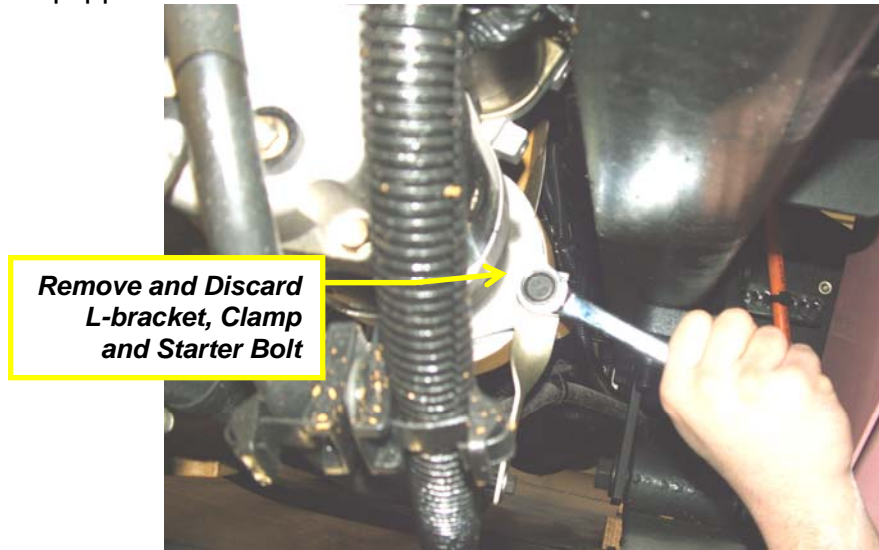
Figure 2

4. Remove and discard starter L-bracket, clamp and 12-point starter bolt, if equipped.

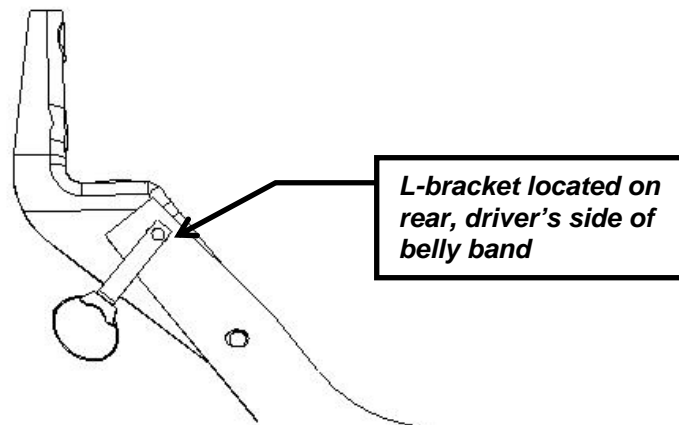
5. If vehicle was built with feature code **001GTC** - *CROSSMEMBER, FRAME TIE Deep Drop; Mounted Between Front Cab Mounting Brackets*, also referred to as a 'belly band,' remove and discard the L-bracket and clamp connected to the rear of the belly band.

Figure 3 – Belly Band Looking Forward

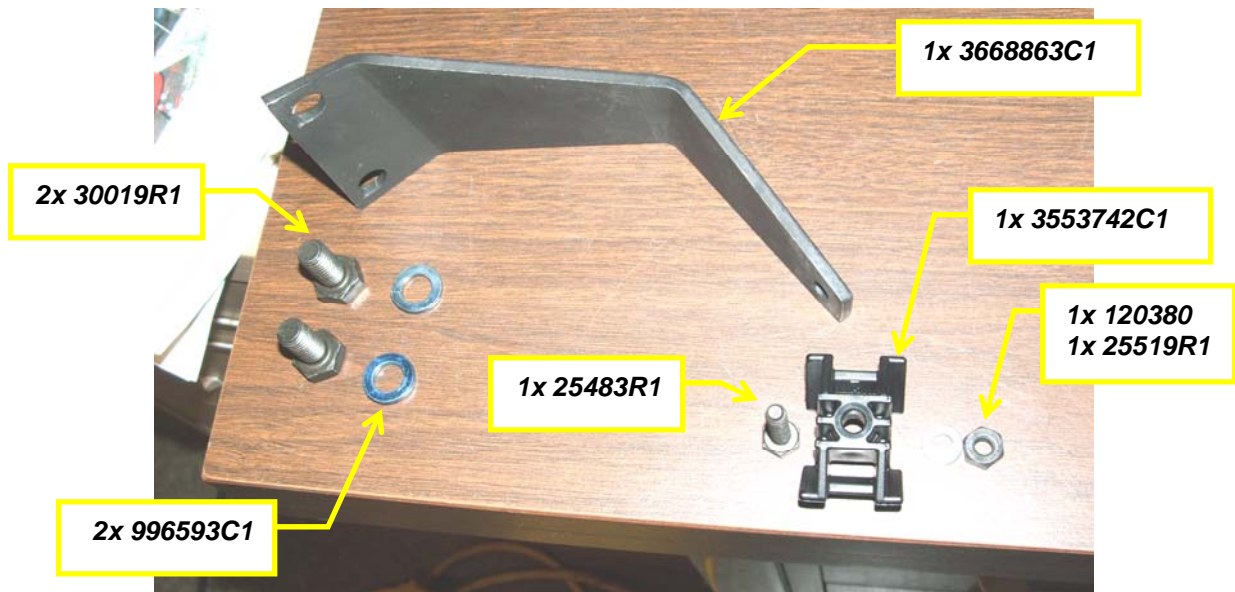
7. Install the forward engine block mounting bracket.

Figure 4a – Forward Engine Block Mounting Bracket Parts.

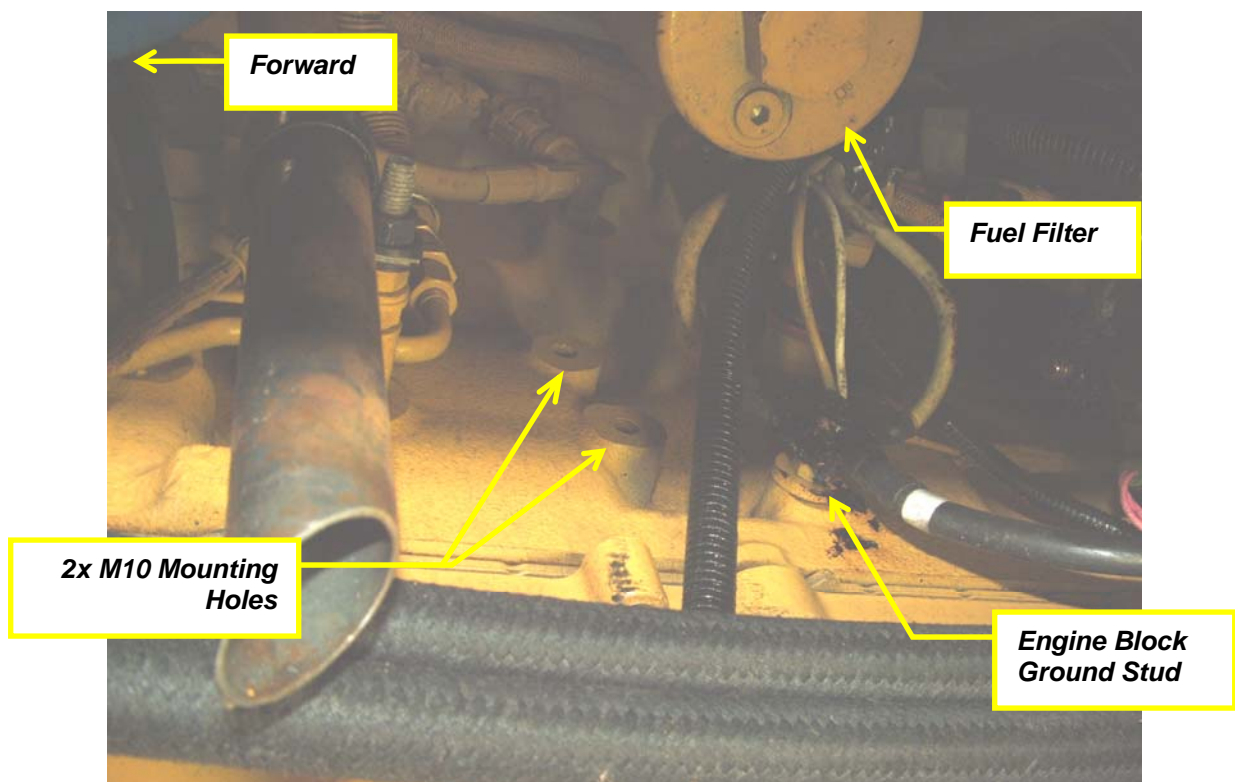
Figure 4b – Mounting Holes in Engine Block -- View from Below

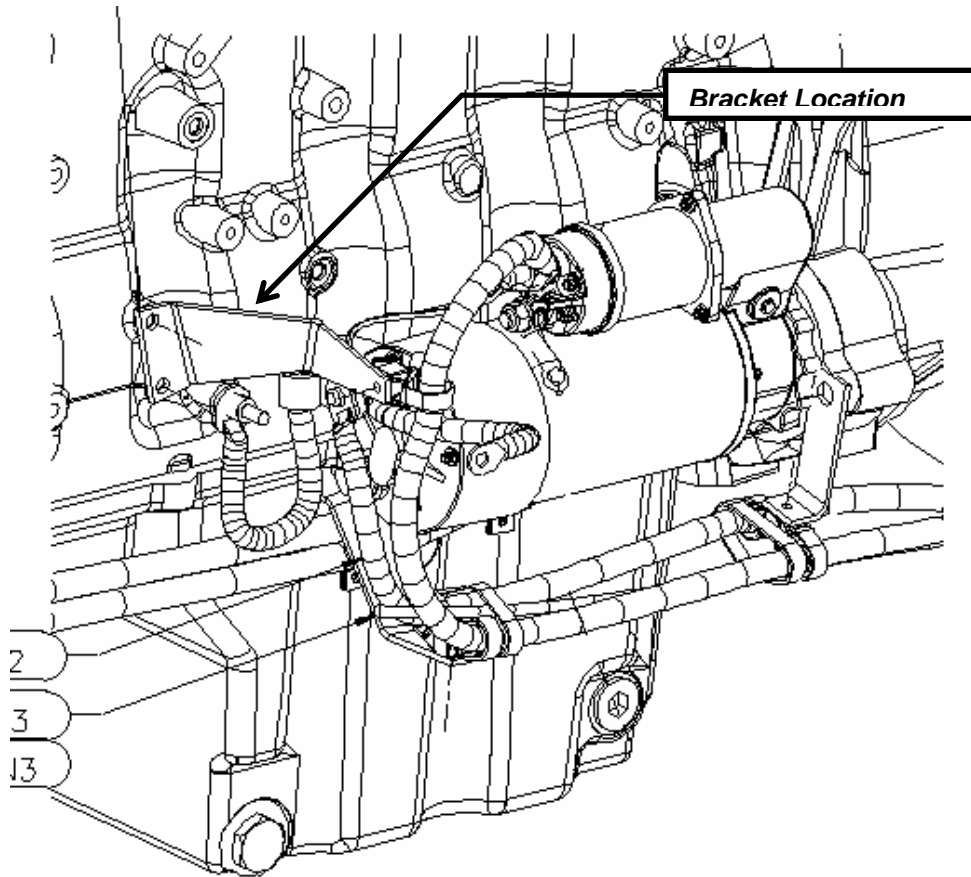
Figure 4c – Frame Rail Removed for Clarification

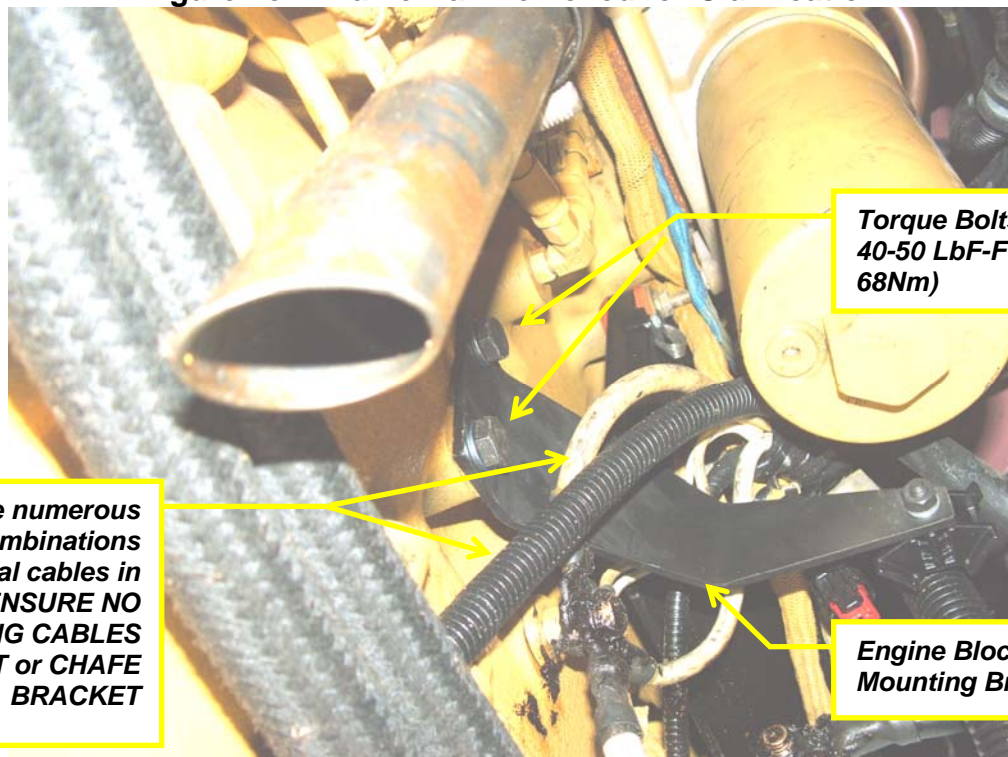
Figure 4d – In Vehicle

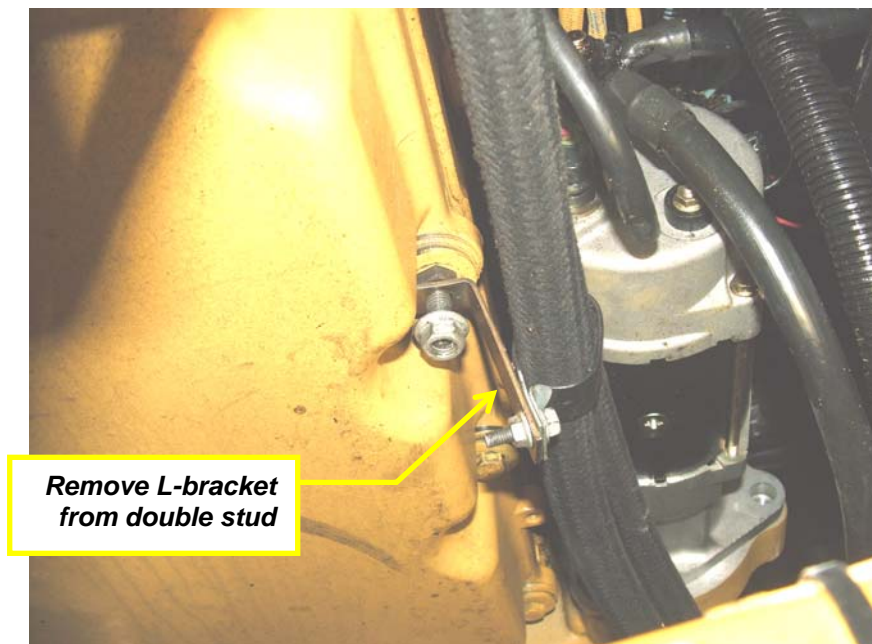
Figure 5

8. Remove the transmission oil cooler hose L-bracket from the oil pan double stud bolt.

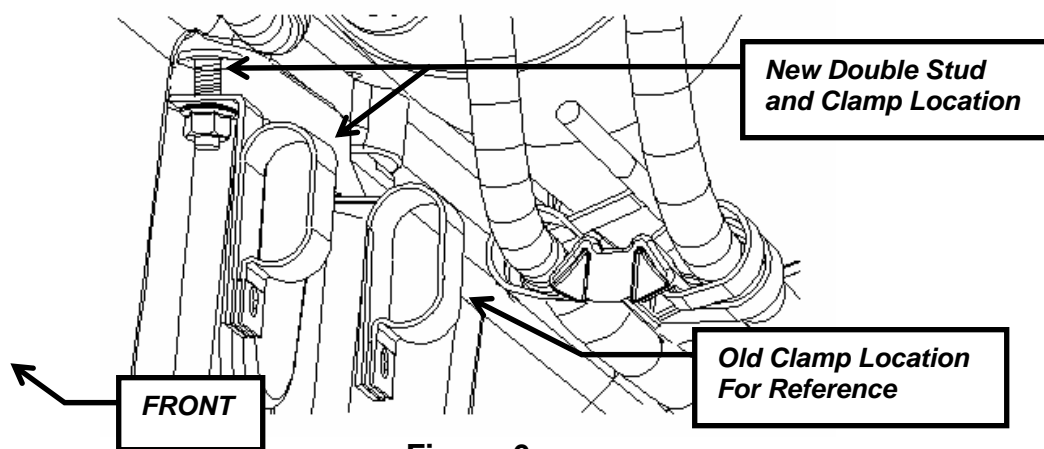
Figure 6

9. **For C10/C12, skip to step 10.** Remove the double stud bolt from the oil pan. Replace with new double stud bolt, reuse existing spacers (washers). Torque new double stud bolt to **33-48 LbF-Ft (45-65Nm)**.
10. Loosen transmission oil cooler hose clamp and slide **FORWARD** to the next oil pan bolt.

11. Remove oil pan bolt and replace with second new double stud bolt. Torque second new double stud bolt to **33-48 LbF-Ft (45-65Nm)**. – Do not install L-bracket on new double stud at this time.

NOTE: For C10/12, install washer/spacer between oil pan and existing stud spacers. Ensure stud is not bottoming out against block before moving on to step 12.

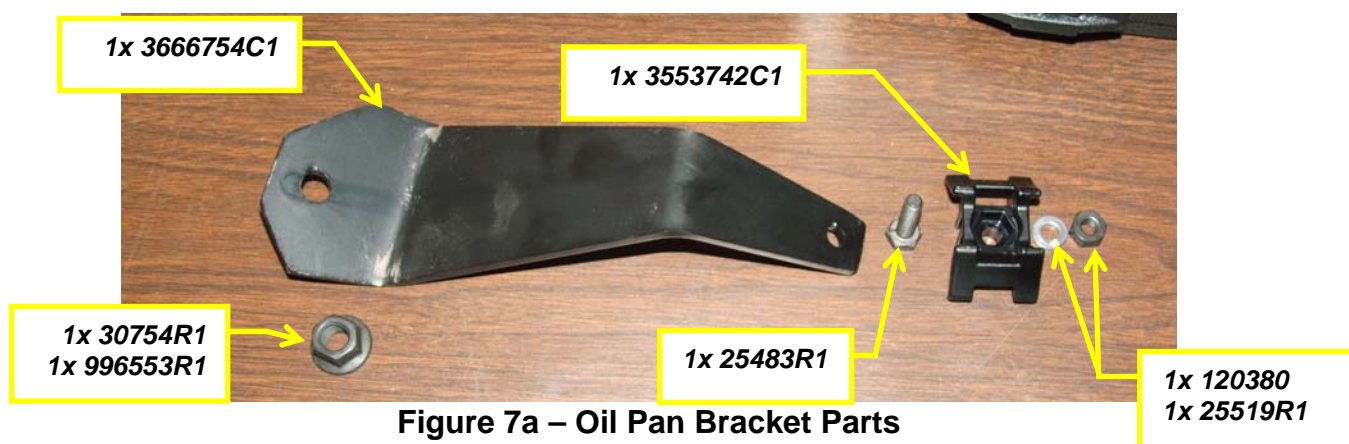
12. Install oil pan rail mounting bracket.

Figure 7a – Oil Pan Bracket Parts

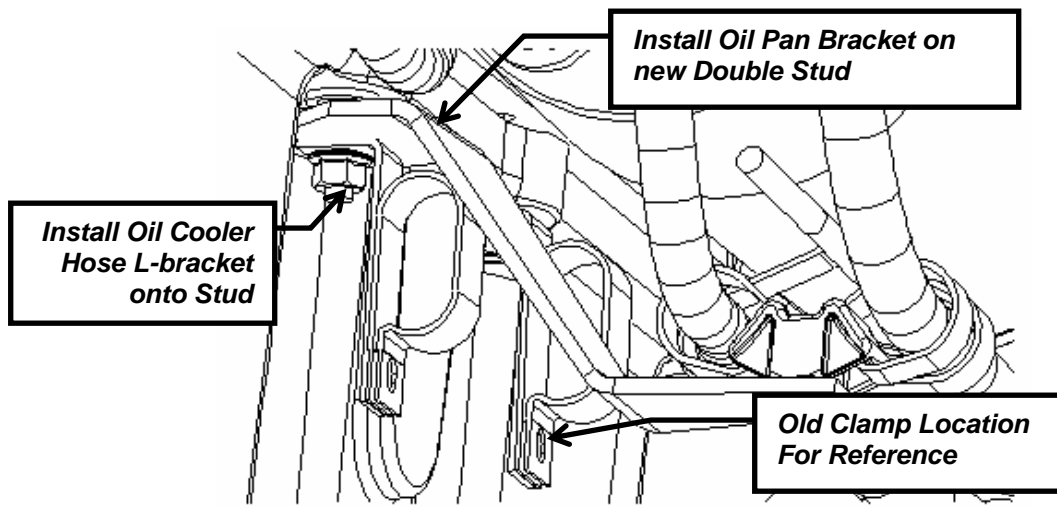
Figure 7b – Frame Rail Removed for Clarification

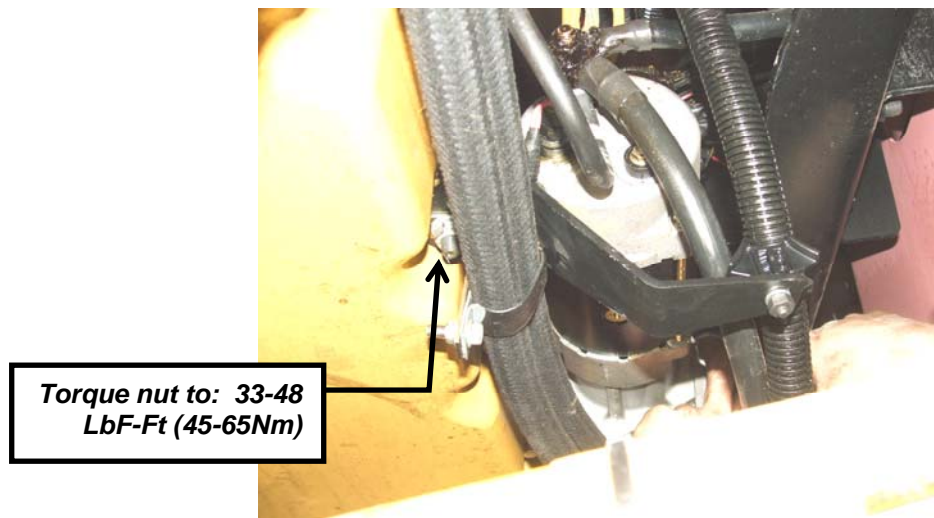
Figure 7c – In Vehicle

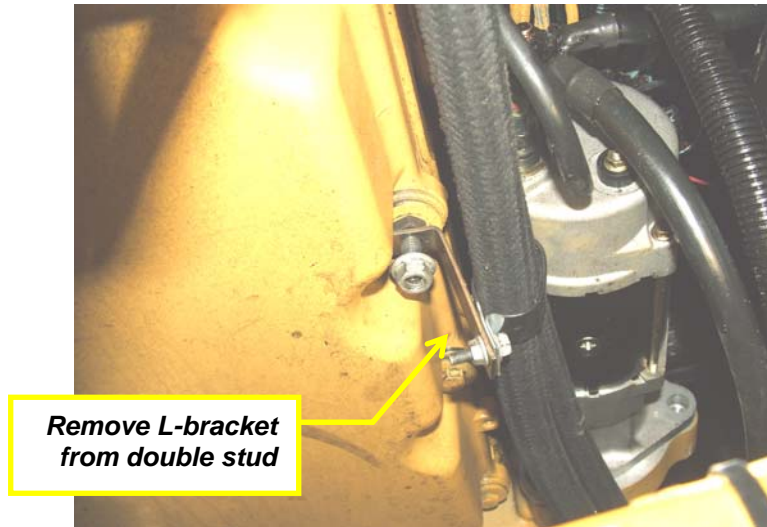
Figure 8

13. Remove the transmission oil cooler hose L-bracket from the oil pan double stud bolt.

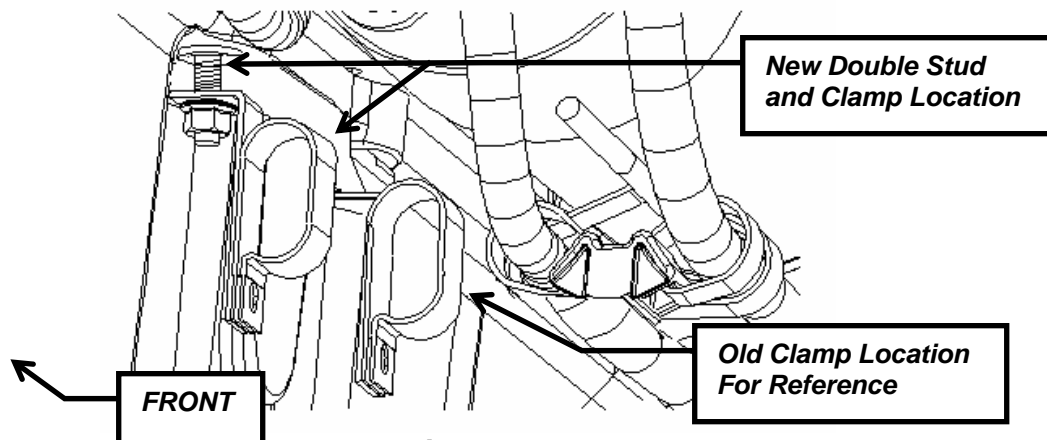
Figure 9

14. Remove the double stud bolt from the oil pan. Replace with new double stud bolt, reuse existing spacers (washers). Torque new double stud bolt to **28-41 LbF-Ft (38-56Nm)**.
15. Loosen transmission oil cooler hose clamp and slide **FORWARD** to the next oil pan bolt.
16. Remove oil pan bolt and replace with second new double stud bolt. Torque second new double stud bolt to **28-41 LbF-Ft (38-56Nm)**. – Do not install L-bracket on new double stud at this time.

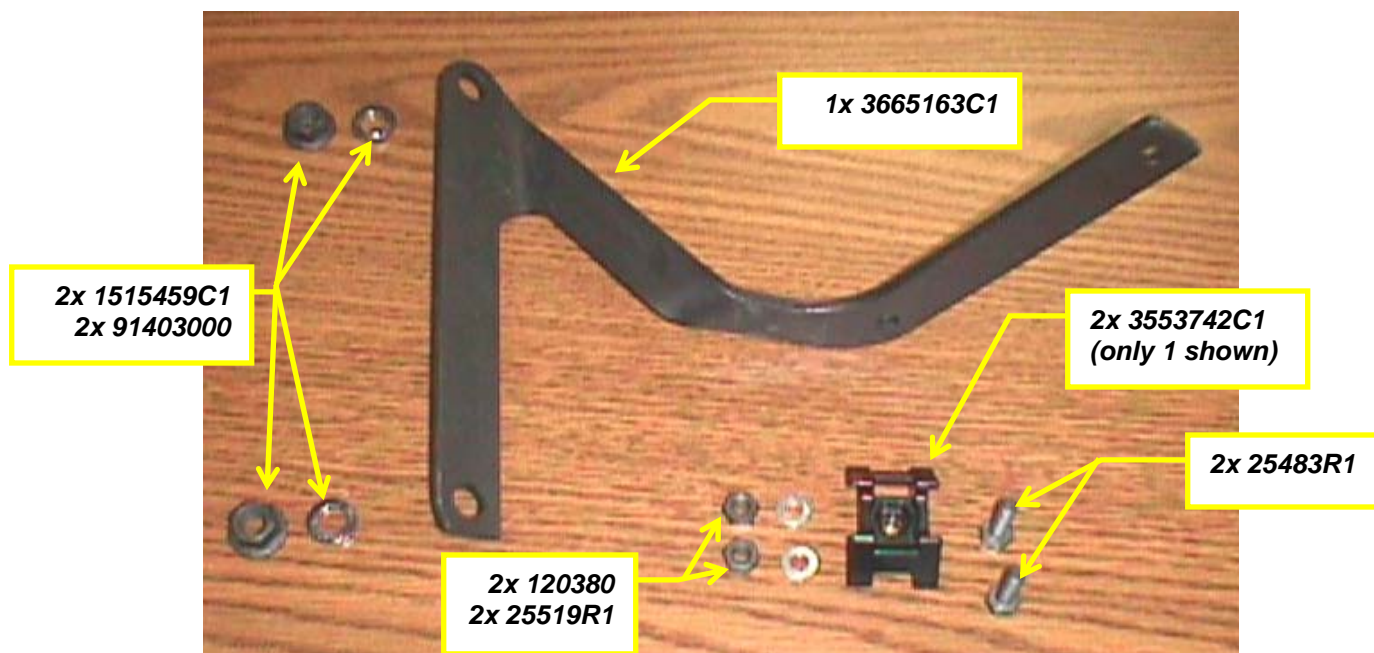
17. The C15 and C16 engine uses a single combination bracket in place of the C10, C11, C12, & C13's engine block *and* Oil Pan mounting Bracket.

18. Install Single Forward Mounting Bracket (C15/C16 only).

Figure 10a – Combination Bracket Parts

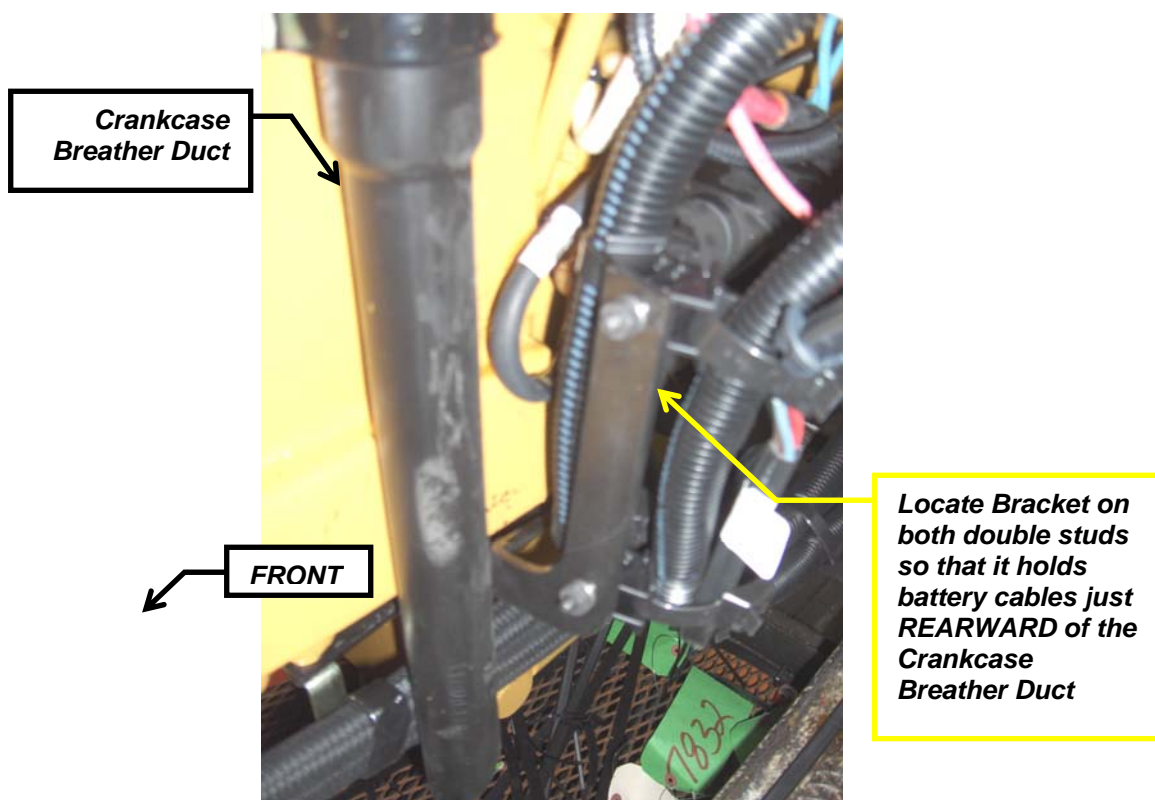
Figure 10b – Locate Bracket Rearward of Breather

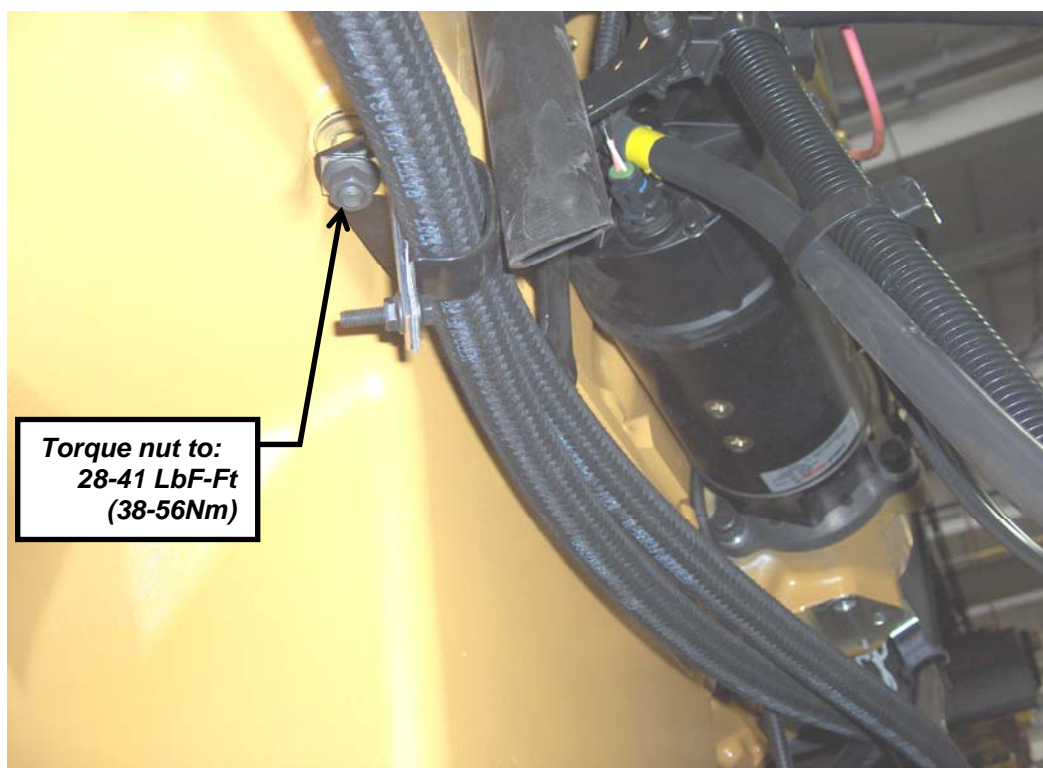
Figure 10c – In Vehicle – Oil Cooler Hose L-bracket Location

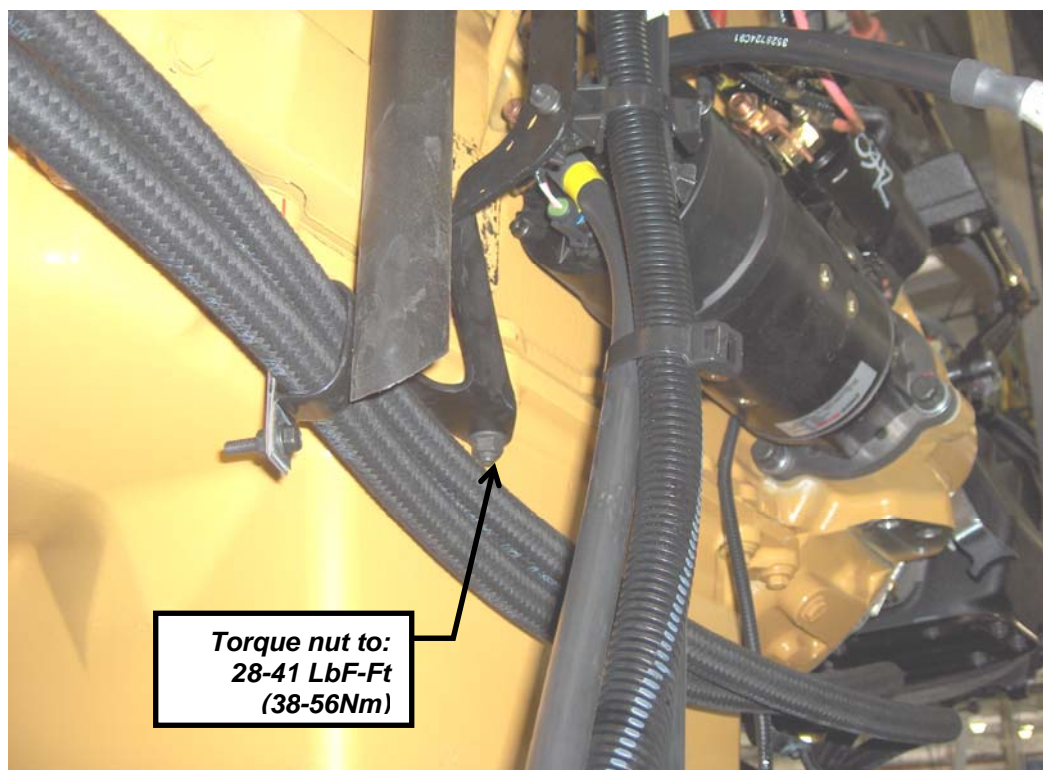
Figure 10d – In Vehicle – Frame Rail Removed for Clarity

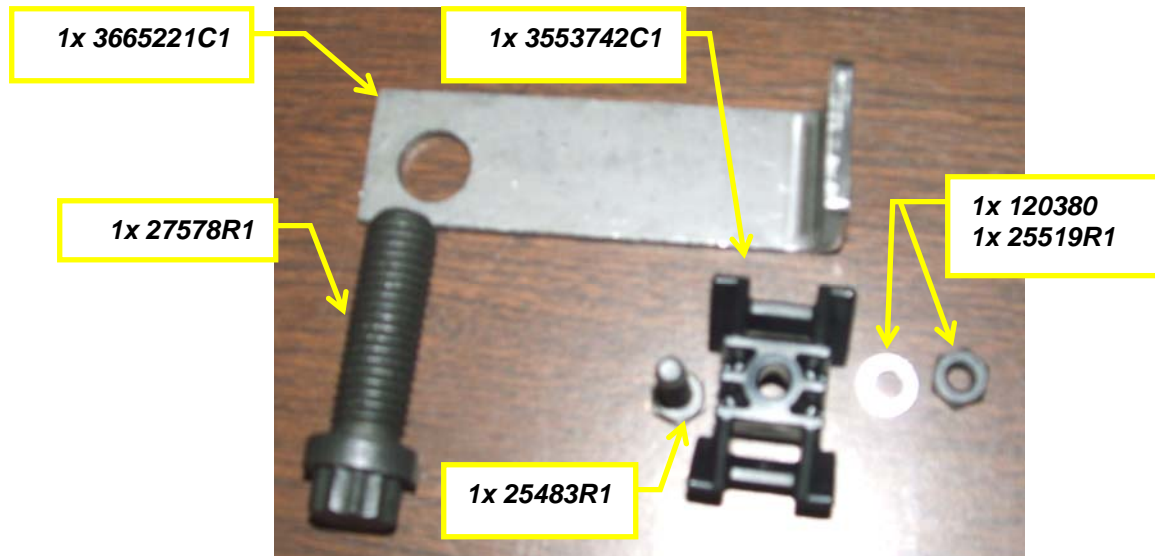
19. Install the starter mounting L-bracket.

Figure 11a – Starter Mounting L-bracket Parts

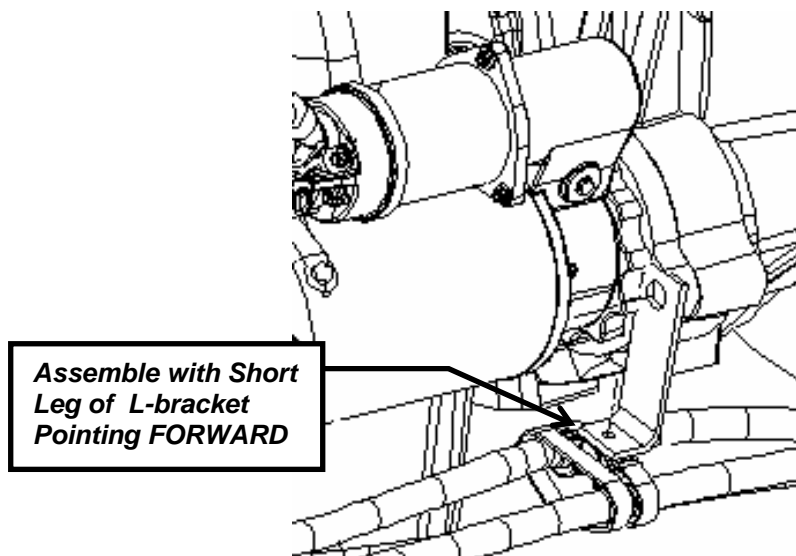
Figure 11b – Frame Rail Removed for Clarification

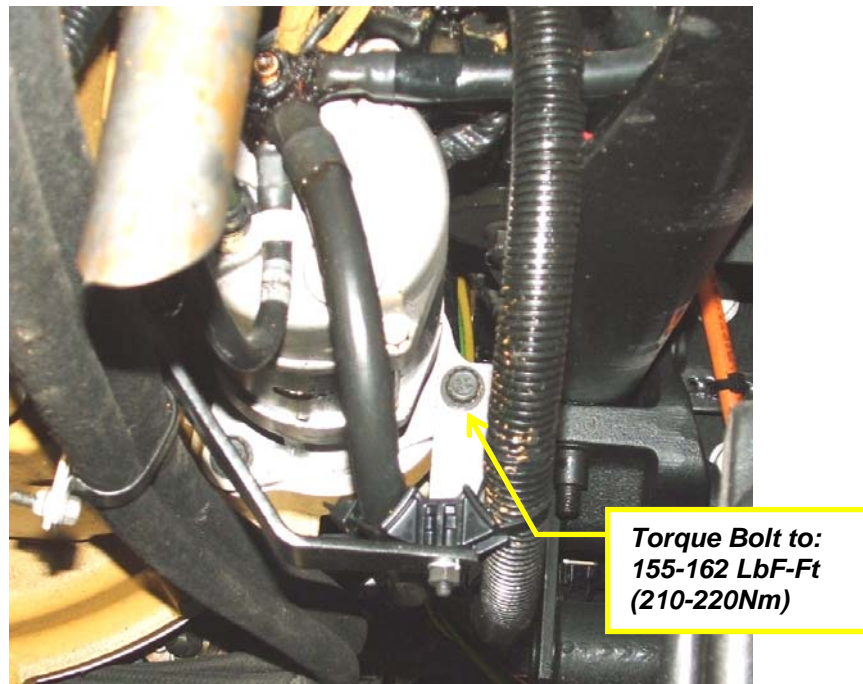
Figure 11c – In Vehicle

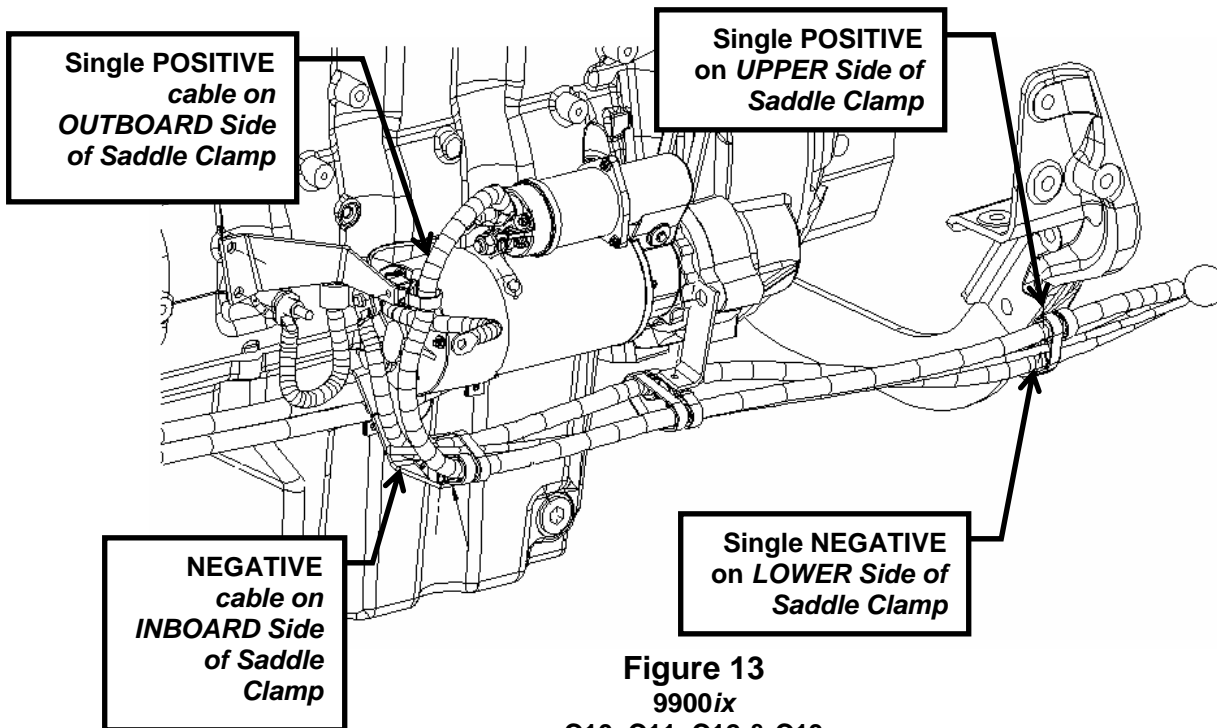
Figure 13
 9900ix
 C10, C11, C12 & C13
 Under CAB Battery Box and Belly Band

21. Based on the vehicle configurations listed below in Table 1, refer to the following figures for the proper routing of the forward section of battery cables.

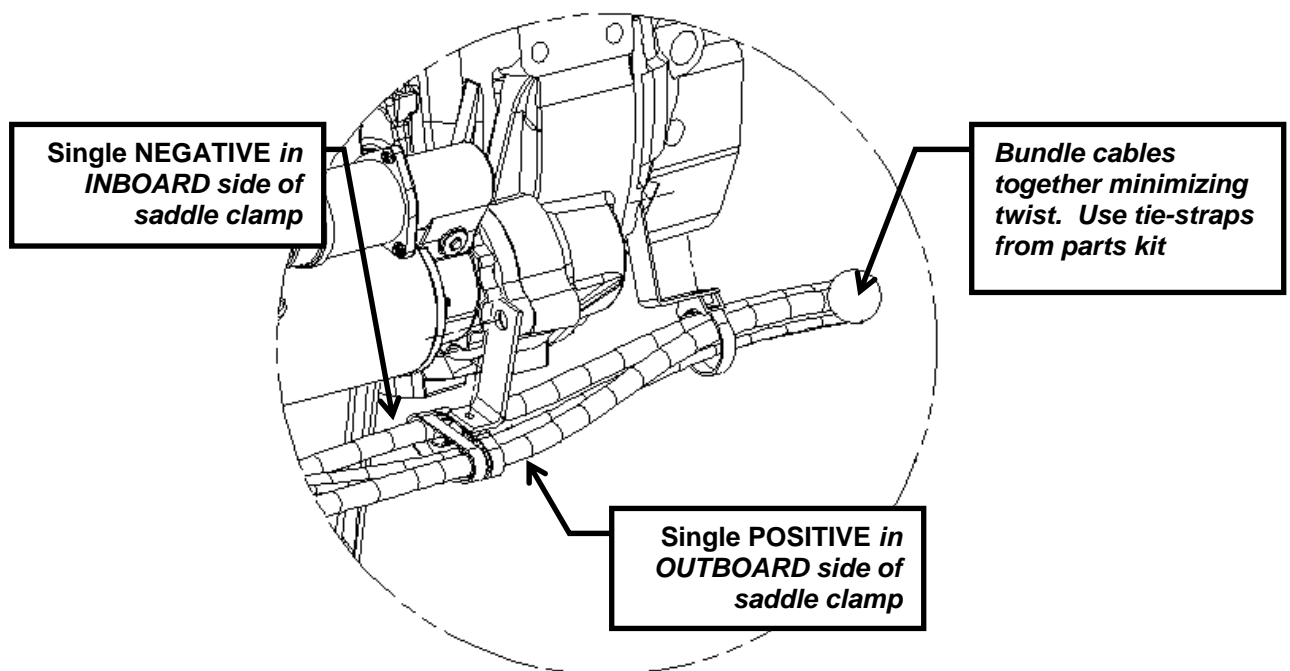
Figure 14
 9900ix
 C10, C11, C12 & C13
 Under CAB Battery Box, NO Belly Band
 Forward Portion of Routing Same as Figure 13

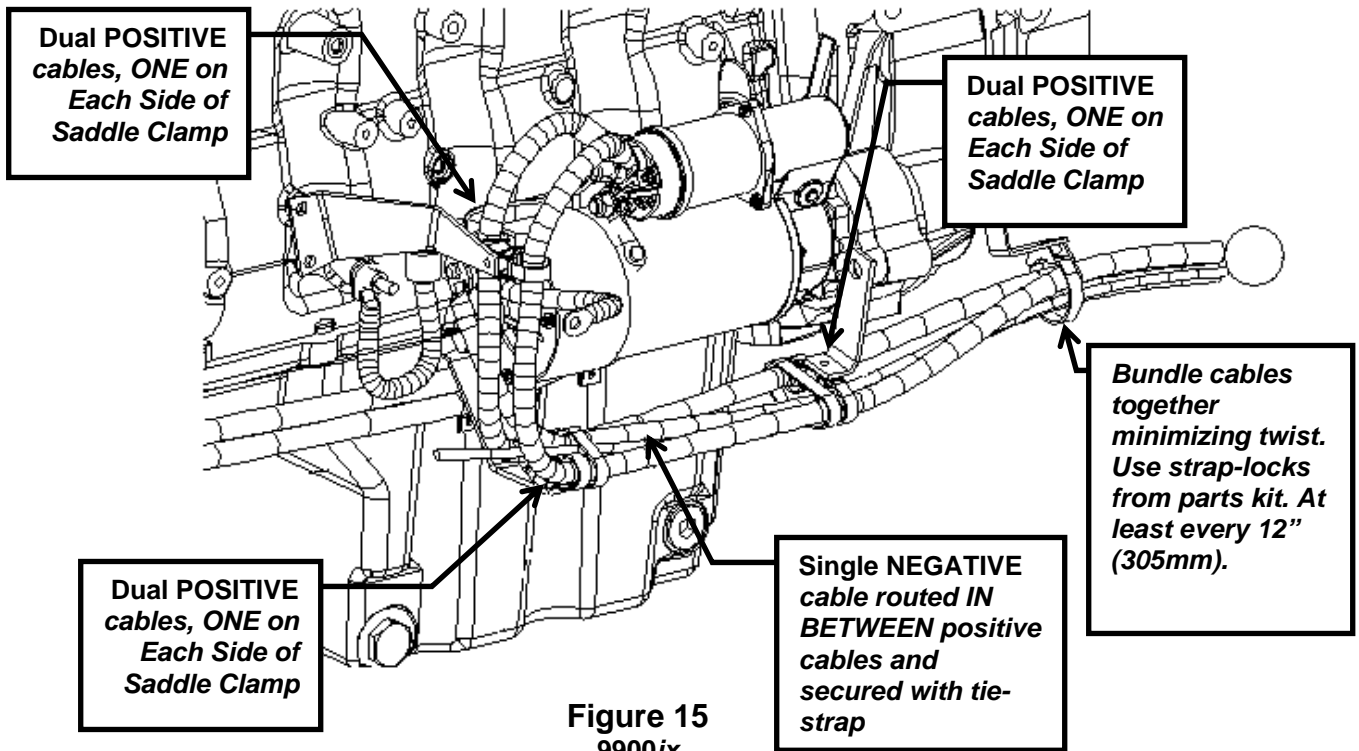
Figure 15
9900ix
C10, C11, C12 & C13
Back of Cab Battery Box NO Belly Band

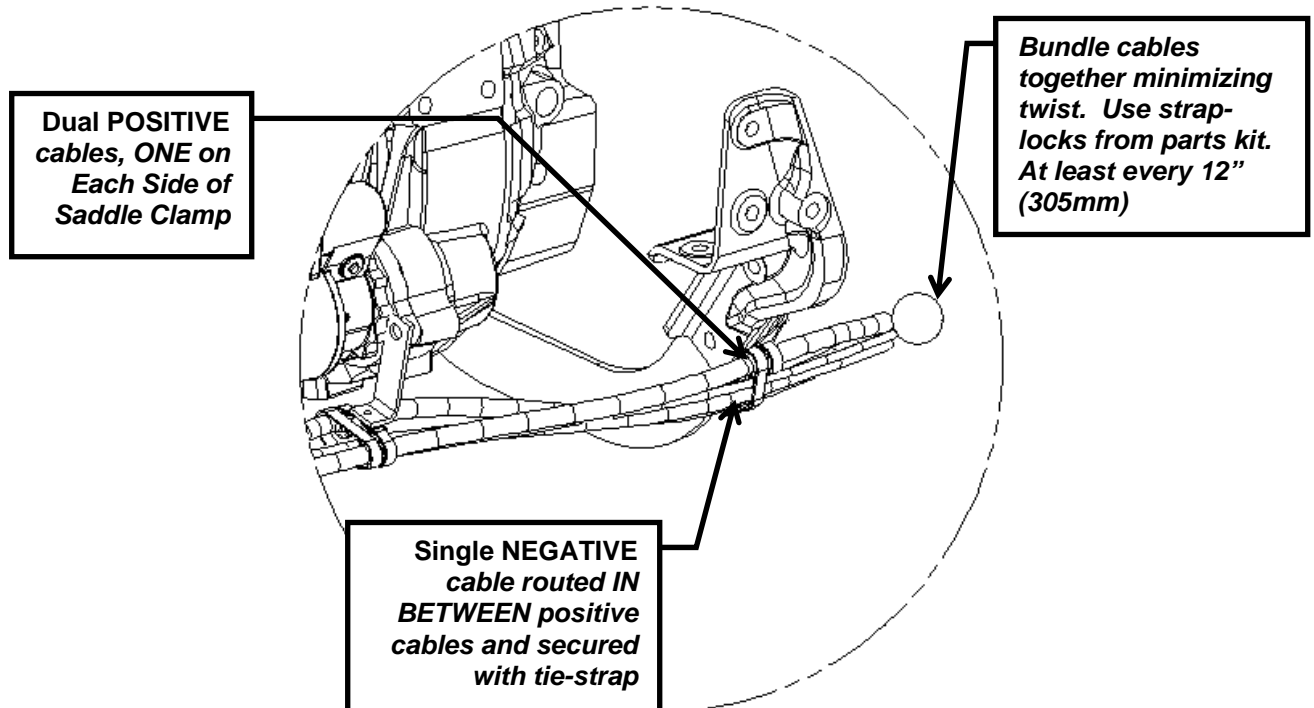
Figure 16
9900ix
C10, C11, C12 & C13
Back of Cab Battery Box, with Belly Band
Forward Portion of Routing Same as Figure 15

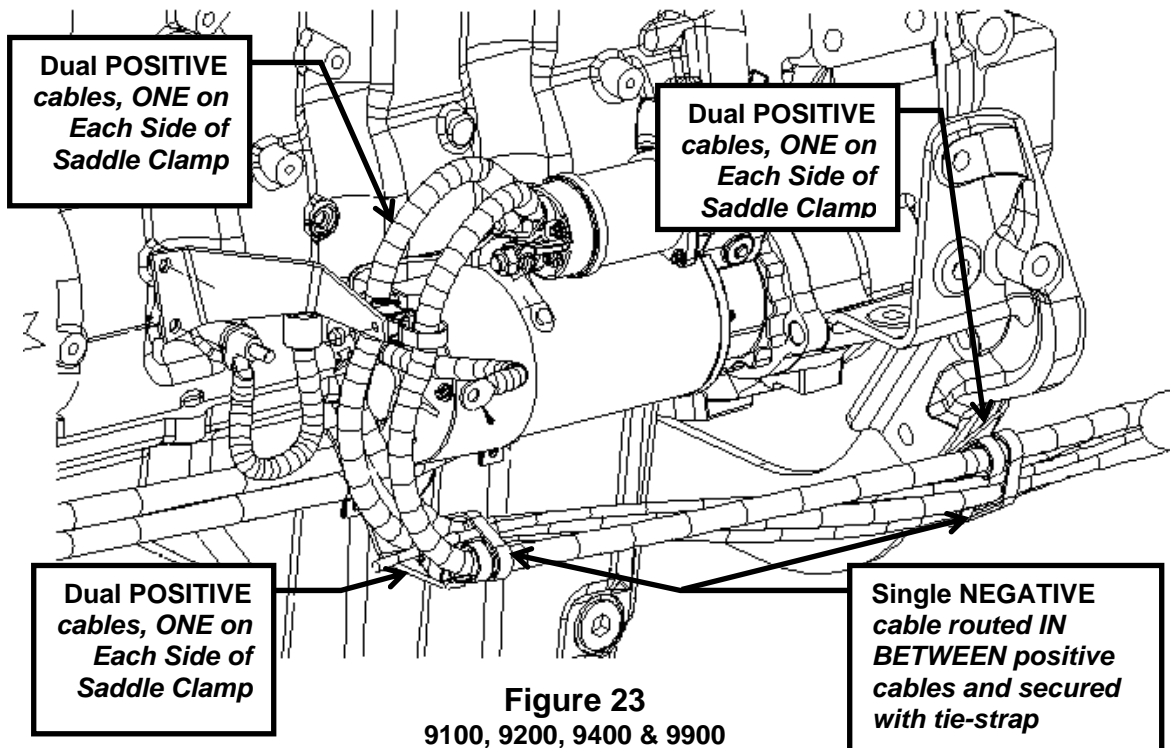
Figure 23
9100, 9200, 9400 & 9900
C10, C11, C12 & C13
With Back of Cab Battery Box and Belly Band

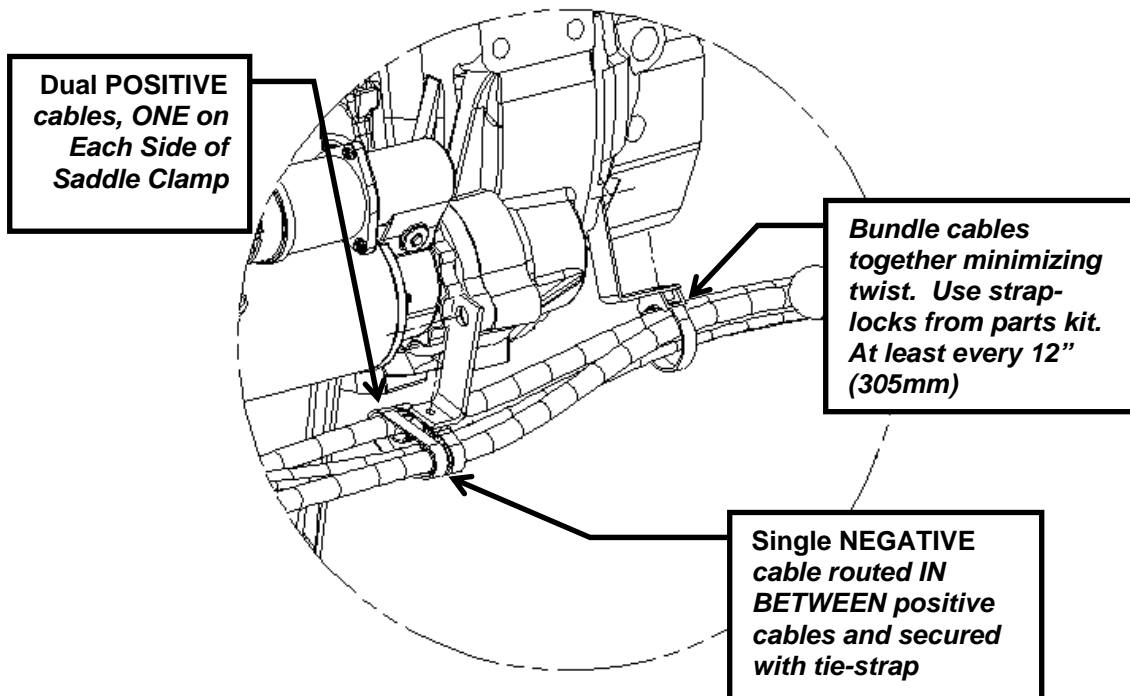
Figure 24
9100, 9200, 9400 & 9900
C10, C11, C12 & C13
Back of Cab Battery Box NO Belly Band
Forward Portion of Routing Same as Figure 23

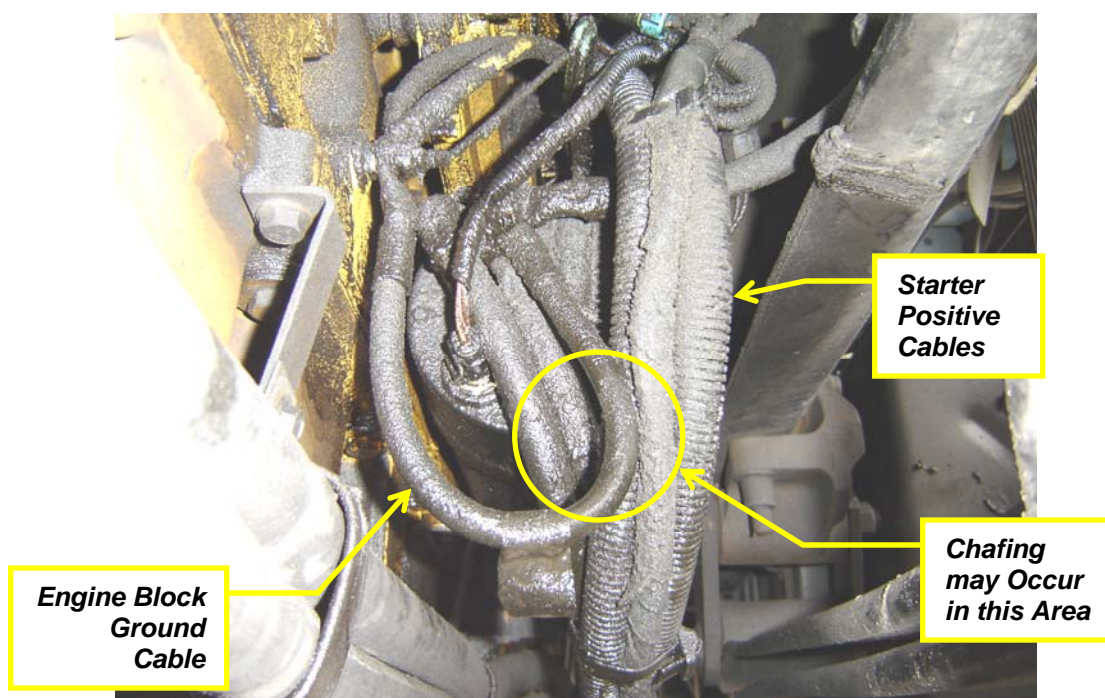
TO PREVENT CHAFING OF THE POSITIVE CABLES AGAINST THE ENGINE BLOCK GROUND CABLE (SEE FIGURE 29), PLEASE ENSURE ENGINE BLOCK GROUND CABLE IS CLOCKED IN THE DOWNWARD (6 O'CLOCK) POSITION, SEE FIGURE 30.

**Figure 29 --
Chafing may occur between Engine Block Ground and Newly Located Positive cables.**

NOTE: *If NO contact or chafing is present between CAT ENGINE GROUND cable and battery cables, NO re-clocking is necessary.*

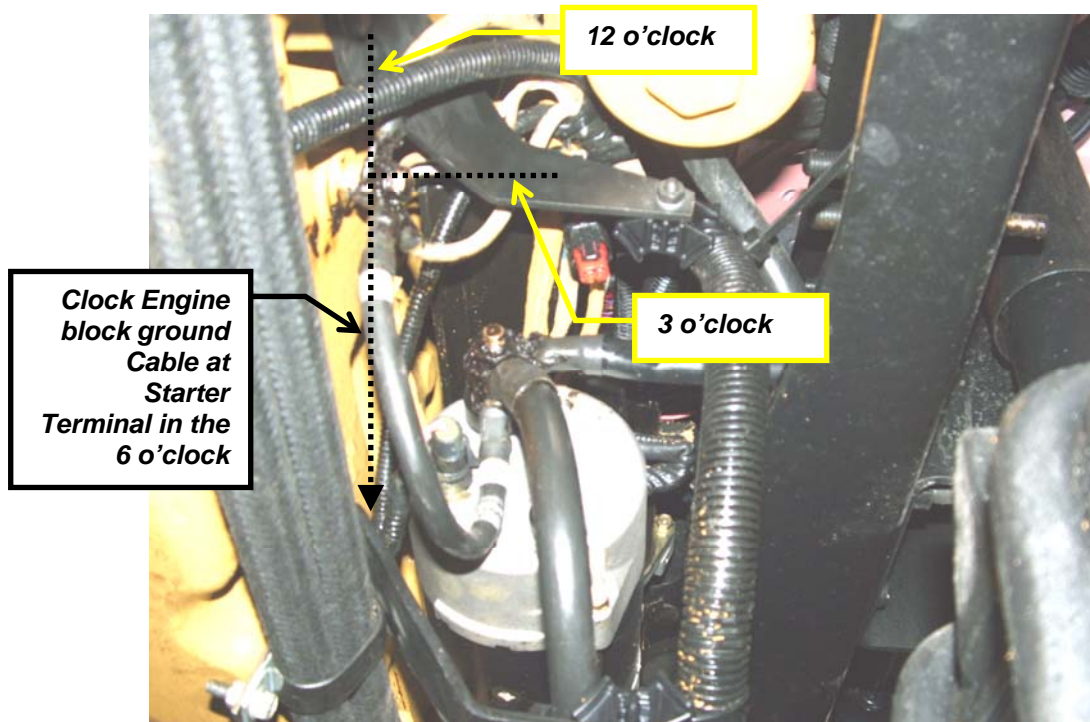
Figure 30 – Correct engine block ground cable routing.

- ***If contact or chafing of the ENGINE GROUND cable against the Battery Cables is present***, rotate and tighten the ground cable on the starter terminal so it is straight down (6 o'clock position) and *not* contacting the starter positive cables, see figure 30.

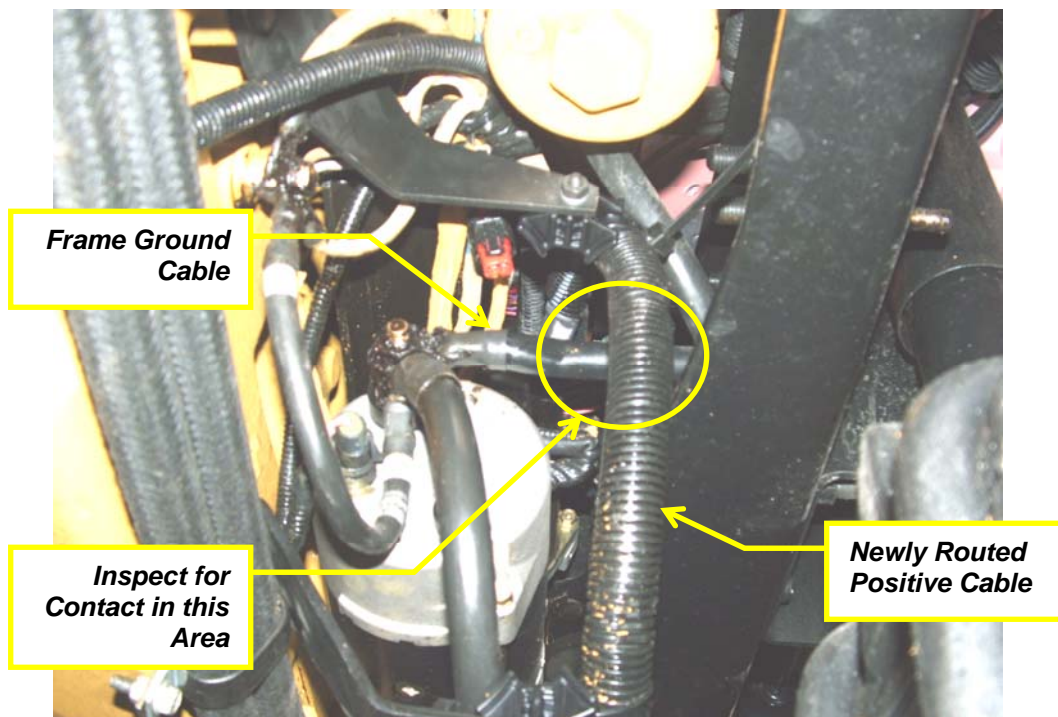
TO PREVENT CHAFING OF THE POSITIVE CABLES AGAINST THE FRAME GROUND CABLE (SEE FIGURE 31), PLEASE ENSURE FRAME GROUND CABLE IS NOT IN CONTACT WITH THE NEWLY ROUTED POSITIVE CABLES, SEE FIGURE 32.

Figure 31 – FRAME Ground Inspection

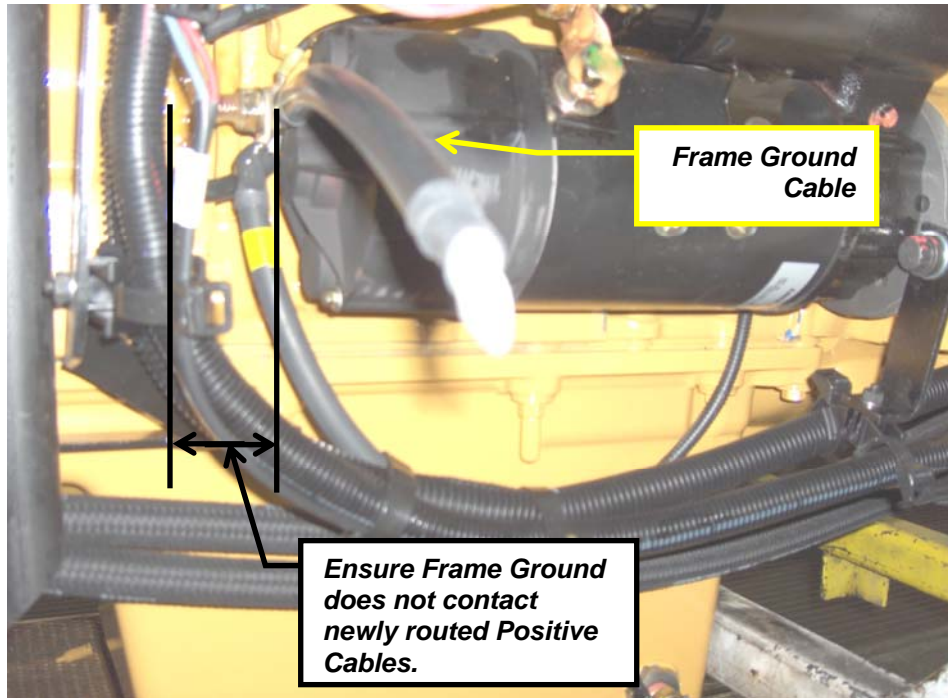
- Ensure cables are not in contact.

Figure 32 – Frame Rail Removed for Clarity
