VEHICLE RECALL

G-05502

SUBJECT: SAFETY RECALL (U.S., EXPORT)

**CAB MOUNTS on certain 4000, 7000, and 8000
Series Models built 1/16/2004 thru 11/1/2004**

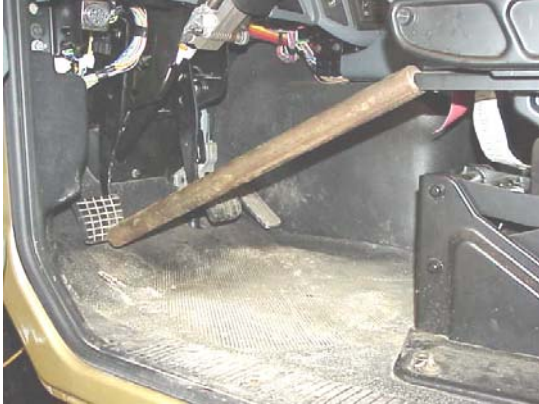
Figure 1 – Clutch Hold Down

4. For 7600, 7700 and 8600 with Caterpillar® engines:
 - a. To access the bolts on the driver's side cab mount bolts, you will also need to fully depress the clutch and use a deep well socket or socket extension. See figures 1 and 2.

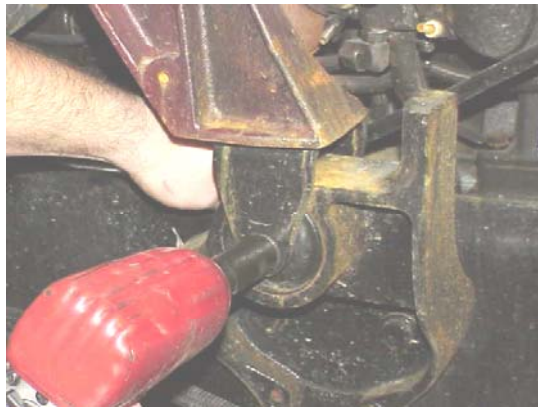
Figure 3 – Remove Lower Mount Bolt

5. For 7700 with Cummins® engines:
 - a. To access the passenger's side cab mount bolts, you will also need to remove the lower mount bolt and raise the cab for access.

6. After replacement of the cab-side cab mount bolts, un-block and lower cab, re-install lower cab mount bolt (see Figure 3).
7. Reinstall the fender extensions.

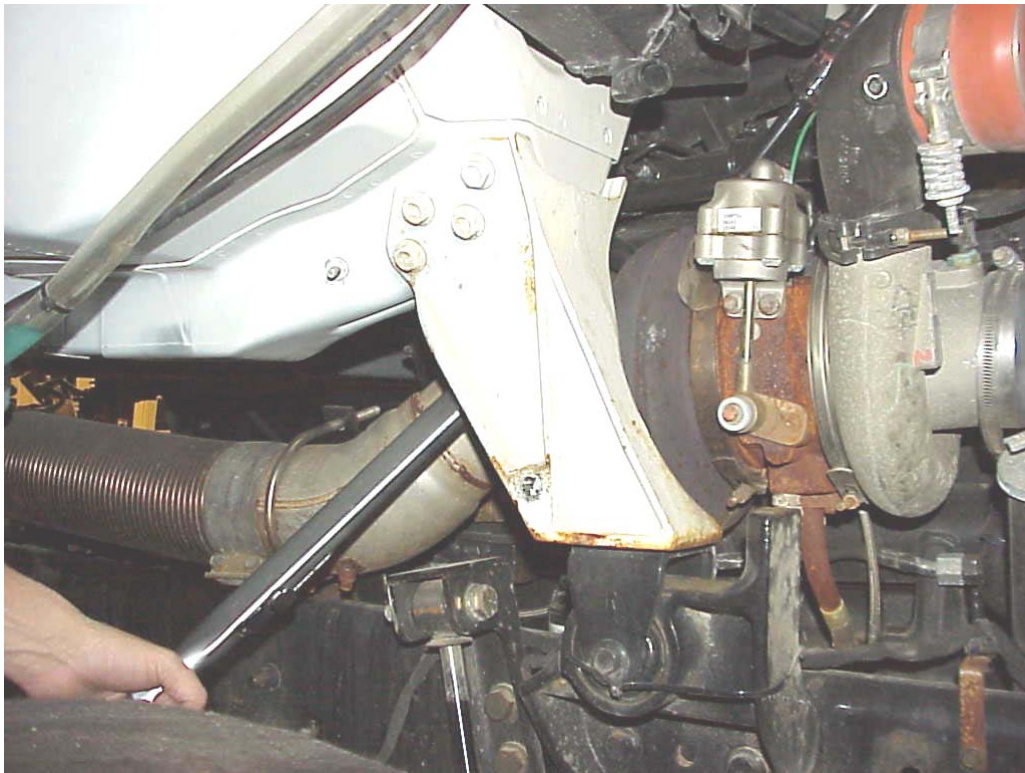
**Figure 7 – Access Inner Bolts from Under and Behind Mounts
(Passenger Side Shown)**
