Authorized Field Change

AFC 08903R2

Subject: VT 275 and MaxxForce 5 Case to Head Tube and Plug D-Ring Seal Deterioration

Engine Family: VT 275

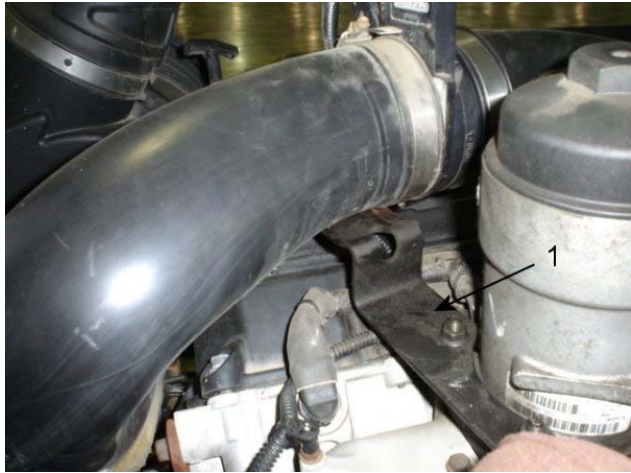
Figure 2

1. Air Cleaner Outlet Pipe Bracket

3. Remove air cleaner outlet pipe bracket (Figure 2).

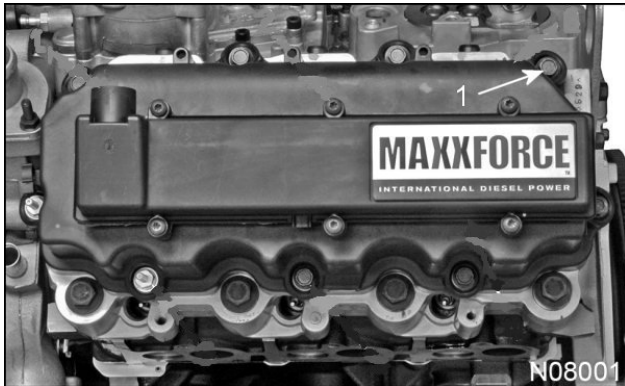
Figure 4 Left Valve Cover

1. Valve Cover Bolt (9)

5. Remove valve cover mount bolts, left (Figure 4).

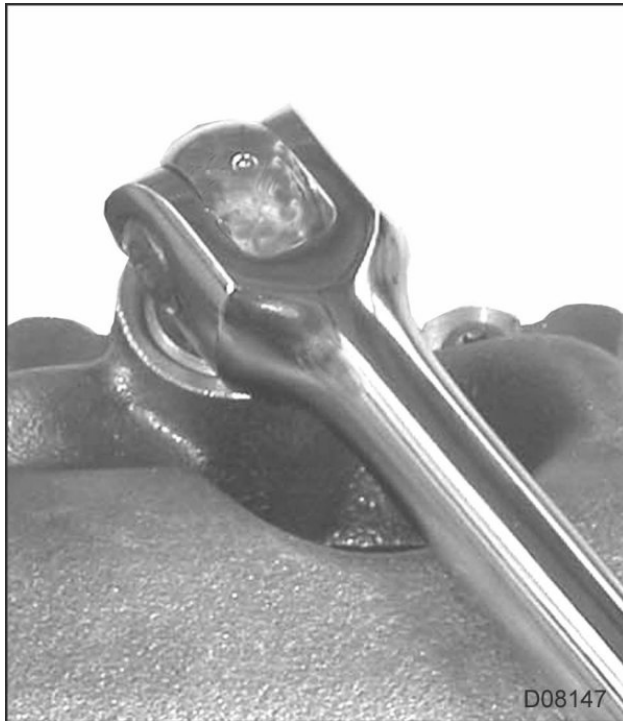
Figure 6 Removing crankcase-to-head tube plug (square head socket shown)

7. Loosen the crankcase-to-head tube assembly plug using a 1/2 inch breaker bar and Allen Hex type or square head socket (Figure 6).

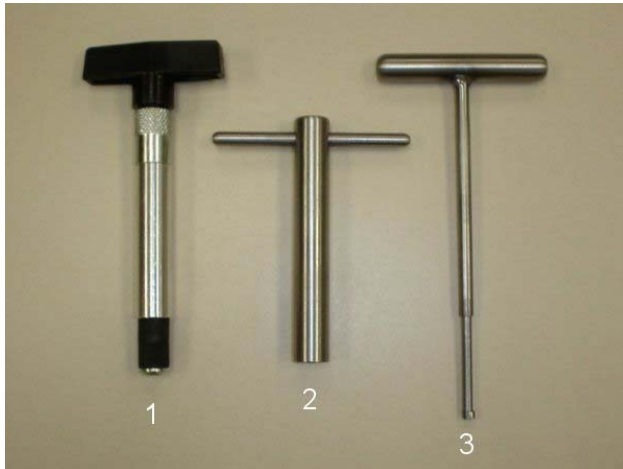
Figure 10 Crankcase-to-Head Tube Removal Tool

1. Tube Removal Tool ZTSE4694A
2. Lower Plug and Tube Removal Tool ZTSE4923
3. Broken Lower Plug Removal Tool ZTSE4922

8. Using the needed service tool (Figure 10), remove the crankcase-to-head tube assembly from the high-pressure oil rail (Figure 11).

9. Insert the Crankcase-to-head tube Removal Tool, (Item 1, Figure 10) into the crankcase-to-head tube, tighten T-handle, and pull out tube. If the lower portion of the plug remains in the lower crankcase-to-head tube, use tool 2 to attach to the lower plug and pull out plug and tube.

If the lower portion of the plug has had the threaded top broken off, use tool 3 to hook the plug and pull out plug and tube.

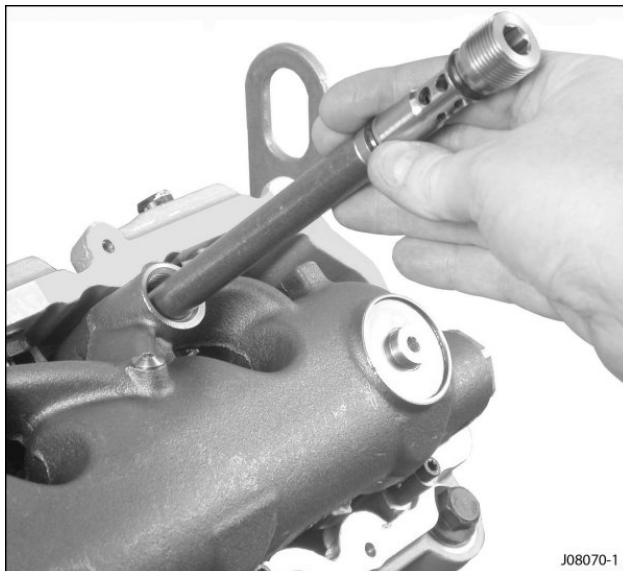
Figure 11 Removing the crankcase-to-head plug (with check valve)

11. Lift out the crankcase-to-head tube assembly and discard.

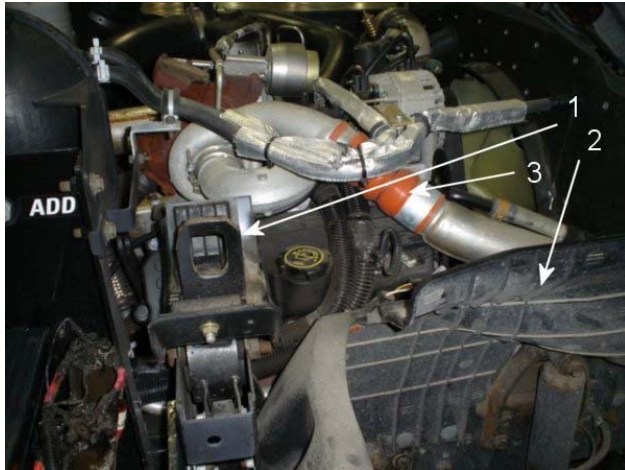
Figure 13

1. Cab Mounting Bracket
2. Engine Splash Shield
3. Charge Air Cooler Intake Hose

1. Disconnect charge air cooler intake hose from turbo and reposition (Figure 13).
2. Remove engine splash shield, right (Figure 13).

3. Remove cab mounting bracket (Figure 13) and right valve cover.
4. Remove injector control pressure sensor (ICP) (Figure 14).
