# VEHICLE RECALL

**G-02512  
December 2002**

**SUBJECT: VEHICLE RECALL (U.S., EXPORT)  
TC-7 Hand Operated Trailer Brake Control Valve  
With Push-to-Connect Fittings May Have Slow Air  
Delivery and Exhaust on Certain 2000, 4000, 5000,  
7000, 8000 & 9000 Models Built Between 4/24/02 and  
6/21/02**

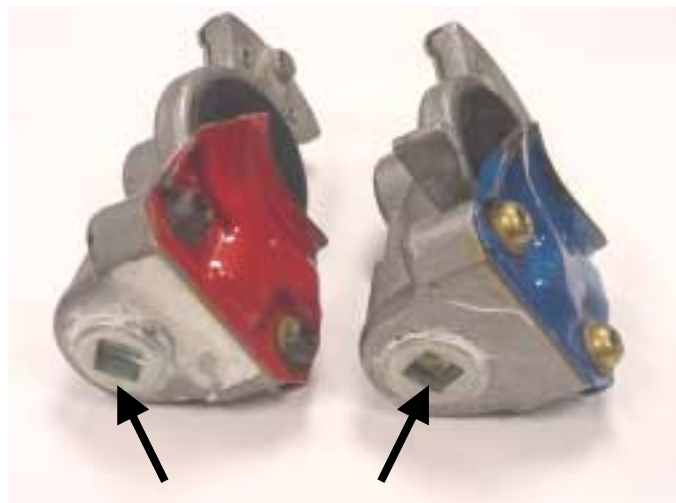
**Figure 1 – Plugged Glad-hands**

1. **WARNING: Block the wheels to prevent the vehicle from moving. If a vehicle moves unexpectedly or suddenly, the result could be serious personal injury or death.**
2. Obtain two glad-hands, with the ports plugged, for this test procedure (See Figure 1). Block off both service and emergency glad-hands on the vehicle by connecting them to the plugged glad-hands shown in Figure 1.

3. Start the engine and keep it running until the governor reaches cutout pressure (125 psi minimum).
4. Push in both the Red and Yellow MV-3 dash buttons (trailer supply and tractor parking buttons).
5. Shut off the engine and release the service brakes if applied.

6. Move the hand control valve to full apply, making a full trailer brake application.
7. Wait 5 seconds to allow the pressure to stabilize.
8. Quickly move the hand control valve back to zero, making a full exhaust.

9. Measure the time it takes to exhaust the control line until no audible exhaust sounds are heard. If the exhaust time is less than a second, the time it takes to quickly say “**one thousand one**”, the valve does not need to be replaced and you can go directly to step 21. If the exhaust time is one second or longer, proceed to steps 10 through 21 and replace the hand control valve. Disconnect and remove the plugged glad-hands from the vehicle.
