VEHICLE RECALL

**G-02509
December 2002**

SUBJECT: VEHICLE RECALL (U.S., EXPORT)

**Fuel Line Harness Inspections and Retrofits on
Certain 7300, 7400 and 7500 Models Built from
7/19/01 through 7/16/2002 with Right Side Frame Rail
Mounted Fuel Filter and with a Left Side Mounted
Fuel Tank**

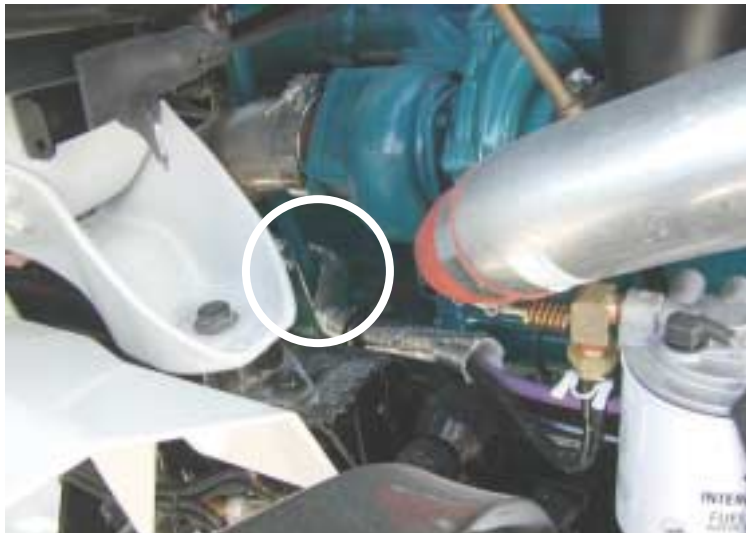
**Figure 1: ABOVE: GOOD ROUTING
NO ACTION REQUIRED.**
The harness is between the engine breather tube and the engine.

4. **Inspect the fuel line routing.** From the right side wheel well, locate the fuel line harness as shown in Figure 1. The fuel line harness must be routed behind the engine breather tube or between the engine breather tube and the engine as shown in Figures 1 and 2. If the fuel line on your vehicle is routed as shown in Figure 1 and 2, it passes the inspection and you should go directly to steps 22 and 23. If the fuel line is routed for the two different exhaust systems, as shown in Figures 3 or 4, a new fuel line harness must be installed and you must continue to step 5 to complete this recall procedure. Reference the **PART INFORMATION** section and obtain the correct fuel line harness and routing kit.

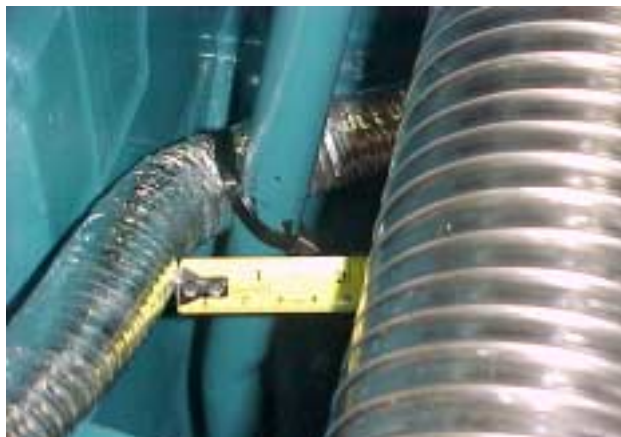
**Figure 2: GOOD ROUTING
NO ACTION REQUIRED.**
View looking forward from transmission

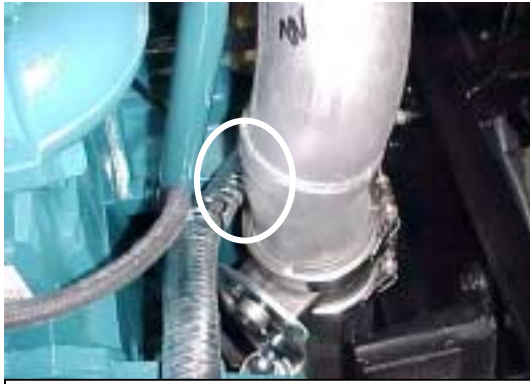
Figure 3: BAD ROUTING

The harness is too close to the **smooth turbo pipe**.
The Fuel Harness Must Be Replaced and Re-Routed.
Continue to step 5. View looking forward from transmission.

15. Lay the fuel line harness in place. Use Figures 5 and 7 for vehicles with the exhaust system that has the smooth exhaust pipe shown in Figure 3. Use Figures 6 and 7 for vehicles with the exhaust system that has the flex exhaust pipe shown in Figure 4.

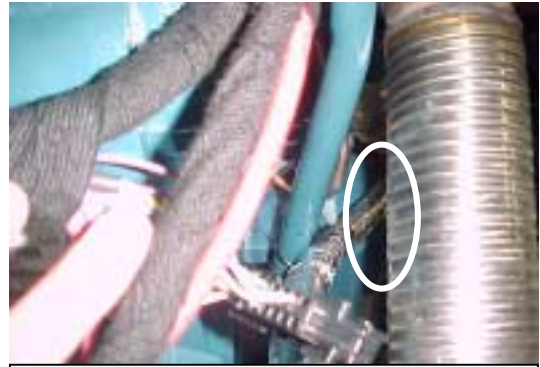
Figure 4: BAD ROUTING

The harness is too close to the **flex exhaust pipe**.
The Fuel Harness Must Be Replaced and Re-Routed.
Continue to step 5. View looking forward from transmission.

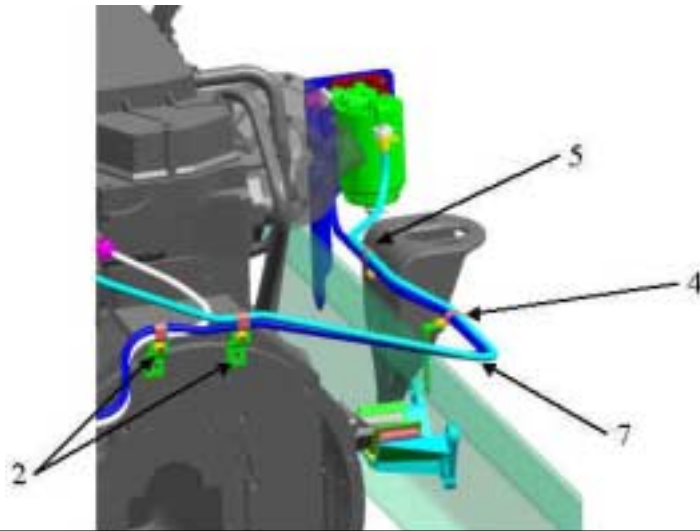
Figure 5: Routing From Bell Housing Forward, Routing Kit 8900088R91 for Vehicles With A Smooth Exhaust Pipe

- Items:
- 2. Two Z-style extension clips, p-clamps, M8 nuts/bolts
 - 4. One L-shaped extension clip, p-clamp, M8 nut/bolt, mounted to upper/forward engine mount
 - 5. One clamp, M6 bolt/nut on cab mount
 - 7. Fuel harness

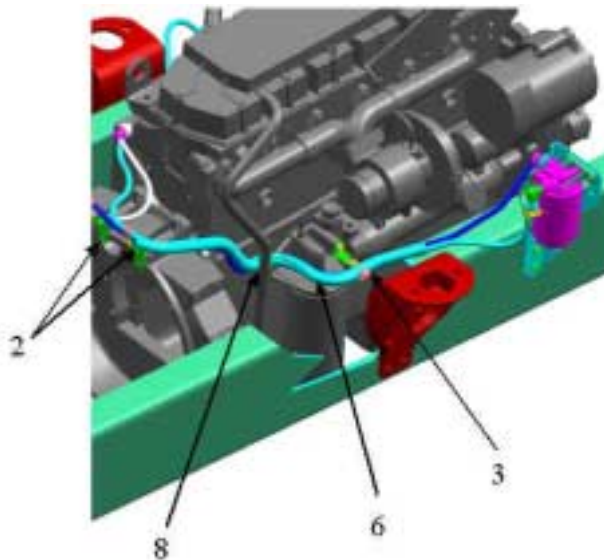
Figure 6: Routing From Bell Housing Forward, Routing Kit 8900087R91 For Vehicles With A Flex Exhaust Pipe

- Items:
- 2. Two Z-style extension clips, p-clamps, M8 nuts/bolts
 - 3. Straight extension clip, clamp, at filter base
 - 6. Fuel line harness
 - 8. The harness **MUST** be behind the breather tube.

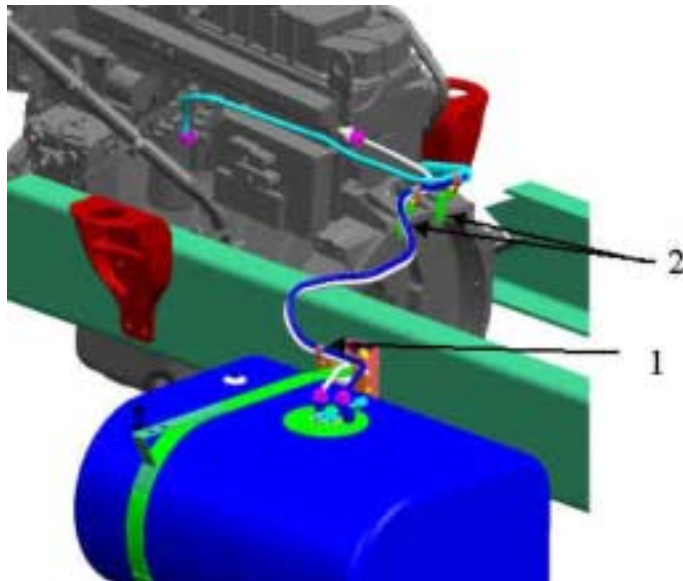
Figure 7: Routing From Tank to Bell Housing & Pump, Applies To All

Items:

1. Save original clamping hardware and reuse during installation.
2. Two Z-style extension clips, p-clamps, M8 nuts/bolts

10. Position the cab floor mat out of your way.
11. Remove the engine cover.
12. Remove and discard all clipping from the fuel line harness except for item 1 in Figure 7. This clip must be reused during the installation. The rest of the clips will be replaced with new ones from the recall kit.

16. Beginning at the fuel tank, install the new harness clips up to the bell housing (see Figure 7). Clips are to be installed at the black tape locations on the harness.
17. From the bell housing forward, the instructions are different depending on which harness is being installed. Using the appropriate Figure, 5 or 6, install the clipping from the bell housing forward.
18. Connect all the fuel lines and bleed the fuel lines as necessary.
19. Install the engine cover and reposition the floor mat.
20. Install the kick panel, sill plate, shifter assembly, cup holder and the seat.
21. Install both hood fender extensions.
22. Install the engine splash shield.
23. Close the hood assembly and remove the wheel chocks.
