VEHICLE RECALL

G-02504
April 2002

SUBJECT: VEHICLE RECALL (U.S., EXPORT)
Missing Cotter Pin at the Connection of the Drag
Link to the Pitman Arm on 4200, 4300 and 4400
Models Built From 1/24/2002 through 1/31/2002.

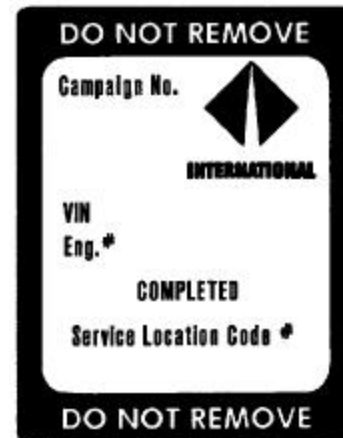
CAMPAIGN IDENTIFICATION LABEL

Each vehicle corrected in accordance with this campaign **MUST BE** marked with a CTS-1075 campaign Identification Label.

Complete the label and attach on a clean surface next to the vehicle identification number (VIN) plate.
