Authorized Field Change

AFC G-05911

Subject: Rerouting of the Instrument Panel (IP) Harness Behind the Front Grille and Main Chassis Harness at the Transmission and Engine Crossmember to Prevent Chafing on CF 500 and CF 600 Models Built Between August 4, 2004 and August 7, 2005

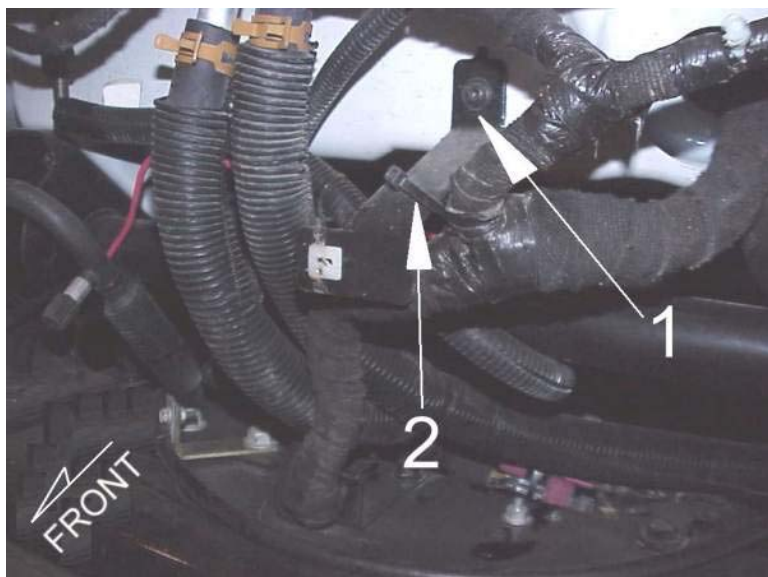
Figure 1 Remove Tie Strap from Bracket

1. Grille Mounting Bracket
2. Cable Strap Lock

1. Remove grille mounting screw, and remove grille.
2. Remove cable strap lock securing the IP harness to grille mounting bracket (Figure 1).

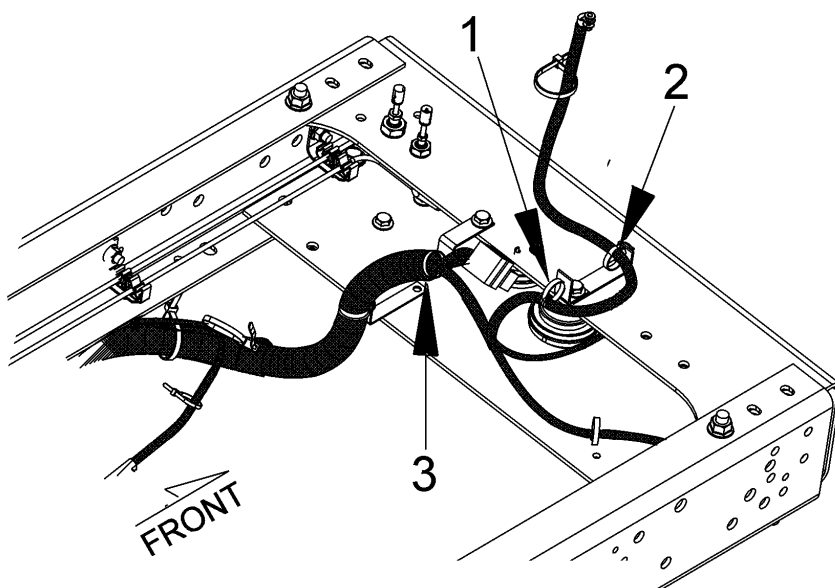
Figure 2 Remove Tie Straps

1. Rear Cable Strap Lock
2. Front Cable Strap Lock
3. Cable Strap Lock, Rear Driver Side Bracket

3. Remove 2 cable strap locks securing the IP harness to passenger side bracket(s) (Figure 2, Item 1 and Item 2). Remove the bracket and save fasteners for reuse during reassembly.

4. Remove cable strap lock securing the IP harness to rear of driver side bracket (Figure 2, Item 3). Remove the bracket and save fasteners for reuse during reassembly.
5. When necessary, remove other cable strap locks to allow movement of wire harness.
6. Use the original fasteners and a small P-clip to secure the harness at the point where the passenger side bracket was removed. Orient the P-clip with the loop to the rear, facing up (Figure 3, Item 2).

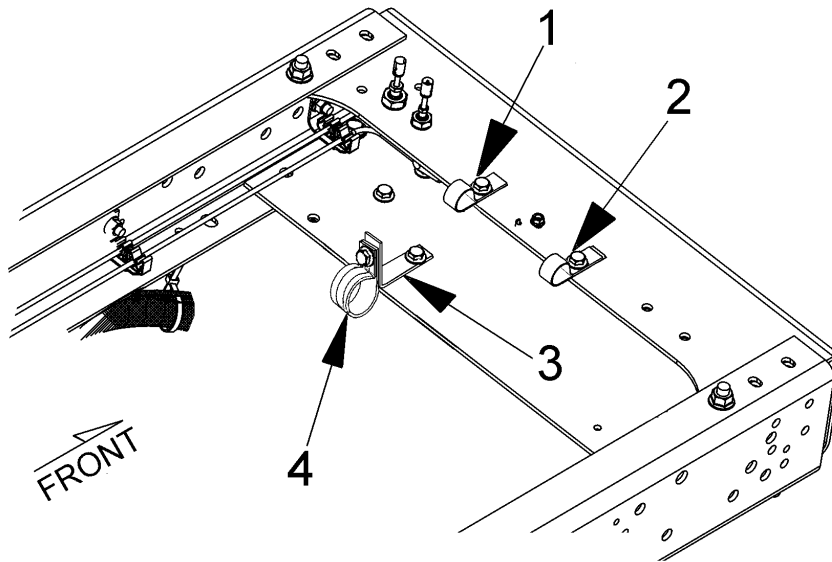
Figure 3 Install P-Clips

1. Small P-Clip, Drivers Side Location
 2. Small P-Clip, Passenger Side Location
 3. Existing "L" Bracket
 4. Larger P-Clip, Drivers Side Location
7. On the driver side, two P-clips (Figure 3, Item 1 and Item 4) will be installed in place of the driver side brackets using the original fasteners. The larger clip, Figure 3, Item 4, must secure the larger harness, and is fastened to the existing "L" bracket, Figure 3, Item 3, with the P-clip loop facing down. The small clip, Figure 3, Item 1, must secure the small harness and should have the loop facing up (Figure 3, Item 1, Item 2, and Item 4).
 8. With the clips in place the harness should be secured so that it runs parallel with the rear of the crossmember and clear of any interference and secure the upper leg of the harness to the cab hinge bar with a cable strap lock (Figure 4 and Figure 5).

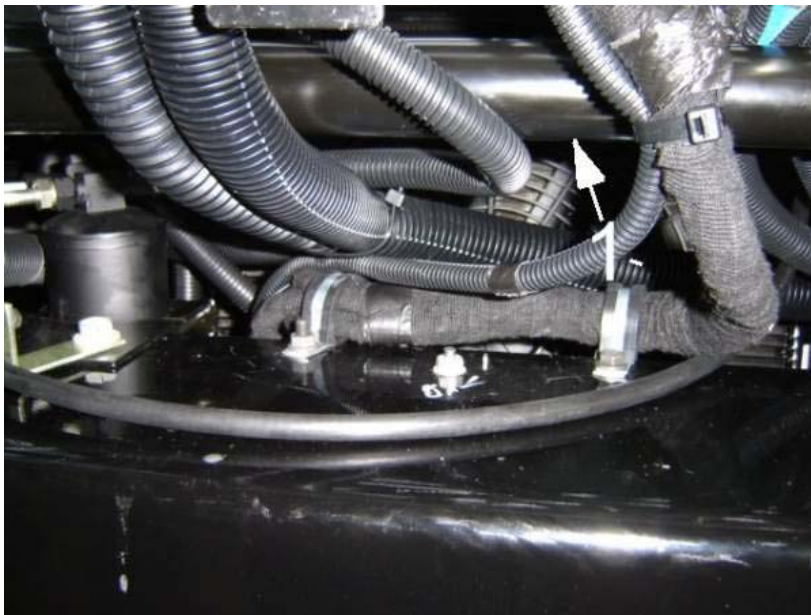
Figure 5 Front View of Revised Harness Routing

1. Hinge Bar

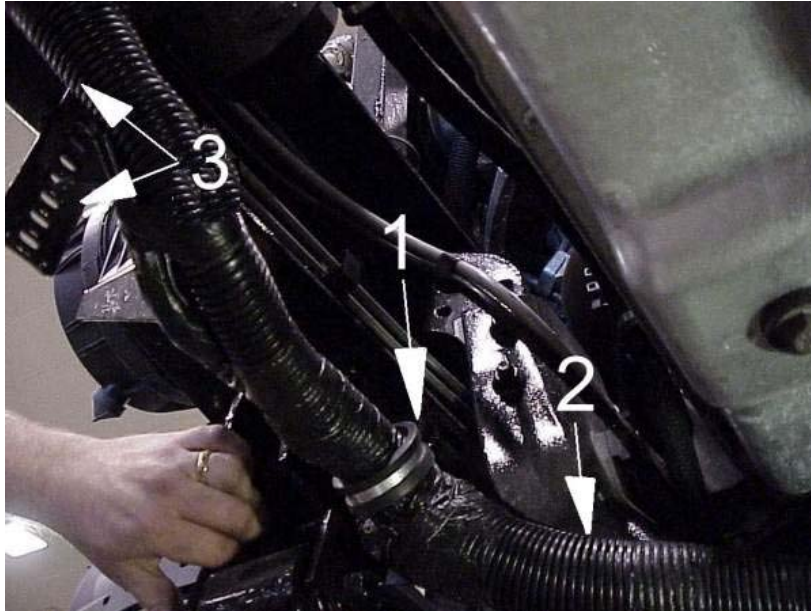
Figure 6 Install Cushioned P-Clip Viewed from Under Chassis

1. Cushioned P-Clip
2. Main Harness
3. Cable Strap Lock and Bracket

10. On the driver side frame rail behind the cab, locate and remove two (2) cable strap locks from the main chassis harness near the break out harness.
11. Remove the cable strap lock bracket near the harness break out and replace it with a cushioned P-clip.
12. Re-install the main chassis harness into the cushioned P-clip (Figure 6, Item 1), before the break out harness (Figure 7, Item 1), and tighten the fasteners .

1. Breakout Harness
13. Install a cable strap lock to the main chassis harness to the rear of the cushioned P-clip as shown in Figure 6, Item 3.
14. From under the chassis locate two (2) cable strap locks securing the main harness to the engine crossmember.
15. Remove the cable strap locks.
16. Remove the fasteners and cable strap lock brackets. Reinstall the brackets so that the bend in the bracket is facing downward (Figure 8, Item 5).

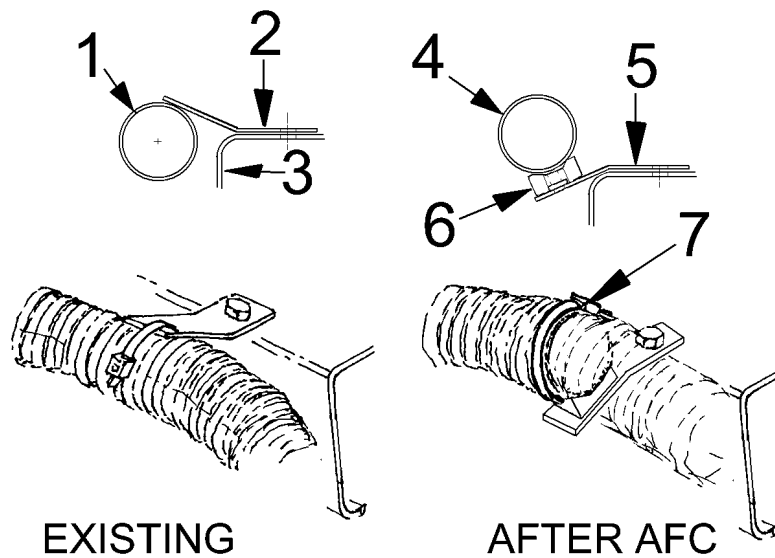
Figure 8 Revised Harness Bracket Orientation

1. (OLD) Break Out Harness Below Bracket
2. (OLD) Bend in Bracket Upward
3. Engine Crossmember
4. (NEW) Break Out Harness Above Bracket
5. (NEW) Bend in Bracket Downward
6. (NEW) Saddle
7. Cable strap lock

17. Install a saddle to both brackets (Figure 8, Item 6) and secure the main harness with cable strap locks (Figure 8, Item 7). When properly routed the harness should look like Figure 9.

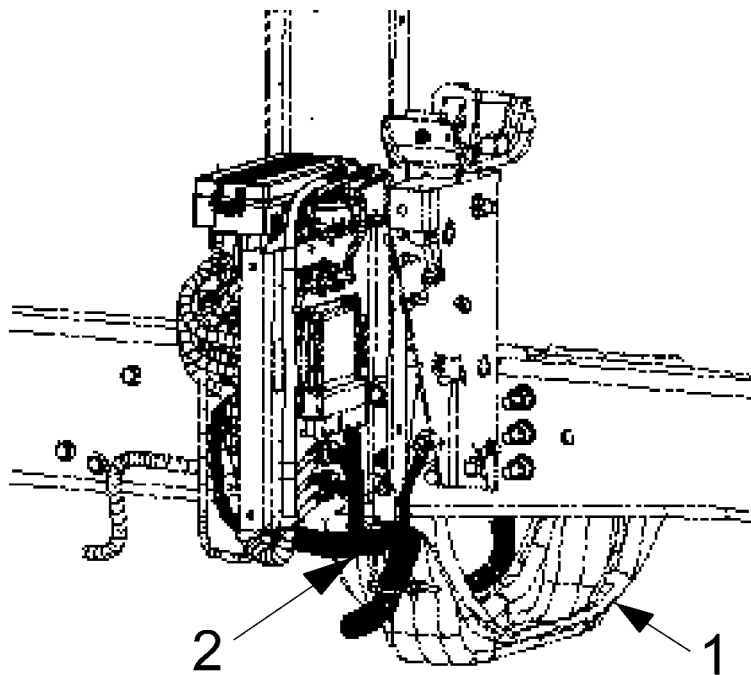
Figure 10 Typical Harness Routing on the Passenger Side of the Engine Crossmember

- 1. Engine Crossmember
- 2. Typical Location of Harness Bracket, Saddle, and Cable Strap Lock

18. Follow the main harness to the passenger side to locate the third (3) cable strap lock. Note the harness, cable strap lock and bracket will be on the passenger side of the engine crossmember (Figure 10, Item 2). Remove the cable strap lock, install a saddle to the existing bracket and secure the harness (Figure 11).
