# VEHICLE RECALL

**G-02513  
December 2002**

**SUBJECT: VEHICLE RECALL (U.S., EXPORT)  
Driveline Parking Brake May Not Function Properly  
On Certain 3200, 4200, 4300 and 4400 Models Built  
Between 11/16/00 and 4/19/02**

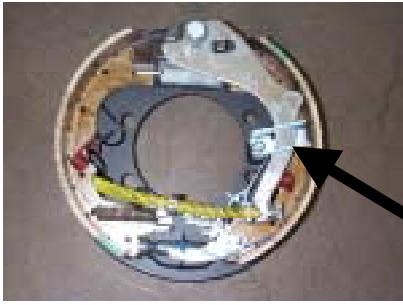
**Figure 2: Left**

**VEHICLE DOES NOT NEED RECALL**

Vehicles with the lever arm and guide called out here do not need the recall performed.
