SERVICE PROCEDURE

G-06511
February 2007

SUBJECT: SAFETY RECALL (U.S., EXPORT)
CAB ENTRY/EGRESS GRAB HANDLE on certain
CF500 and CF600 Models built 6/2/2004 thru
7/20/2006

DEFECT DESCRIPTION

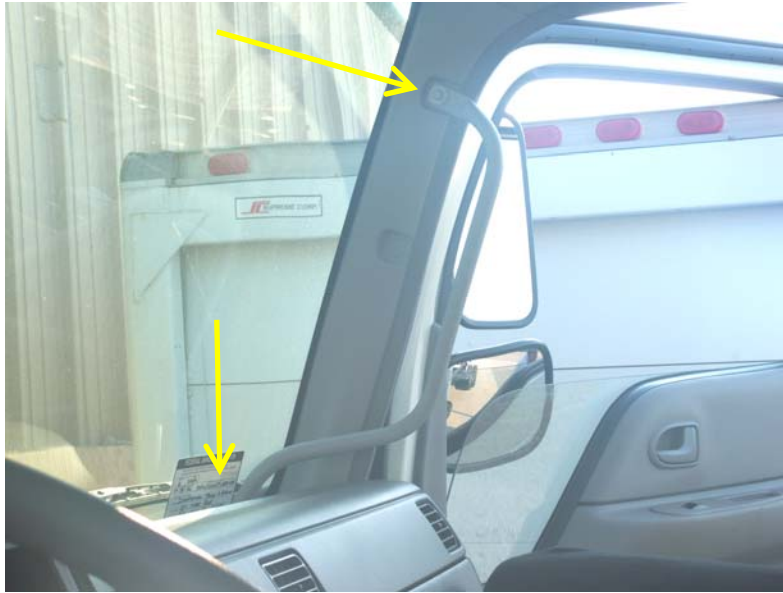
Figure 1

1. Remove the cab entry/egress grab handle by removing two (2) bolts.

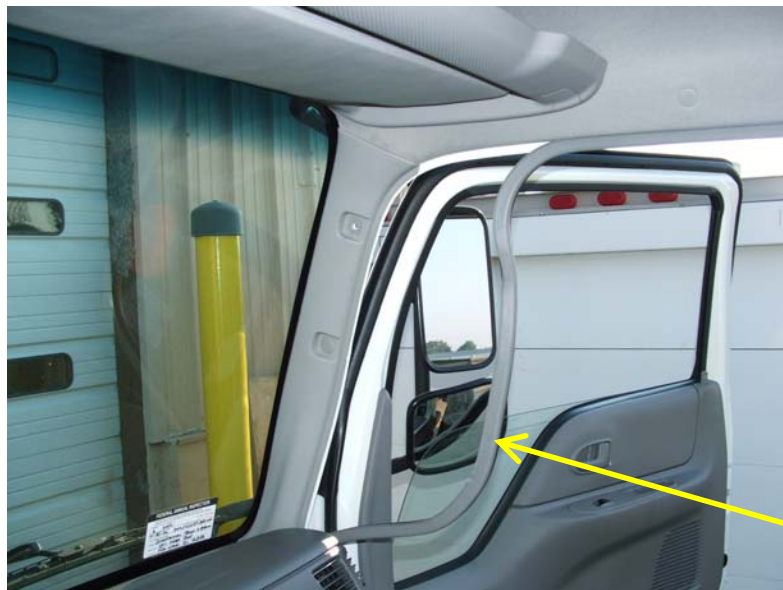
Figure 2

2. Remove a portion of the door frame wind lace for ease in trim panel removal.
